2014 Annual Report of the Ground-Level Monitoring Committee

prepared for
Chino Basin Watermaster

July 2015

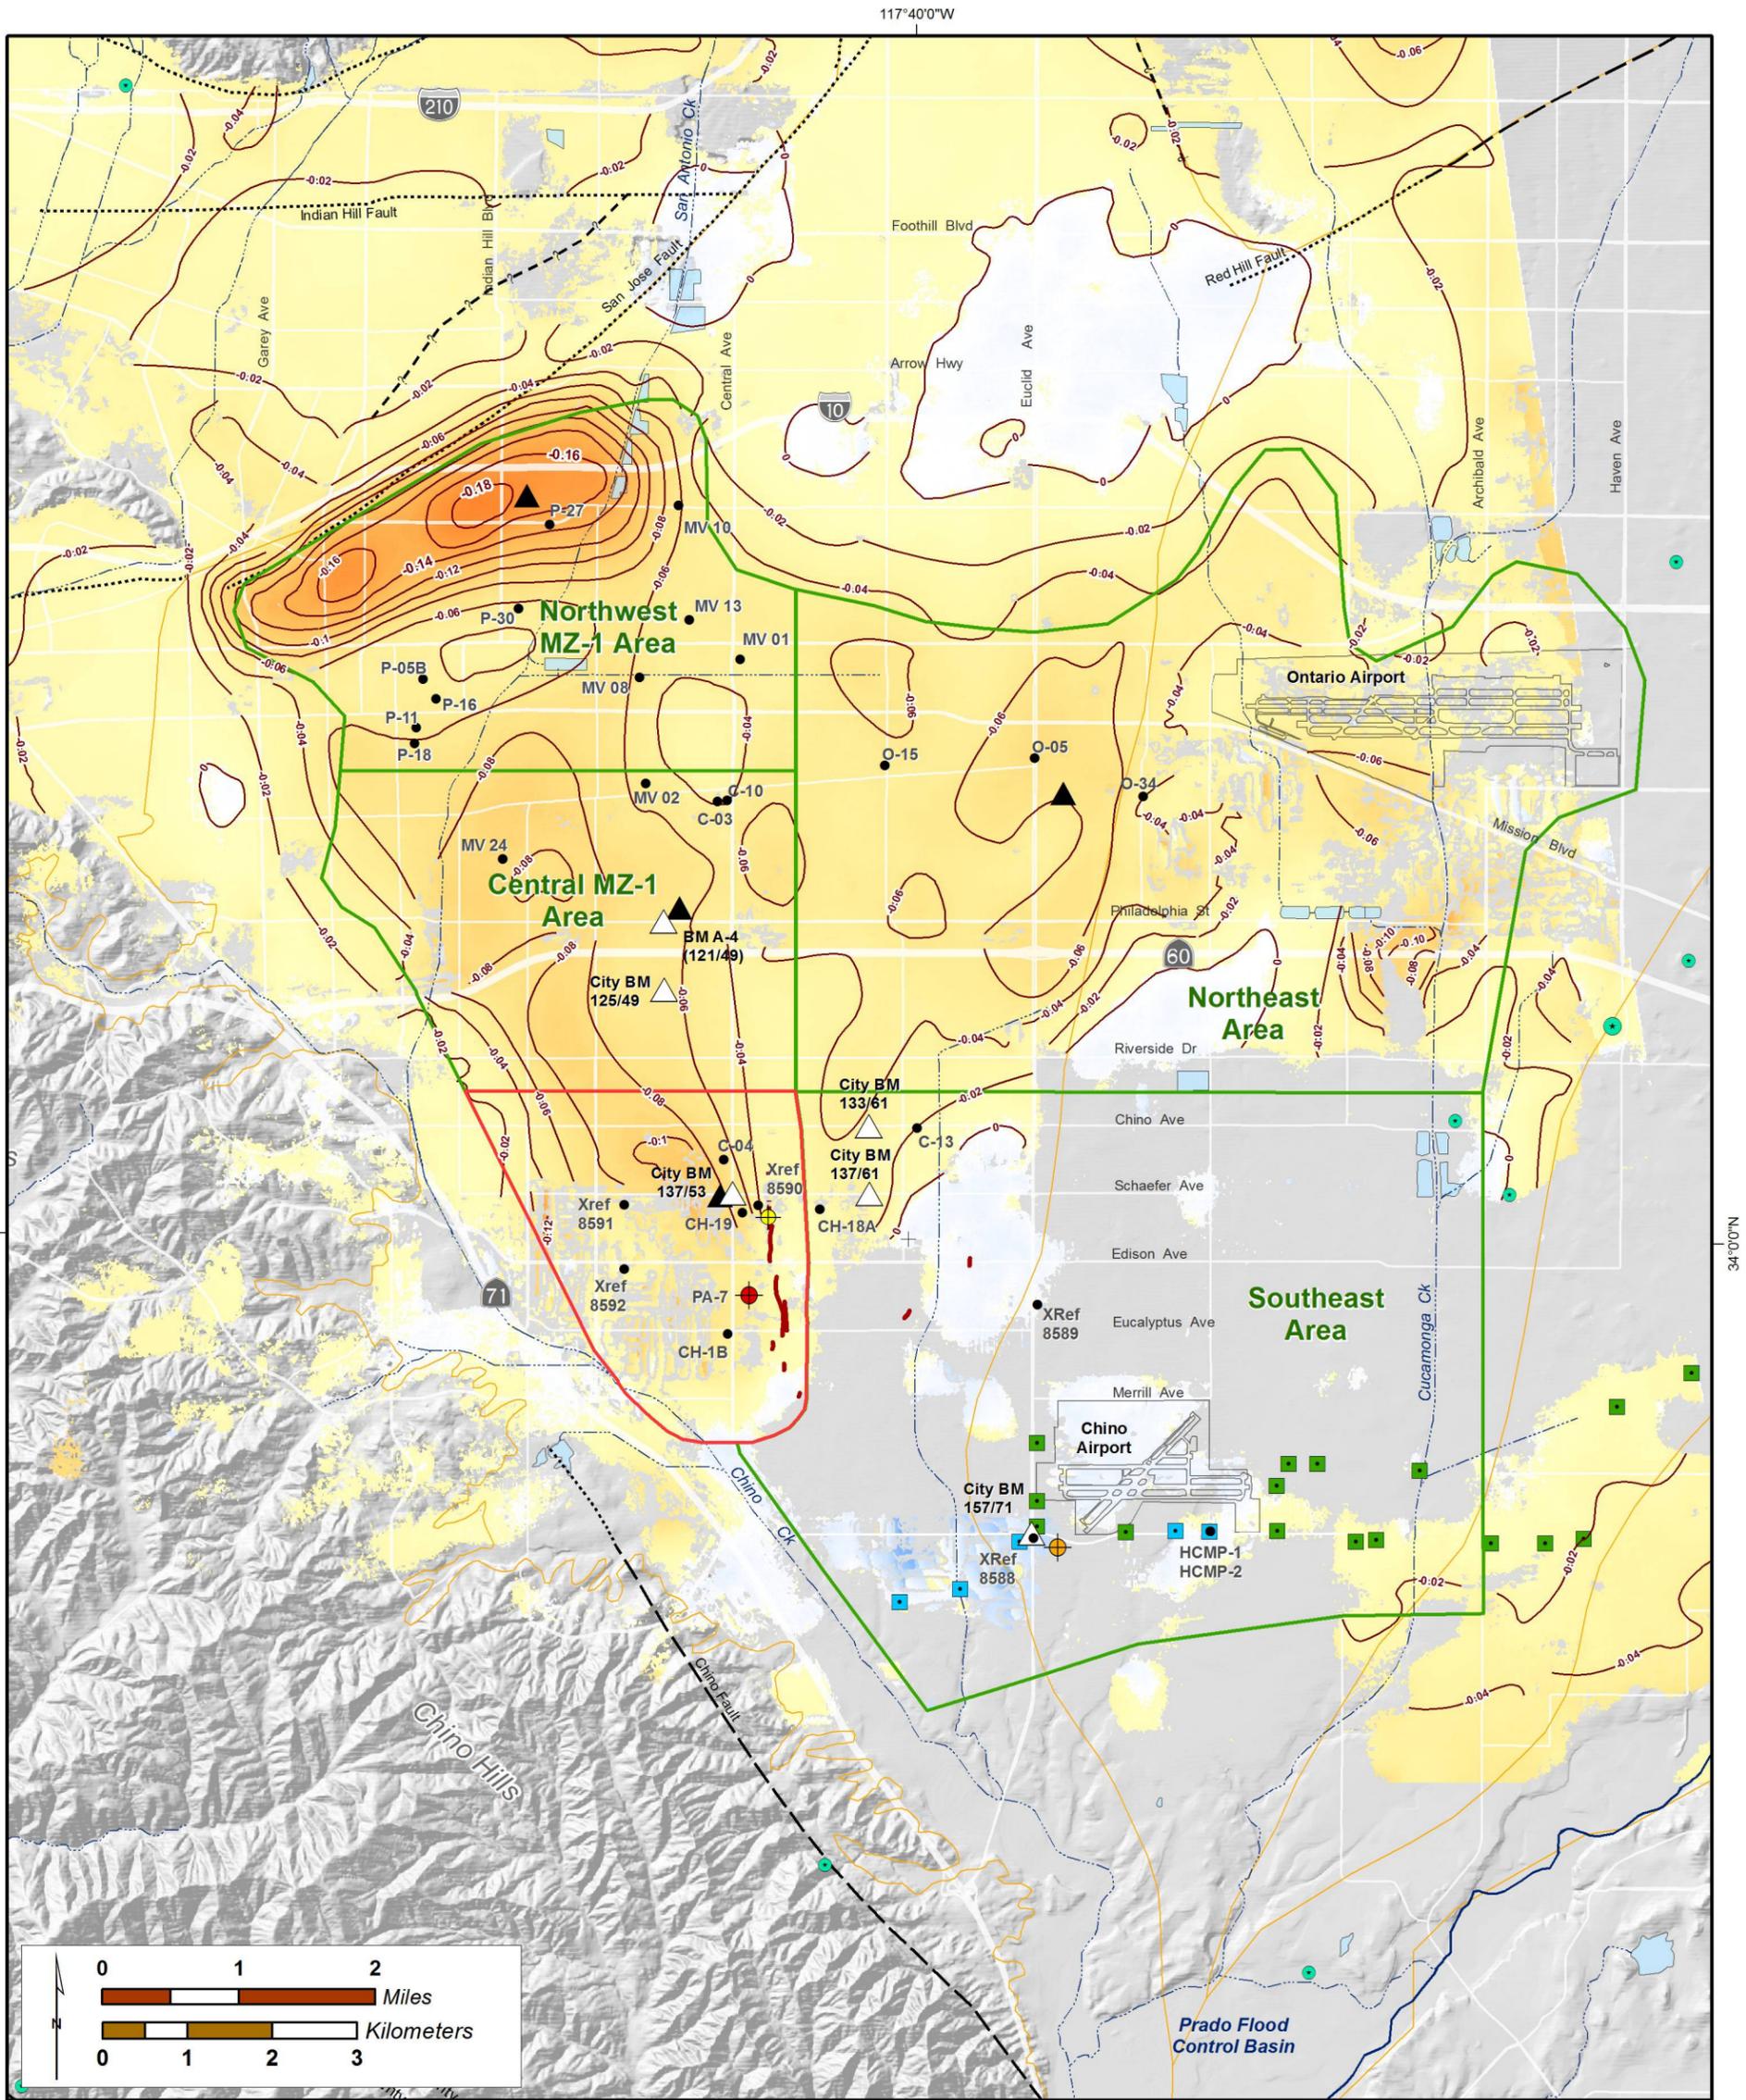
**Vertical Ground Motion
across Western Chino Basin
2011-2014**

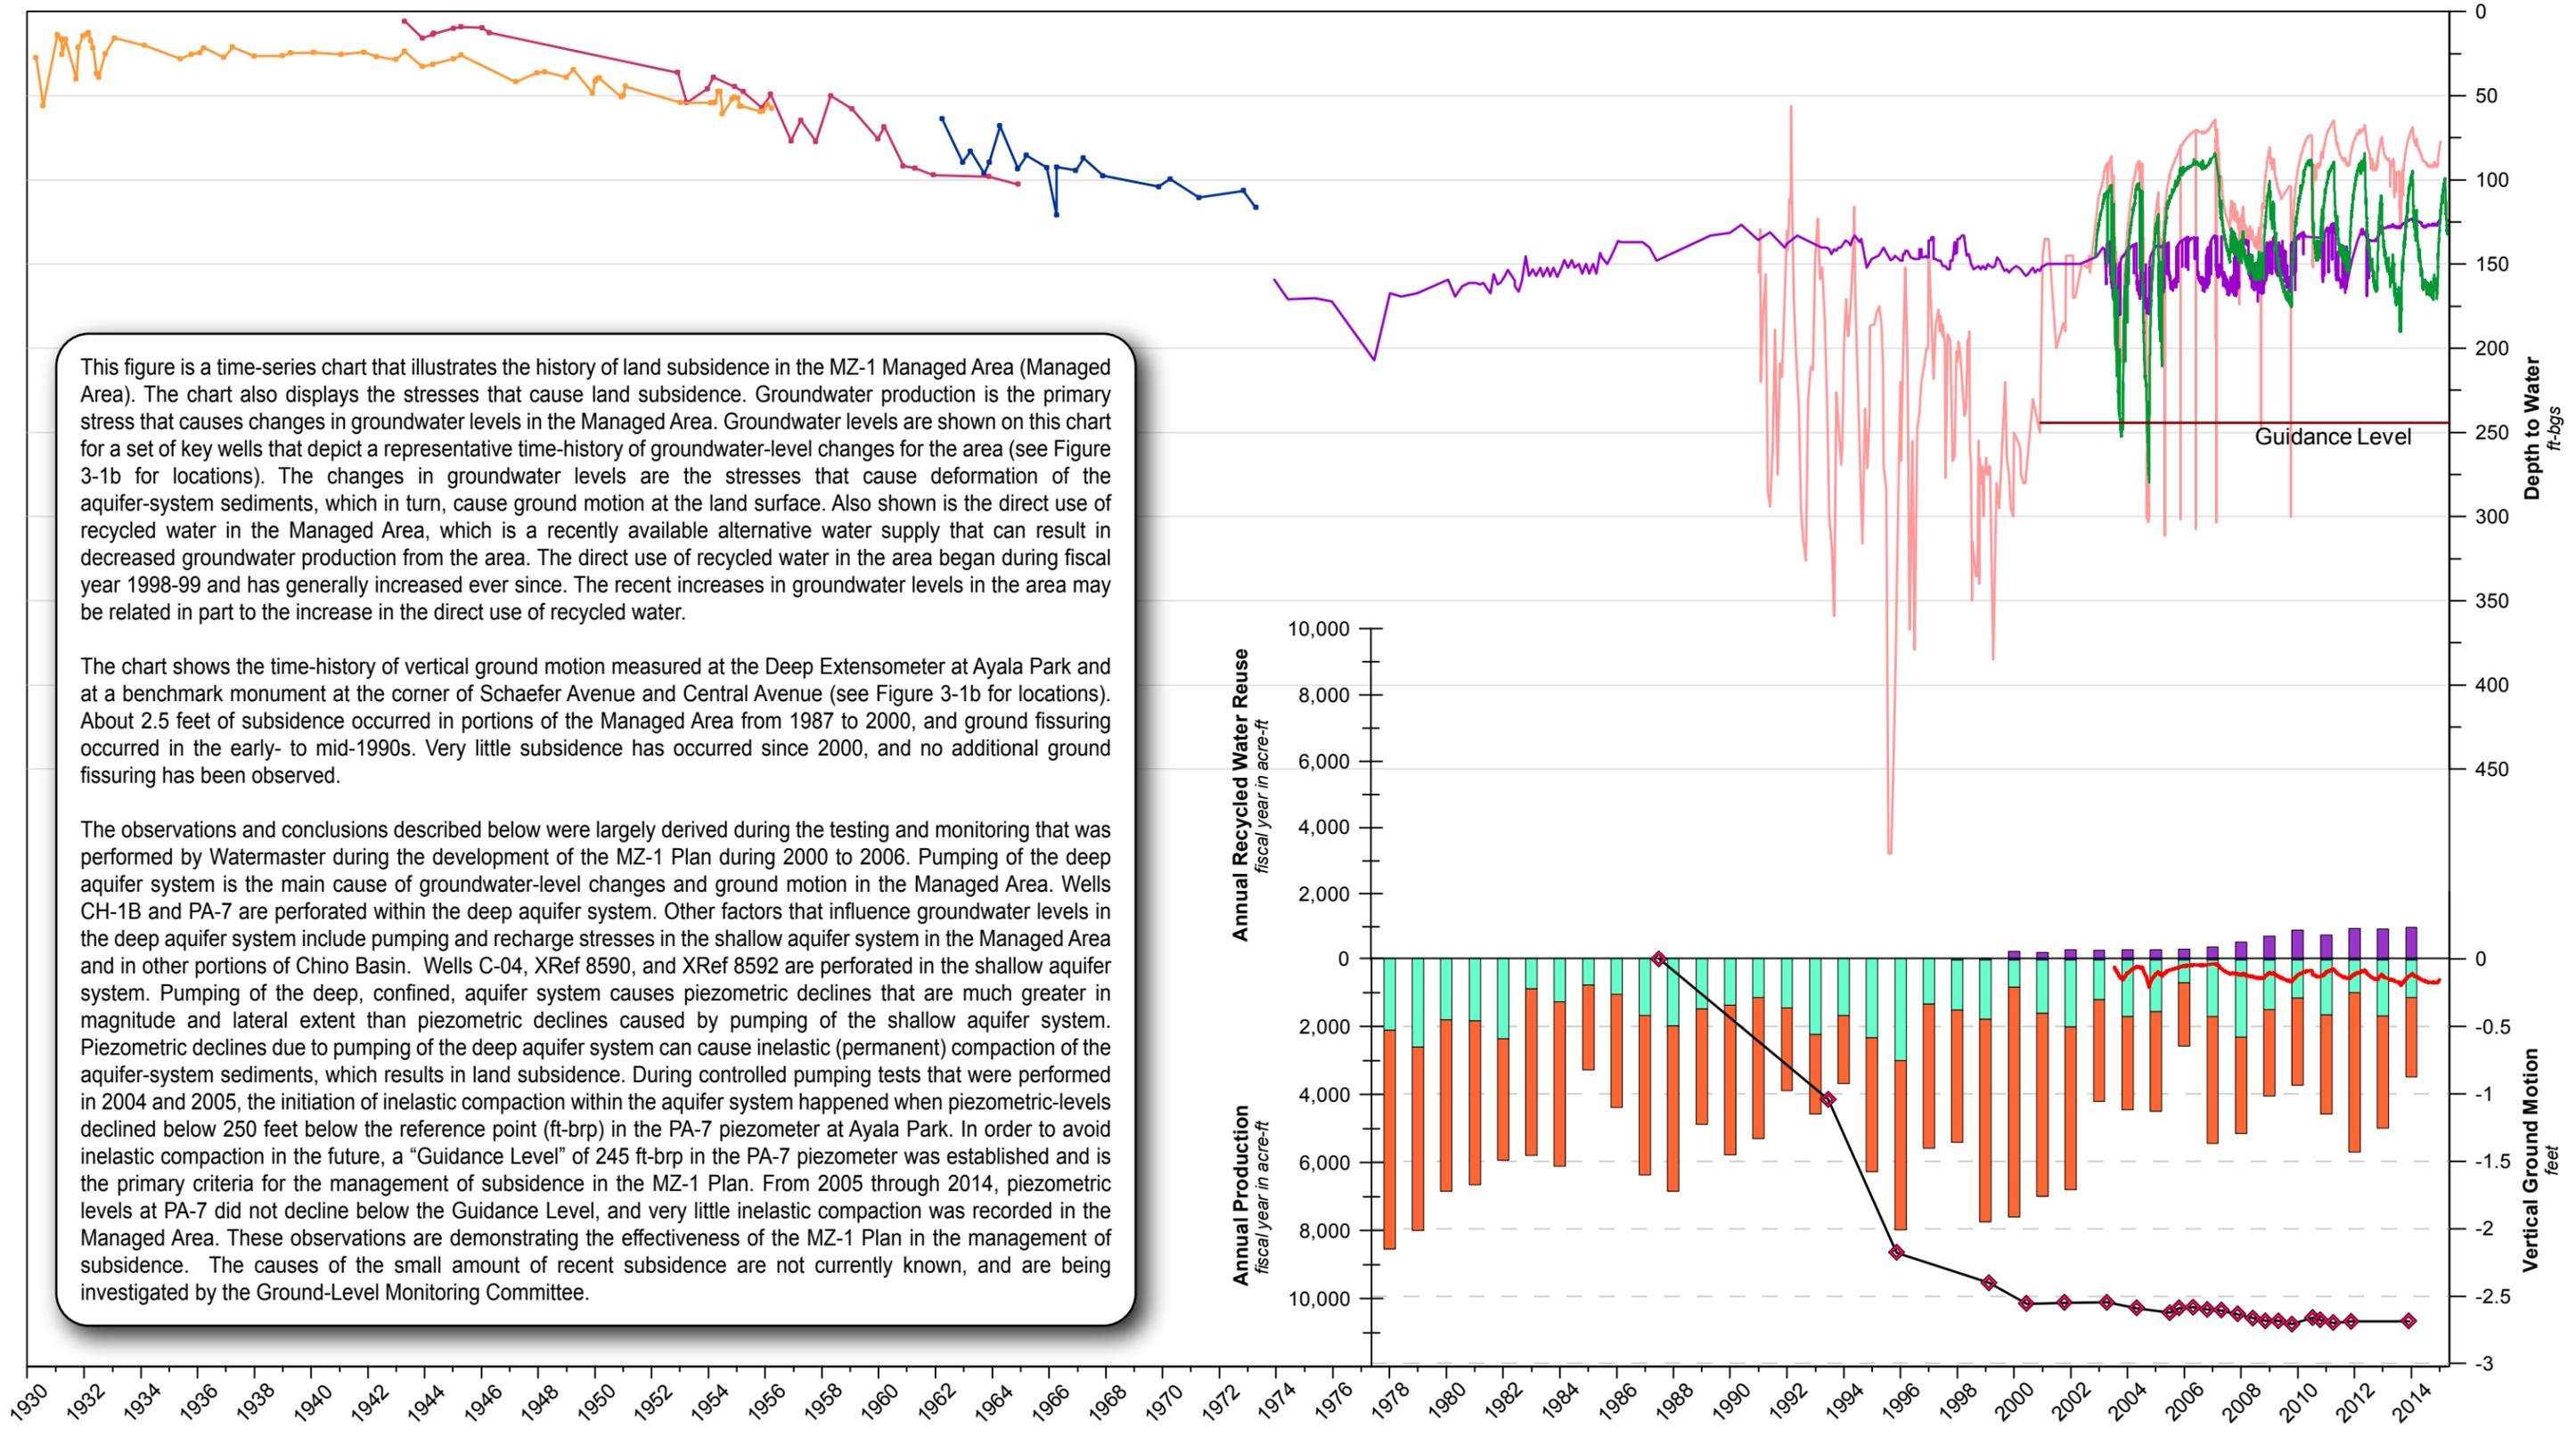
Figure 3-2 is a chart that displays and describes the history of land subsidence in the Managed Area. The main observations from this chart are that pumping from the deep aquifer system during the 1990s caused decline of piezometric levels that coincided with high rates of land subsidence. About 2.5 ft of subsidence occurred from 1987-1999, and ground fissures opened within the City of Chino in the early 1990s. Since 2000, pumping has decreased, piezometric levels in the deep aquifer system have recovered, and the rate of land subsidence has declined significantly to about 0.01 ft/yr.

This figure is a time-series chart that illustrates the history of land subsidence in the MZ-1 Managed Area (Managed Area). The chart also displays the stresses that cause land subsidence. Groundwater production is the primary stress that causes changes in groundwater levels in the Managed Area. Groundwater levels are shown on this chart for a set of key wells that depict a representative time-history of groundwater-level changes for the area (see Figure 3-1b for locations). The changes in groundwater levels are the stresses that cause deformation of the aquifer-system sediments, which in turn, cause ground motion at the land surface. Also shown is the direct use of recycled water in the Managed Area, which is a recently available alternative water supply that can result in decreased groundwater production from the area. The direct use of recycled water in the area began during fiscal year 1998-99 and has generally increased ever since. The recent increases in groundwater levels in the area may be related in part to the increase in the direct use of recycled water.

The chart shows the time-history of vertical ground motion measured at the Deep Extensometer at Ayala Park and at a benchmark monument at the corner of Schaefer Avenue and Central Avenue (see Figure 3-1b for locations). About 2.5 feet of subsidence occurred in portions of the Managed Area from 1987 to 2000, and ground fissuring occurred in the early- to mid-1990s. Very little subsidence has occurred since 2000, and no additional ground fissuring has been observed.

The observations and conclusions described below were largely derived during the testing and monitoring that was performed by Watermaster during the development of the MZ-1 Plan during 2000 to 2006. Pumping of the deep aquifer system is the main cause of groundwater-level changes and ground motion in the Managed Area. Wells CH-1B and PA-7 are perforated within the deep aquifer system. Other factors that influence groundwater levels in the deep aquifer system include pumping and recharge stresses in the shallow aquifer system in the Managed Area and in other portions of Chino Basin. Wells C-04, XRef 8590, and XRef 8592 are perforated in the shallow aquifer system. Pumping of the deep, confined, aquifer system causes piezometric declines that are much greater in magnitude and lateral extent than piezometric declines caused by pumping of the shallow aquifer system. Piezometric declines due to pumping of the deep aquifer system can cause inelastic (permanent) compaction of the aquifer-system sediments, which results in land subsidence. During controlled pumping tests that were performed in 2004 and 2005, the initiation of inelastic compaction within the aquifer system happened when piezometric-levels declined below 250 feet below the reference point (ft-brp) in the PA-7 piezometer at Ayala Park. In order to avoid inelastic compaction in the future, a "Guidance Level" of 245 ft-brp in the PA-7 piezometer was established and is the primary criteria for the management of subsidence in the MZ-1 Plan. From 2005 through 2014, piezometric levels at PA-7 did not decline below the Guidance Level, and very little inelastic compaction was recorded in the Managed Area. These observations are demonstrating the effectiveness of the MZ-1 Plan in the management of subsidence. The causes of the small amount of recent subsidence are not currently known, and are being investigated by the Ground-Level Monitoring Committee.

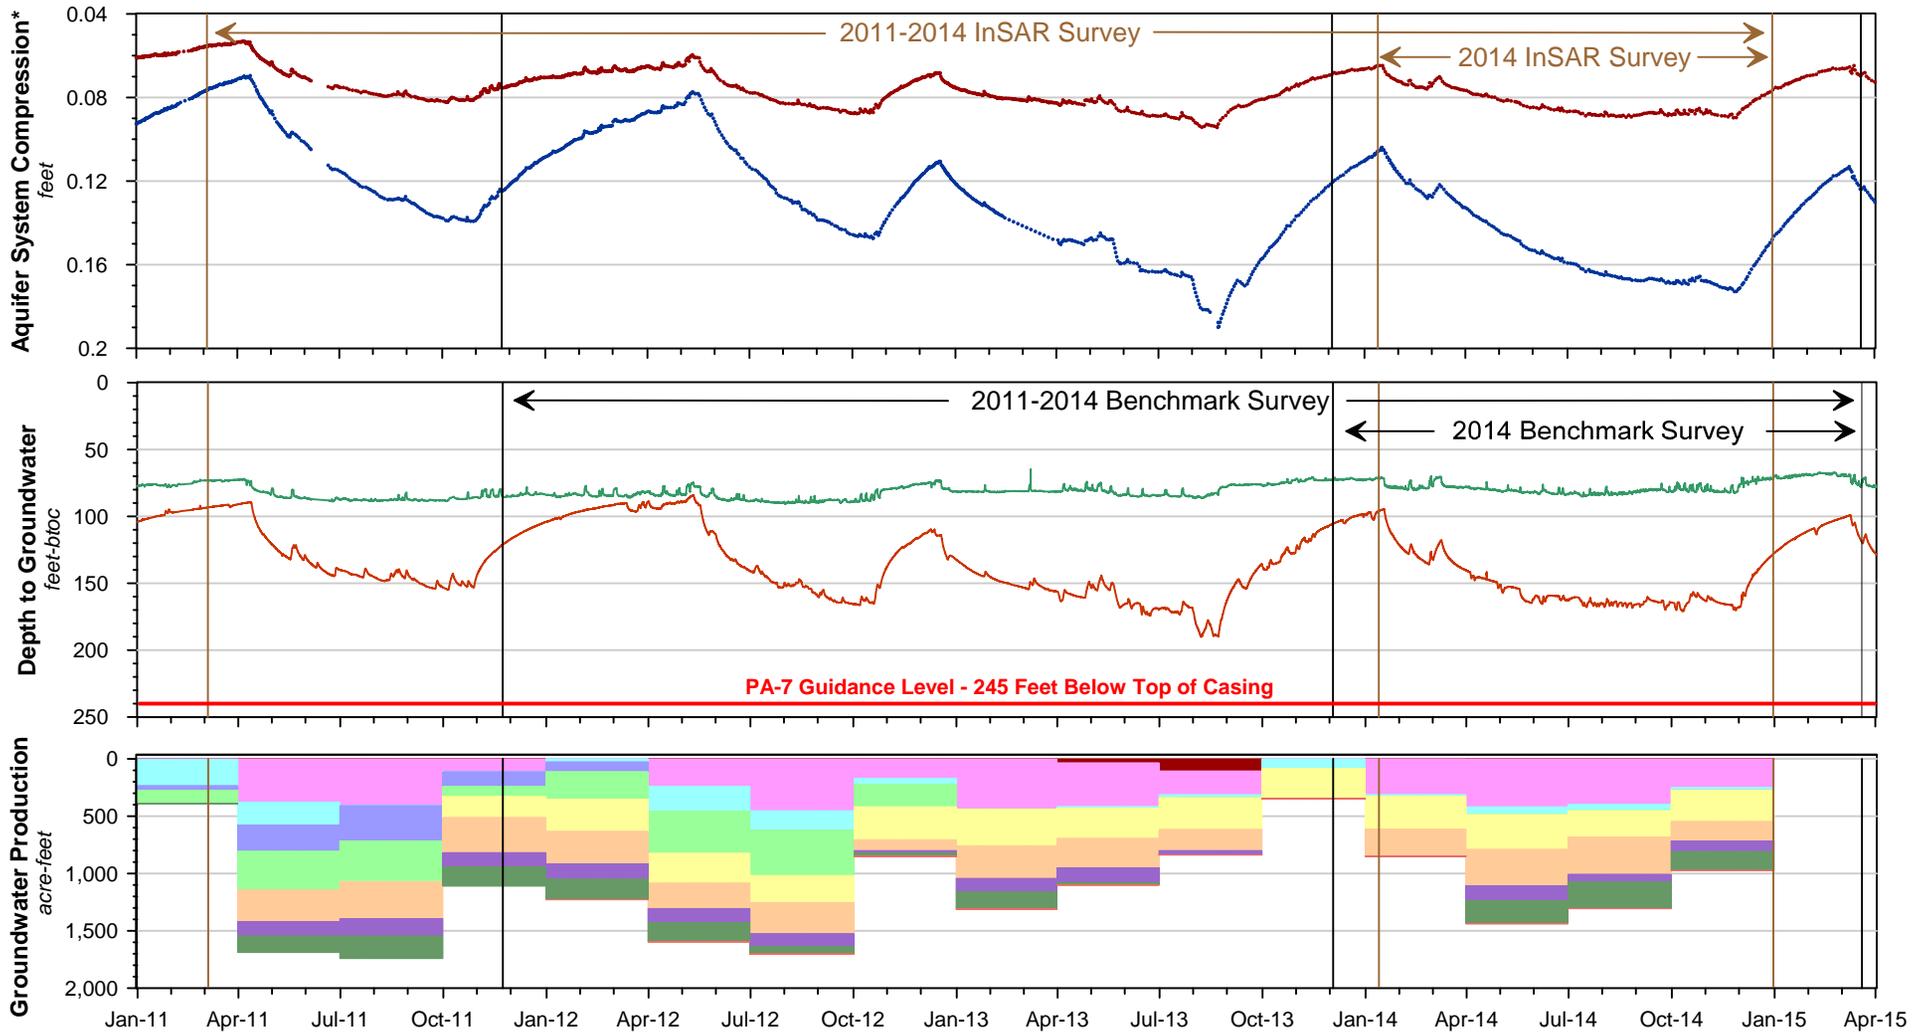
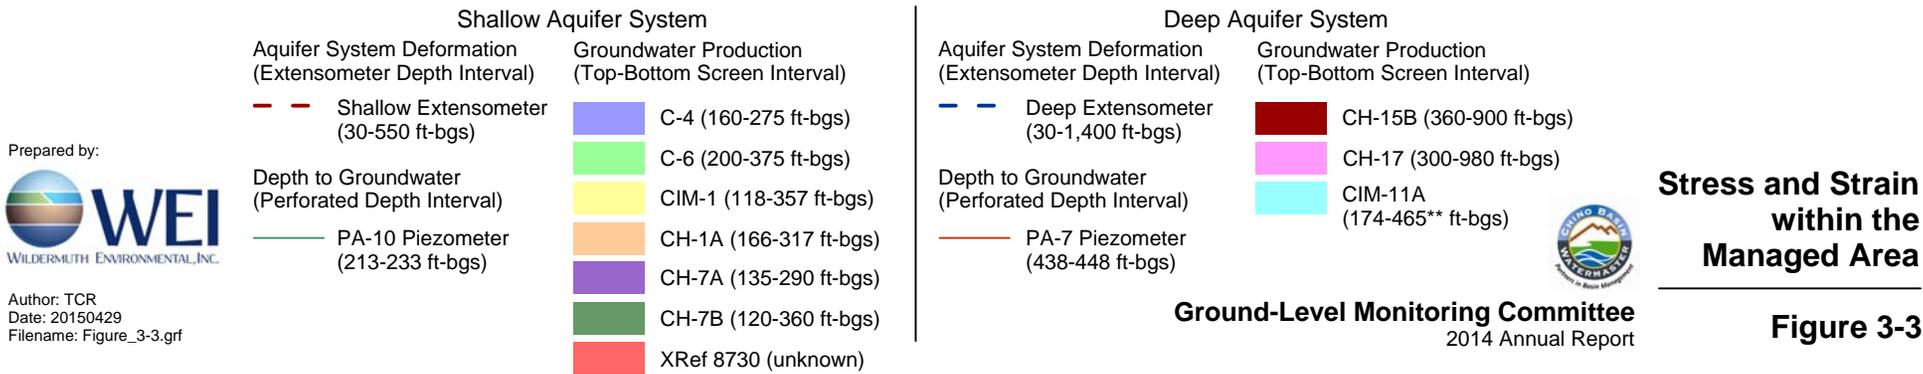
Figure 3-3 includes the time-series of piezometric levels at two piezometers at Ayala Park: PA-7 (deep aquifer system) and PA-10 (shallow aquifer system). These data are consistent with the conclusions of the IMP and show that pumping from the deep, confined, aquifer system causes groundwater-level decline that is much greater in magnitude than groundwater-level decline caused by pumping of the shallow aquifer system—even though more pumping occurs from the shallow aquifer system. In April 2011, piezometric levels at PA-7 were at full seasonal recovery at about 89 ft-btoc. Since then, the Managed Area has experienced four cycles of seasonal groundwater-level decline and recovery. Maximum groundwater-level

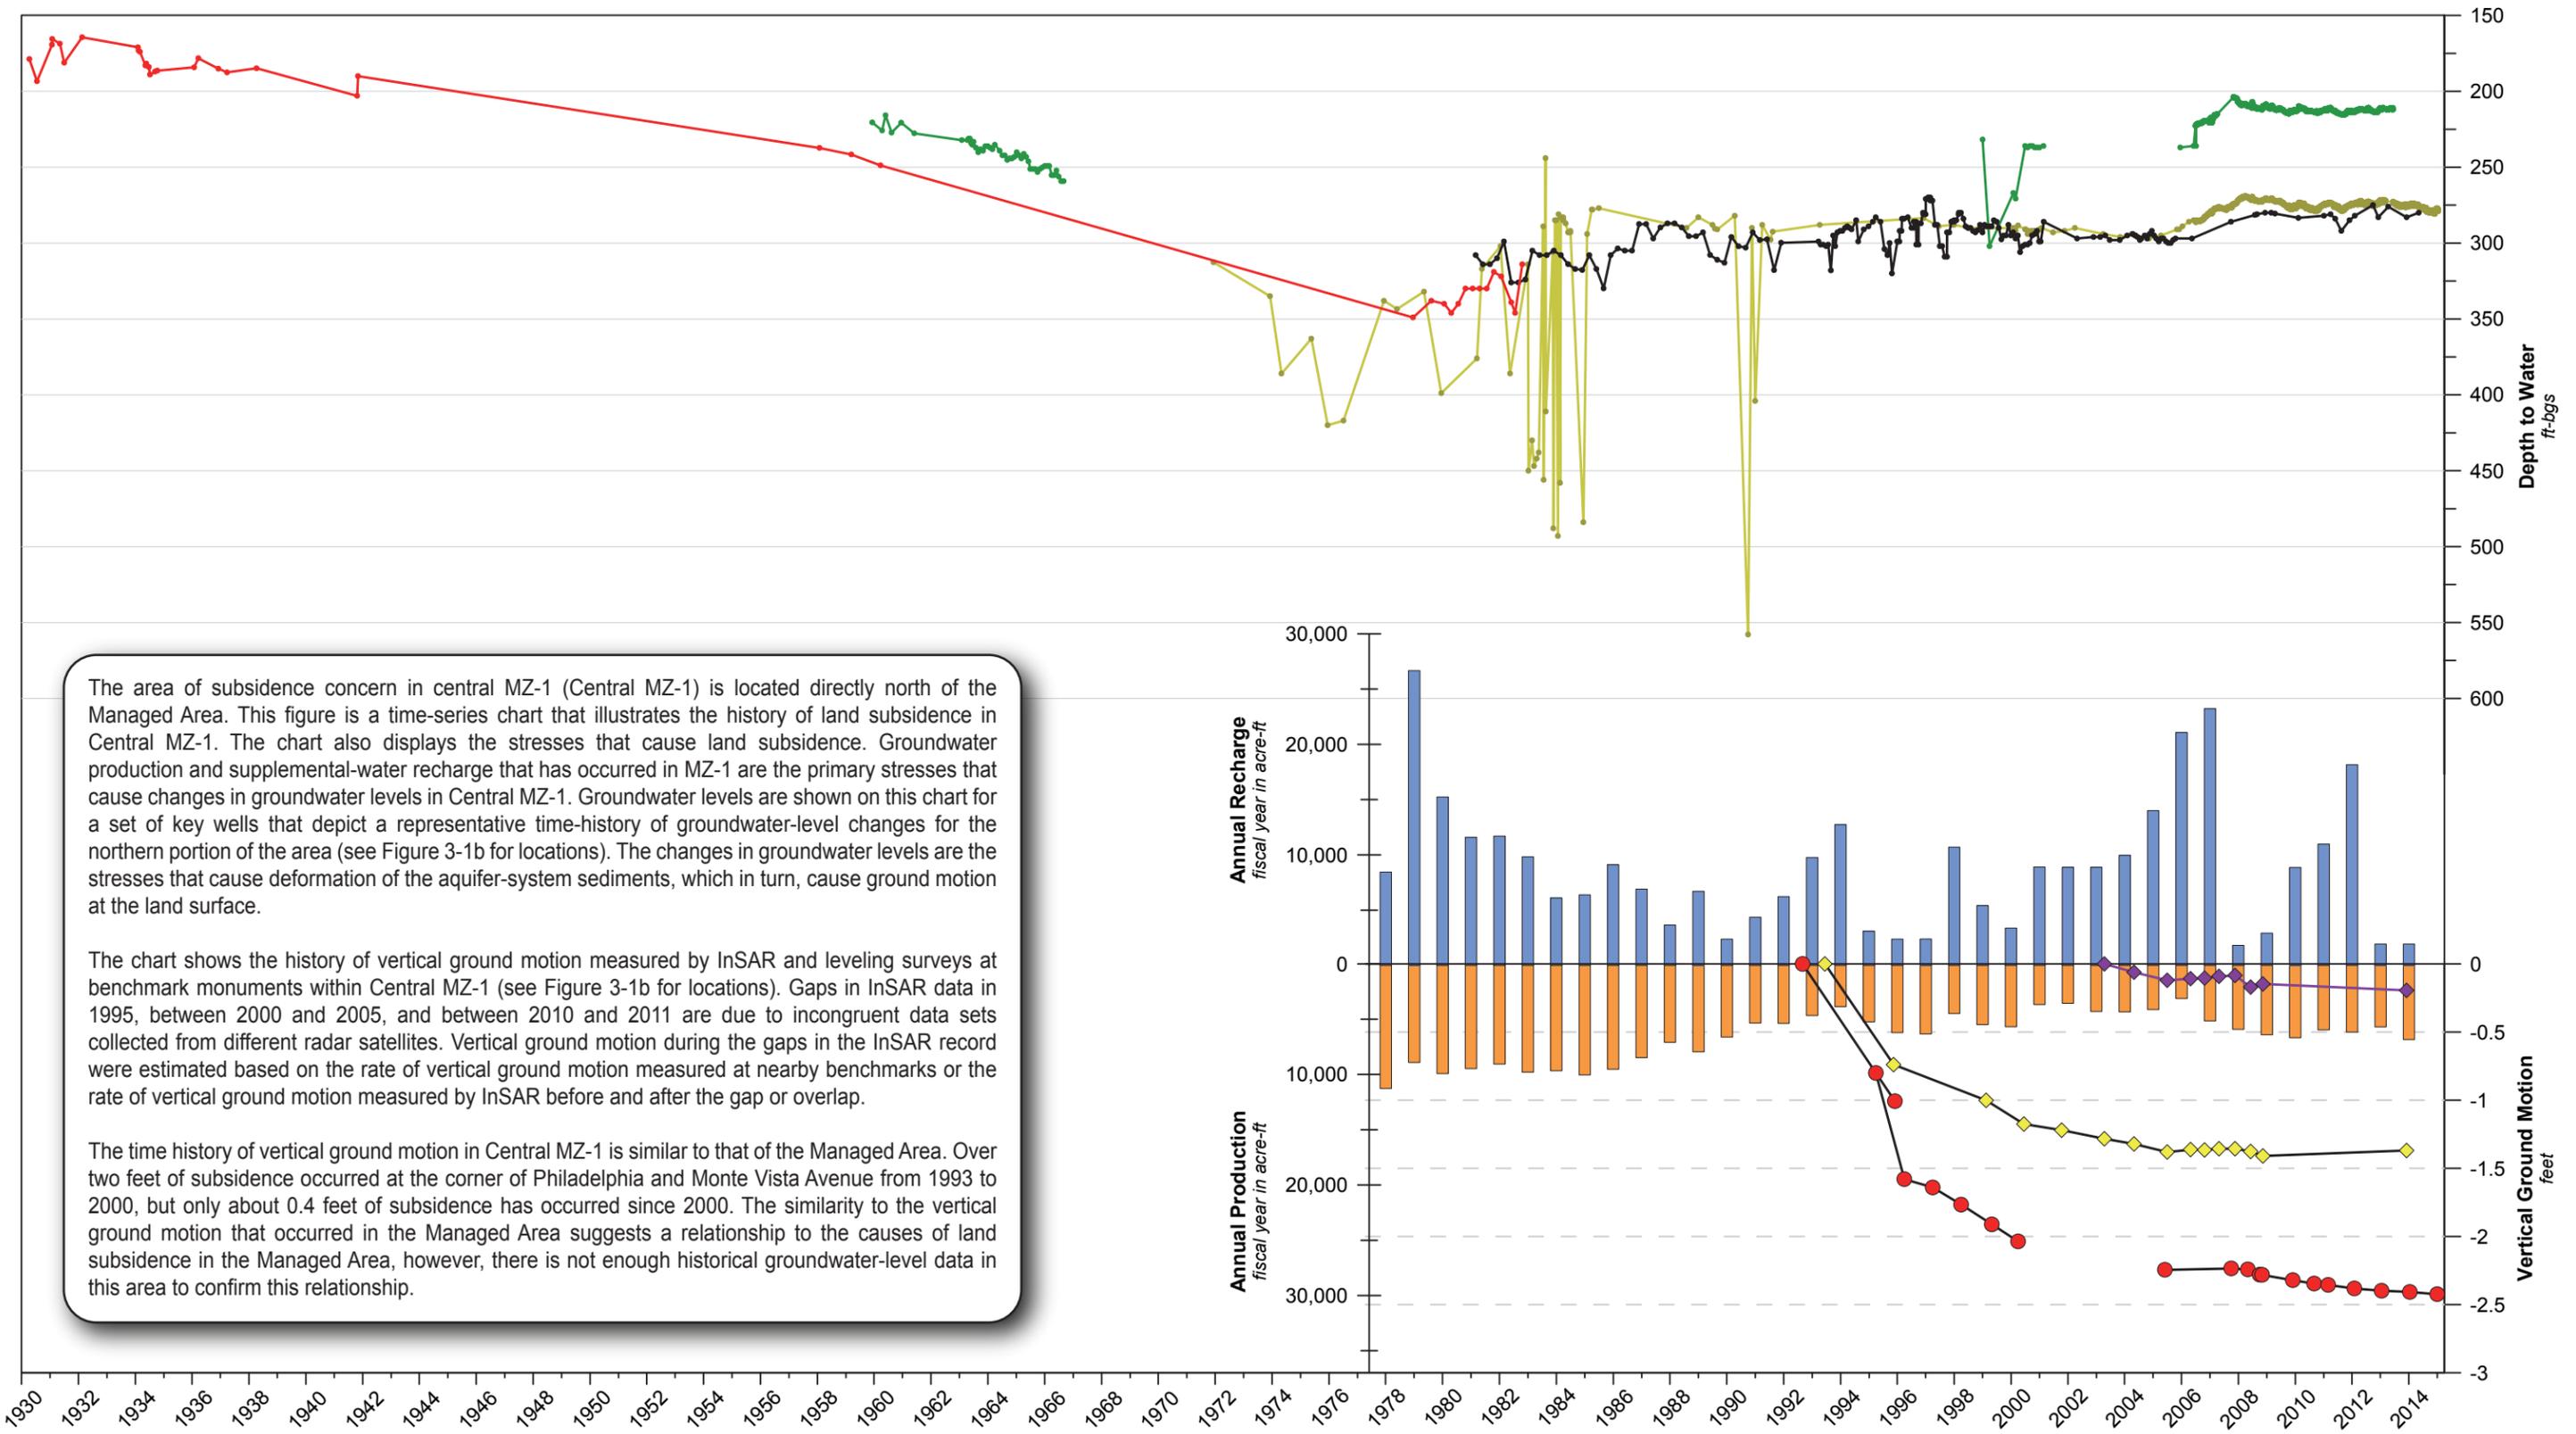
Figure 3-6 is a time-series chart that displays and describes the long-term history of land subsidence in Central MZ-1. The time history and magnitudes of vertical ground motion in Central MZ-1 is similar to that of the Managed Area. Over two feet of subsidence occurred at the corner of Philadelphia Avenue and Monte Vista Avenue from 1993 to 2000, but only about 0.4 feet of subsidence has occurred since 2000. The similarity to the vertical ground motion that occurred in the Managed Area suggests a relationship to the causes of land subsidence in the Managed Area, however, there is not enough historical groundwater-level data in this area to confirm this relationship.

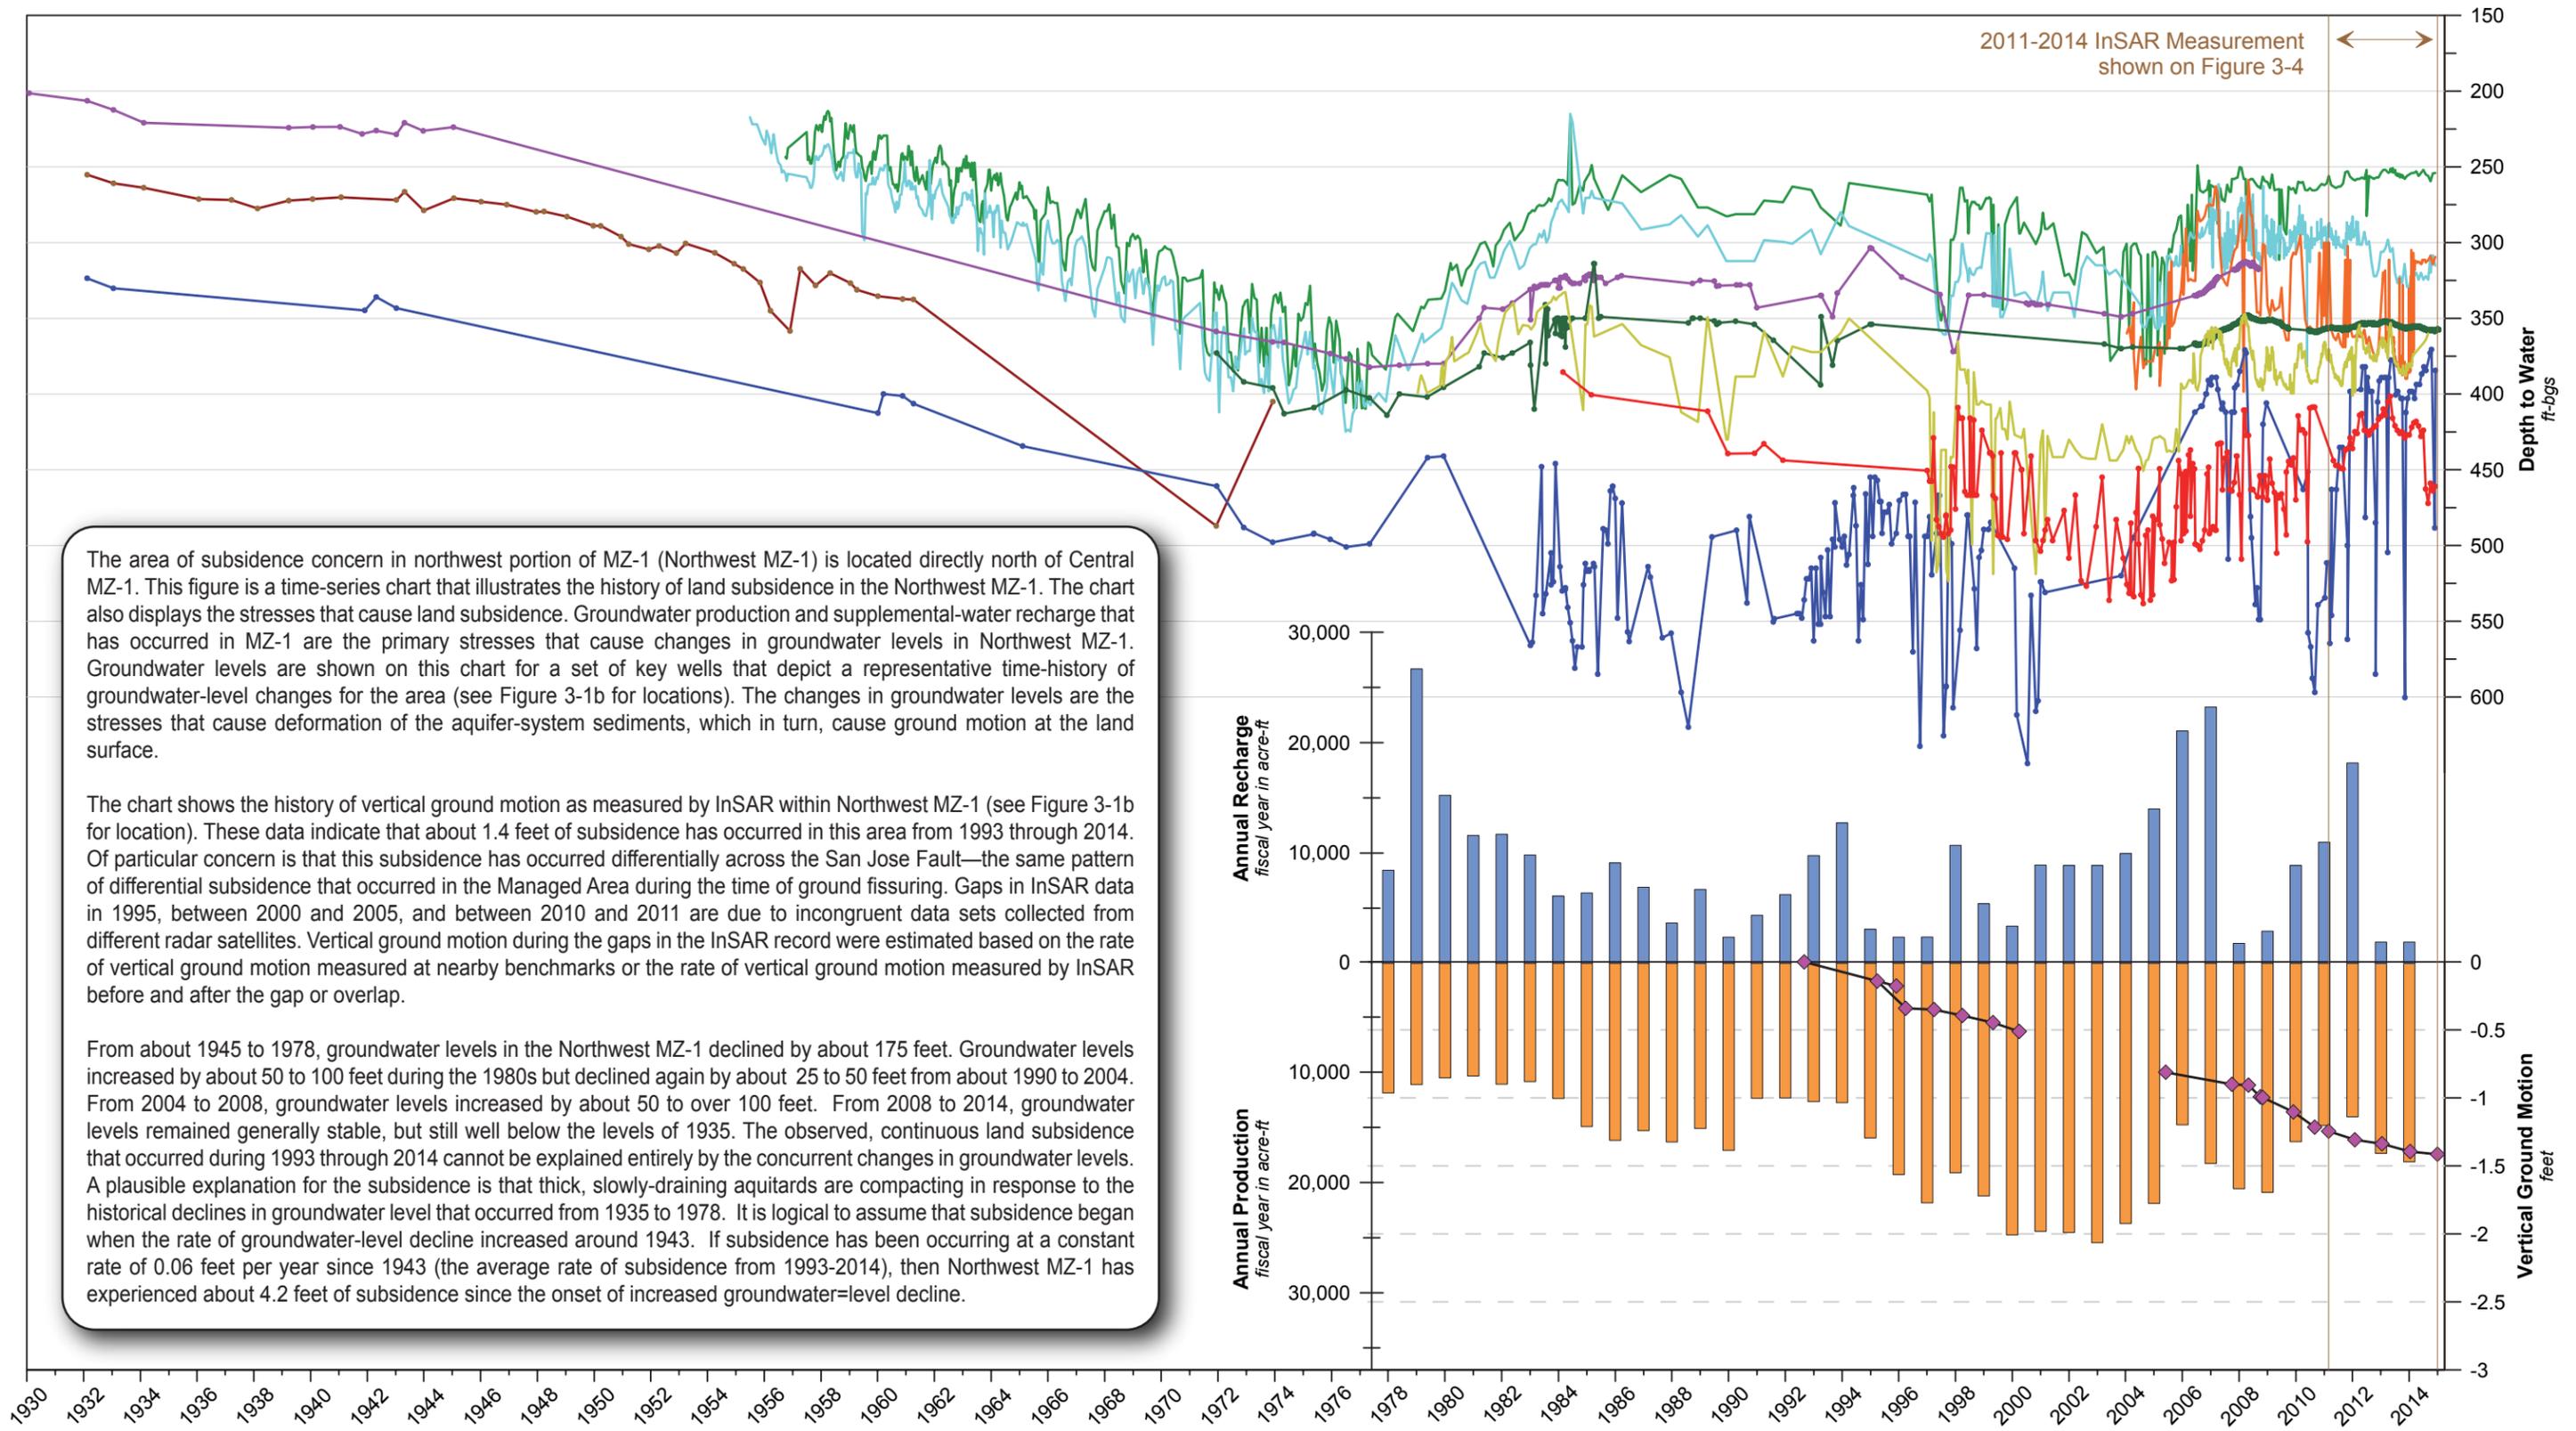
Figure 3-7

The available InSAR data indicate that about 1.4 feet of subsidence has occurred in this area from 1993 through 2014—an average rate of about 0.06 feet per year. From about 1945 to 1978, groundwater levels in the Northwest MZ-1 Area declined by about 175 feet. Since 1978 groundwater levels have fluctuated, and have risen in some wells by more than 100 feet, but groundwater levels in 2014 are still below the 1935 levels. The observed, continuous land subsidence that occurred during 1993-2014 cannot be explained entirely by the concurrent changes in groundwater levels. A plausible explanation for the subsidence is that thick, slowly-draining aquitards are compacting in response to the historical decline of groundwater levels that occurred from 1935 to 1978. If so, subsidence could have begun when the rate of groundwater-level decline increased around 1943. If subsidence has been occurring at a constant rate of 0.06 feet per year since 1943, then the Northwest MZ-1 Area has experienced approximately 4.2 feet of subsidence since the onset of increased groundwater-level decline.

Of particular concern is that the subsidence in the Northwest MZ-1 Area has occurred differentially across the San Jose Fault—the same pattern of differential subsidence that occurred in the MZ1 Managed Area during the time of ground fissuring. Ground fissuring is the main subsidence-related threat to infrastructure. Over the past few years, the Watermaster has increased monitoring efforts in the Northwest MZ-1 Area to include elevation surveys and electronic distance measurements (EDMs) because of the potential for ground fissuring.

The pattern of vertical ground motion on Figures 3-1a and 3-1b is a continuation of the historical time-series of subsidence in this area shown on Figure 3-7, which indicates a total of about 1.4 feet of subsidence since 1992 (about 0.06 ft/yr). Of particular concern in Northwest MZ-1 Area is that the historical and ongoing subsidence has been differential across the San Jose Fault. Differential subsidence can result in ground fissuring, as it did in the Managed Area during the 1990s.

Currently, there are not enough data available to definitively explain the causes of the historical and ongoing subsidence in the Northwest MZ-1 Area, but it is likely related to recent and/or past decline of piezometric levels. If so, subsidence could have begun when the rate of groundwater-level decline increased around 1943. If subsidence has been occurring at a constant rate of 0.06 feet per year since 1943, then the Northwest MZ-1 Area has

In 2014, the Watermaster, consistent with the recommendation of the GLMC, determined that the MZ-1 Plan needs to be updated to include a Subsidence Management Plan for the Northwest MZ-1 Area with the long-term objective to minimize or abate the occurrence of the land subsidence. Watermaster’s Engineer developed a draft work plan to develop the Subsidence Management Plan for the Northwest MZ-1 Area, which includes a description of a multi-year effort with cost estimates and a schedule. Upon recommendation by the GLMC and approval by the Watermaster, the work plan will be attached to the MZ-1 Plan as an appendix, and characterized as an ongoing effort of the Watermaster.
