2014 Annual Report of the Ground-Level Monitoring Committee

prepared for
Chino Basin Watermaster

July 2015

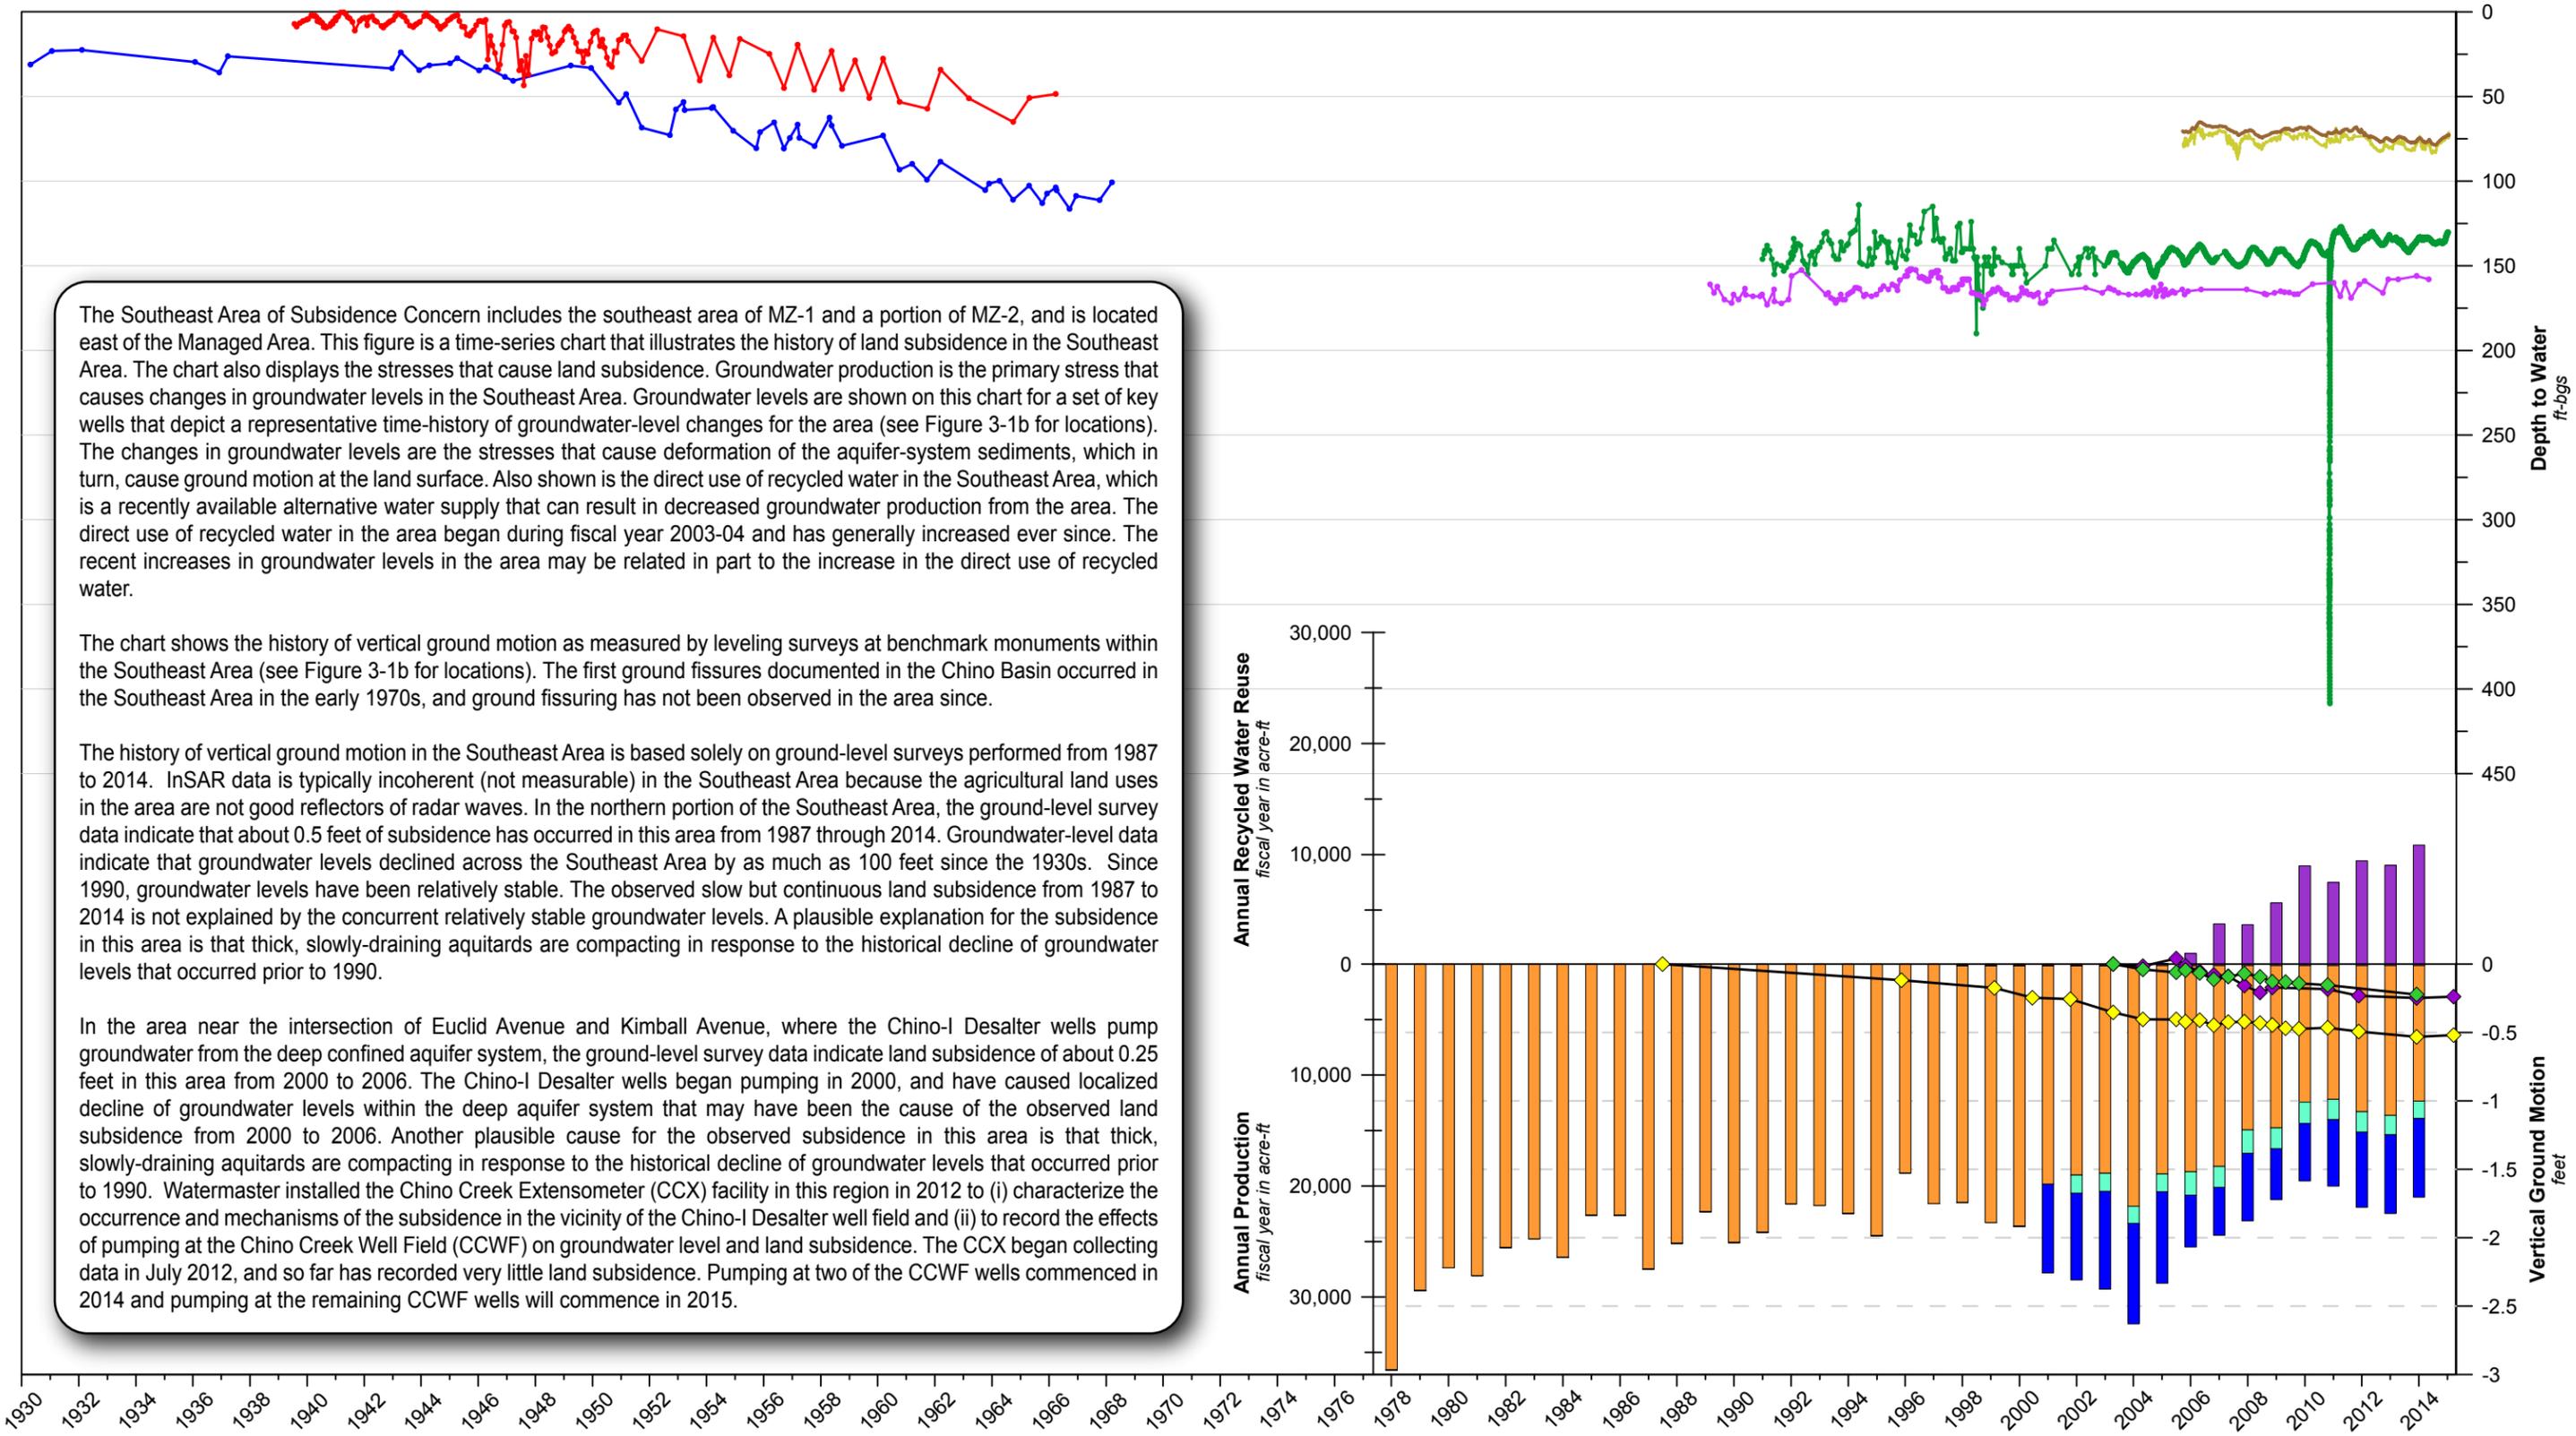
Figure 3-9

These figures show little, if any, recent subsidence across the Southeast Area, and that some areas experienced rebound of the ground surface. Historically, ground fissuring has been documented in the Southeast Area which may have been caused by compaction of the aquifer system. There is not enough historical data to confirm the causes of the fissuring.

The Southeast Area of Subsidence Concern includes the southeast area of MZ-1 and a portion of MZ-2, and is located east of the Managed Area. This figure is a time-series chart that illustrates the history of land subsidence in the Southeast Area. The chart also displays the stresses that cause land subsidence. Groundwater production is the primary stress that causes changes in groundwater levels in the Southeast Area. Groundwater levels are shown on this chart for a set of key wells that depict a representative time-history of groundwater-level changes for the area (see Figure 3-1b for locations). The changes in groundwater levels are the stresses that cause deformation of the aquifer-system sediments, which in turn, cause ground motion at the land surface. Also shown is the direct use of recycled water in the Southeast Area, which is a recently available alternative water supply that can result in decreased groundwater production from the area. The direct use of recycled water in the area began during fiscal year 2003-04 and has generally increased ever since. The recent increases in groundwater levels in the area may be related in part to the increase in the direct use of recycled water.

The chart shows the history of vertical ground motion as measured by leveling surveys at benchmark monuments within the Southeast Area (see Figure 3-1b for locations). The first ground fissures documented in the Chino Basin occurred in the Southeast Area in the early 1970s, and ground fissuring has not been observed in the area since.

In the area near the intersection of Euclid Avenue and Kimball Avenue, where the Chino-I Desalter wells pump groundwater from the deep confined aquifer system, the ground-level survey data indicate land subsidence of about 0.25 feet in this area from 2000 to 2006. The Chino-I Desalter wells began pumping in 2000, and have caused localized decline of groundwater levels within the deep aquifer system that may have been the cause of the observed land subsidence from 2000 to 2006. Another plausible cause for the observed subsidence in this area is that thick, slowly-draining aquitards are compacting in response to the historical decline of groundwater levels that occurred prior to 1990. Watermaster installed the Chino Creek Extensometer (CCX) facility in this region in 2012 to (i) characterize the occurrence and mechanisms of the subsidence in the vicinity of the Chino-I Desalter well field and (ii) to record the effects of pumping at the Chino Creek Well Field (CCWF) on groundwater level and land subsidence. The CCX began collecting data in July 2012, and so far has recorded very little land subsidence. Pumping at two of the CCWF wells commenced in 2014 and pumping at the remaining CCWF wells will commence in 2015.
