TECHNICAL MEMORANDUM

DATE: September 27, 2021 Project No.: 941-80-12-59
SENT VIA: EMAIL

SUBJECT: Chino Basin Watermaster Other Recharge Improvement Projects Study

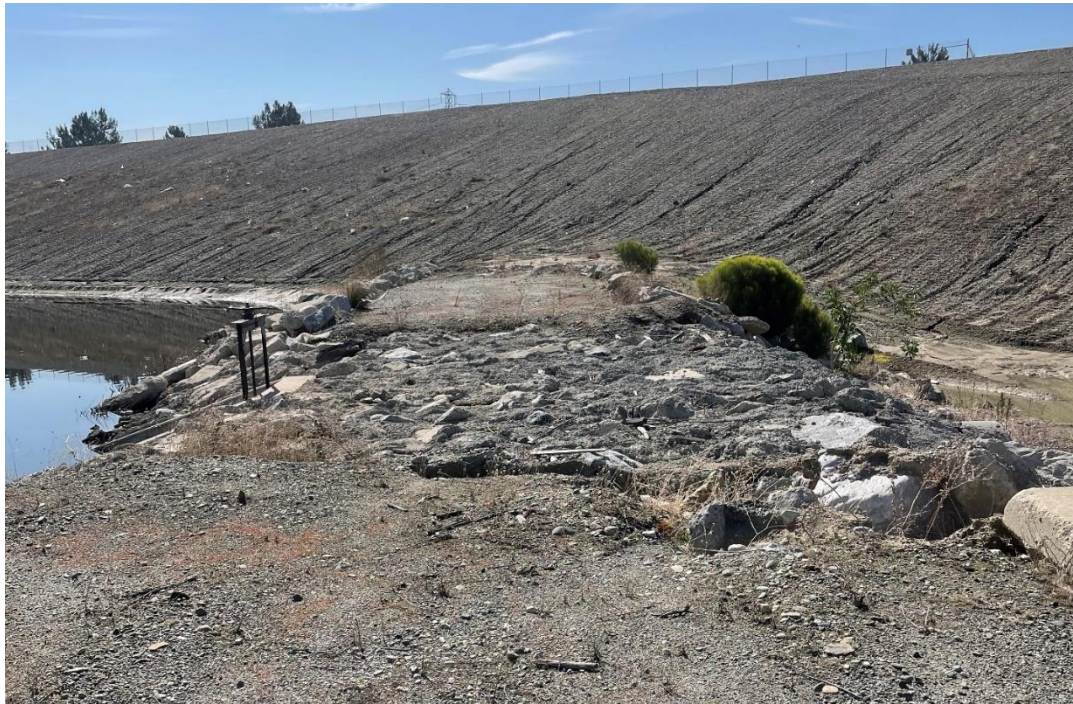
Visual observation of the conservation berm showed there was no significant erosion along the berm except around the weir. The weir area of the conservation berm is armored with concreted rock rip rap. A 42-inch reinforced concrete pipe extends through the weir. There is a headwall with a slide gate on the upstream side of the pipe. The erosion damage is located at the edge of the concreted rock rip rap and extends from about the centerline of the berm to the toe of the west side of the berm. Erosion at the weir is shown in Photo 1. The berm beyond the weir appears in good condition as shown in Photo 2. Berm side slopes are armored with rip rap and large pieces of concrete rubble. Side slopes on the east (water) side of the berm by the basin inflow structure are in good condition as are the side slopes on the west (land) side as shown in Photos 3 and 4. The gravel surface of the roadway on the berm to the south of the weir has washed out as shown in Photo 5; however, the adjacent slopes are in good condition.

Photo 1
Description Erosion along the Edges of Weir

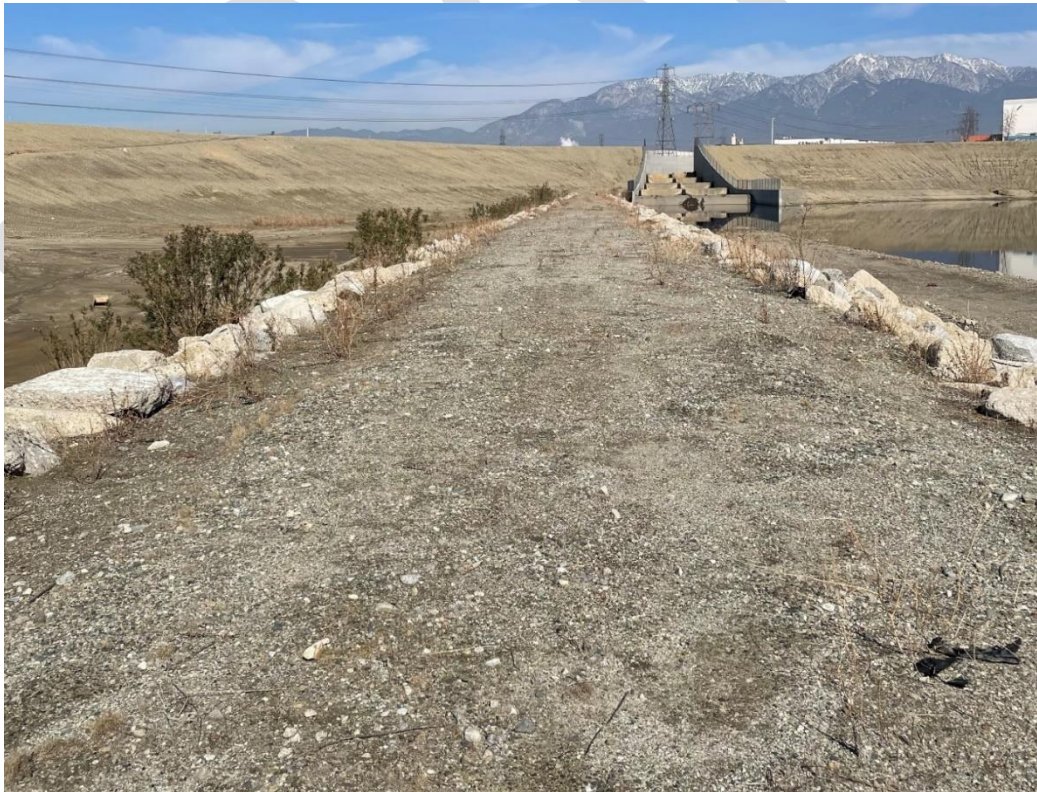
Photo 2
Conservation Berm to the North of the Weir

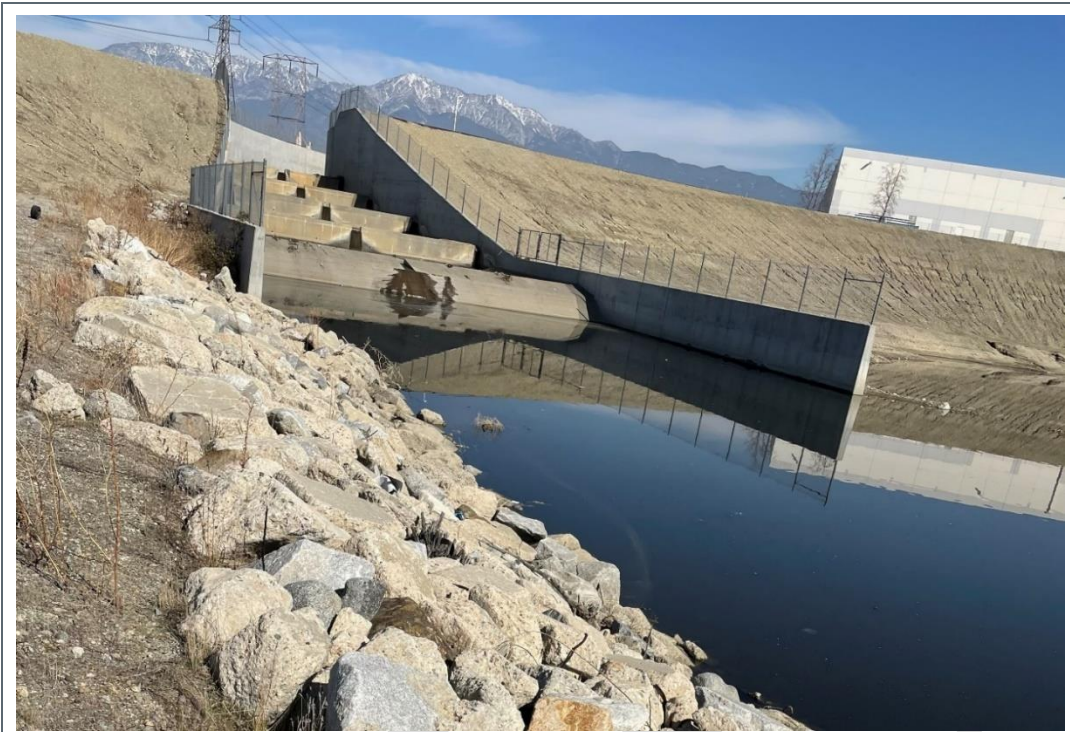
Photo 3
Rock Slope Protection on Conservation Berm East (Water) Side Slope at Inflow Structure

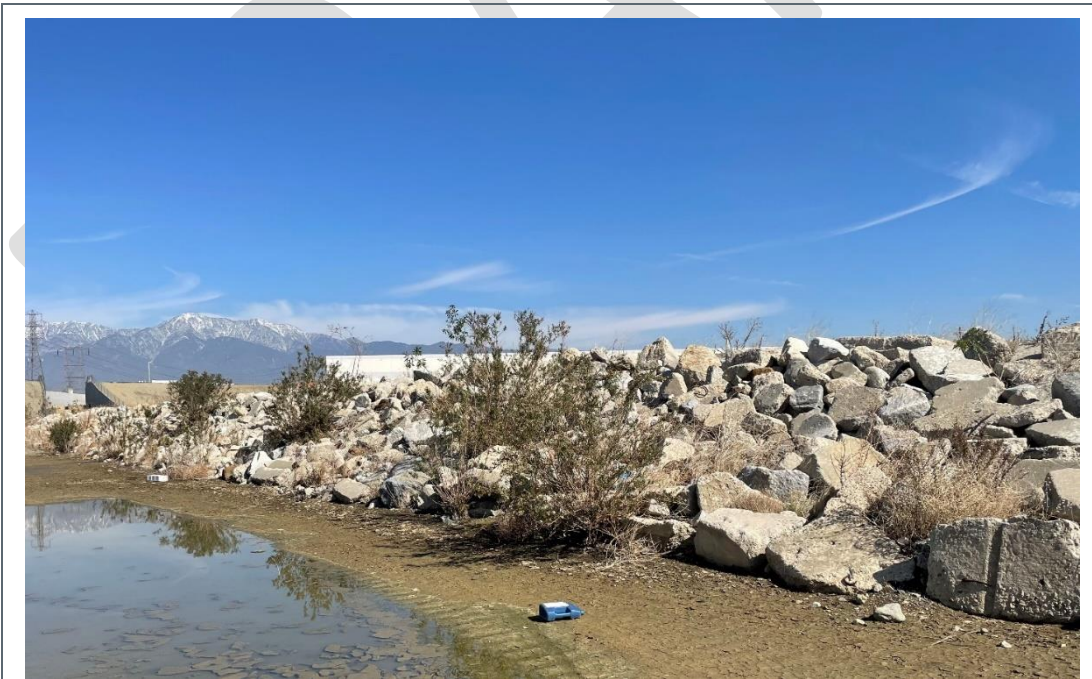
Photo 4
Rock Slope Protection on West (Land) Side Conservation Berm Side Slope

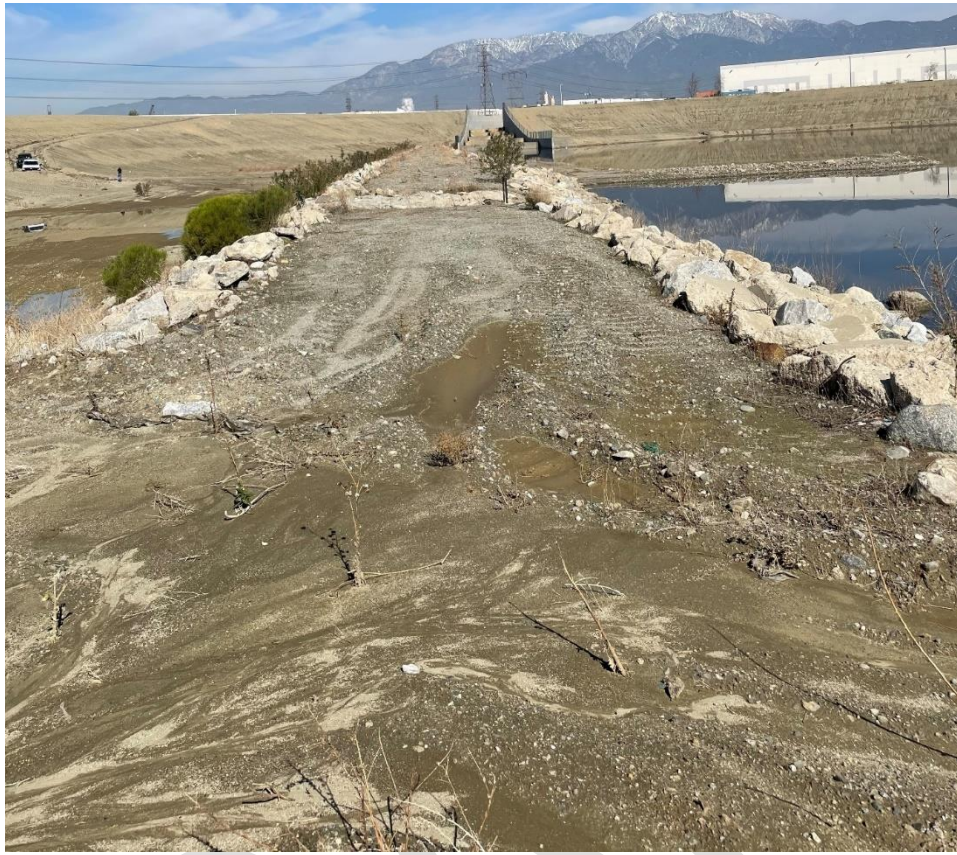
Photo 5
Gravel Surface on Conservation Berm to the South of the Weir

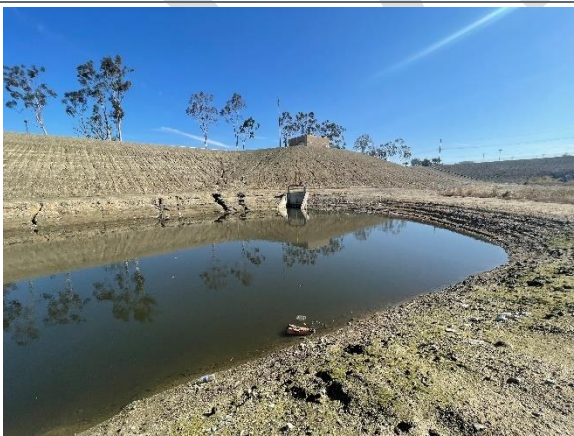
The pump station intake channel is shown in Photo 6 and the intake structure is shown in Photo 7. The intake channel and structure are in good condition. Floating trash was observed in the channel upstream of the intake and at the intake structure.

Photo 6
Pump Station Intake Channel

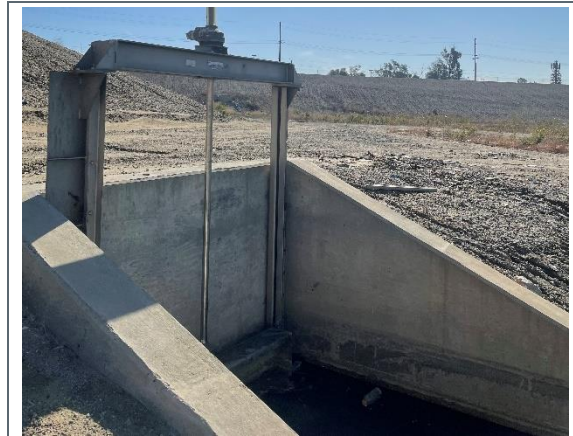
Photo 7
Pump Station Intake Structure

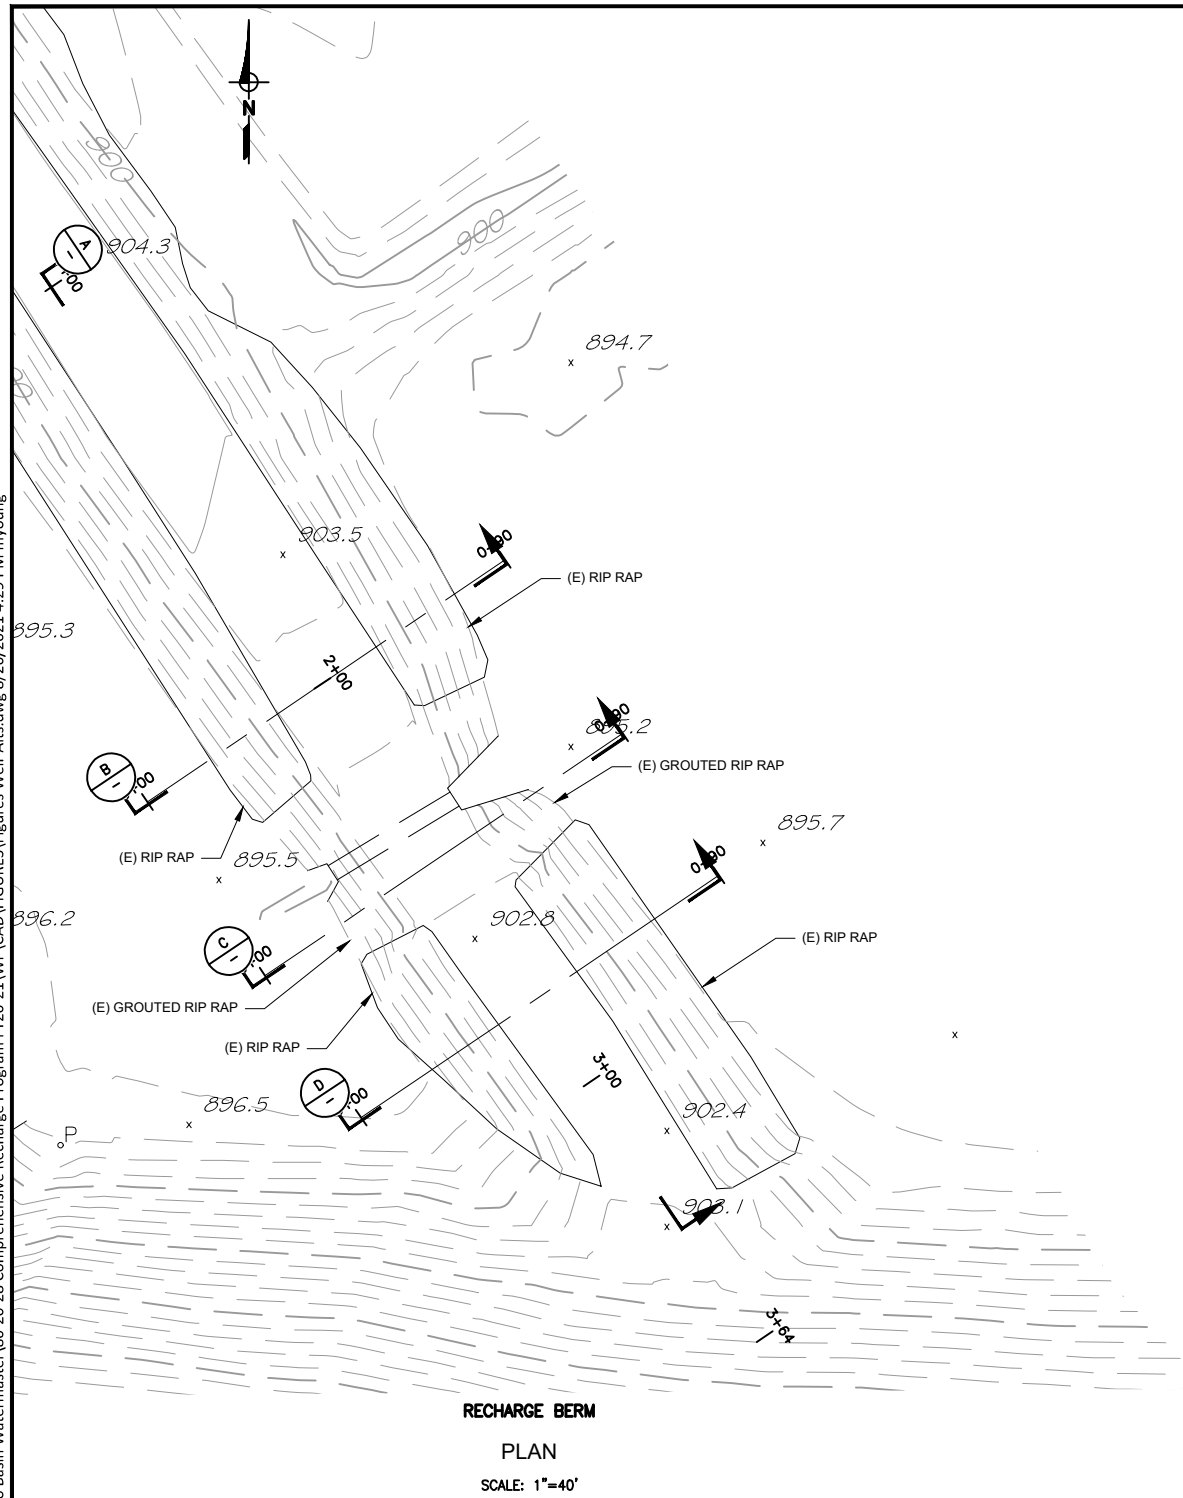
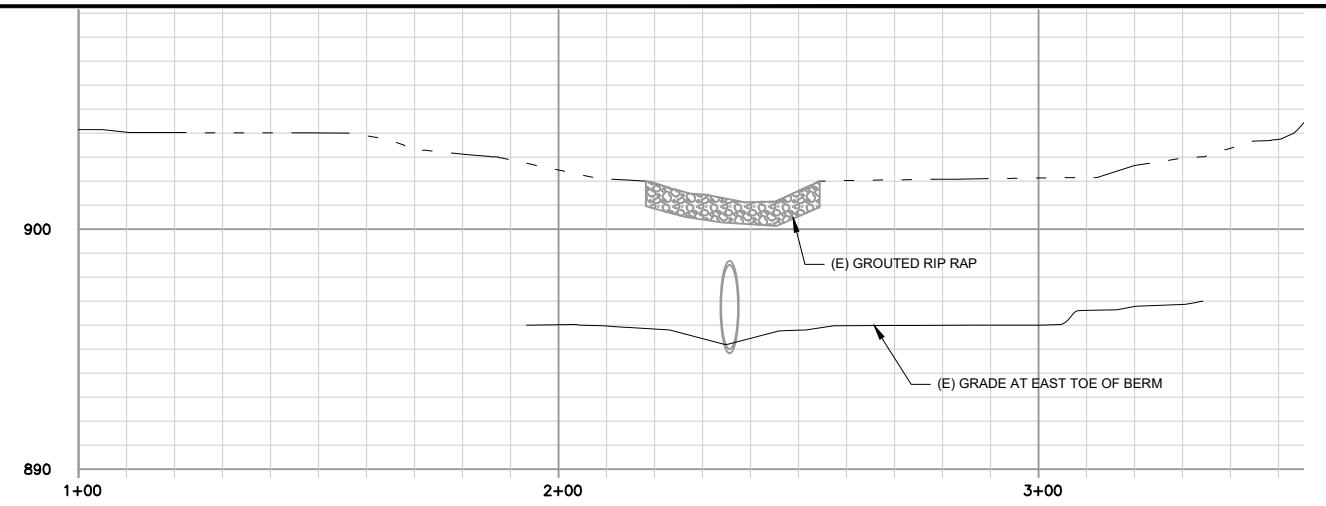
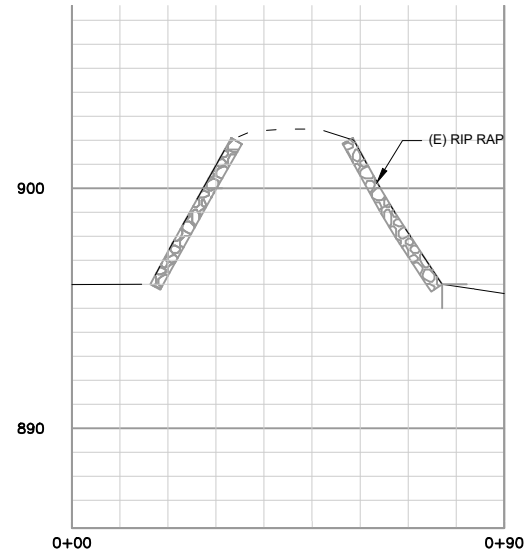
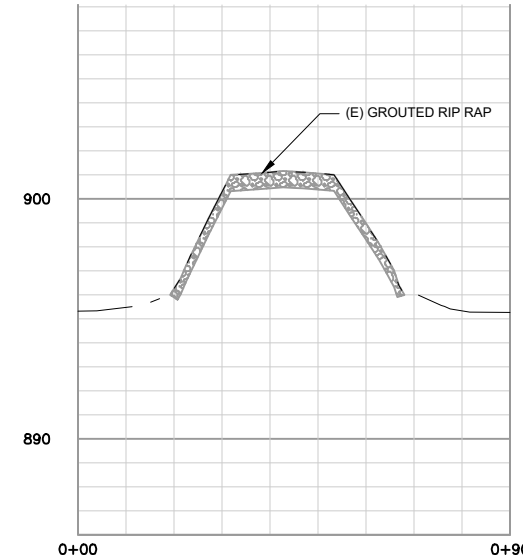
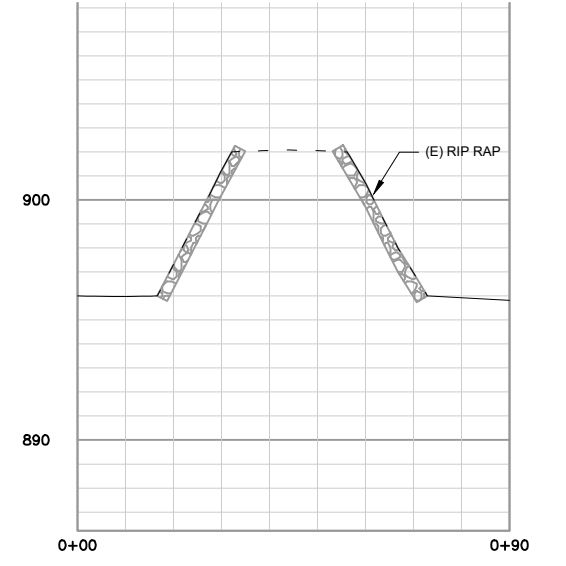
As noted in the documentation of existing conditions, damage to the existing berm is limited to the area of the weir, therefore reconstruction alternatives are also limited to the weir area. Most of the damage is at or beyond the edges of the existing concreted rip rap. Figure 2 includes a profile of the existing weir area based on the aerial topographic survey. As shown in the profile, the existing grouted rip rap at the weir ends where the weir is about one foot above the low point of the weir. According to observations by maintenance staff, the water level is generally at least about one-foot deep when flowing over the weir. To better protect the weir area, West Yost proposed that all reconstruction alternatives extend the revetment along the weir to a location that is two vertical feet above the low point of the weir.

**Existing Conditions
Recharge Berm**
