**GRCC
GWR O&M UPDATE
MAY 23, 2017**

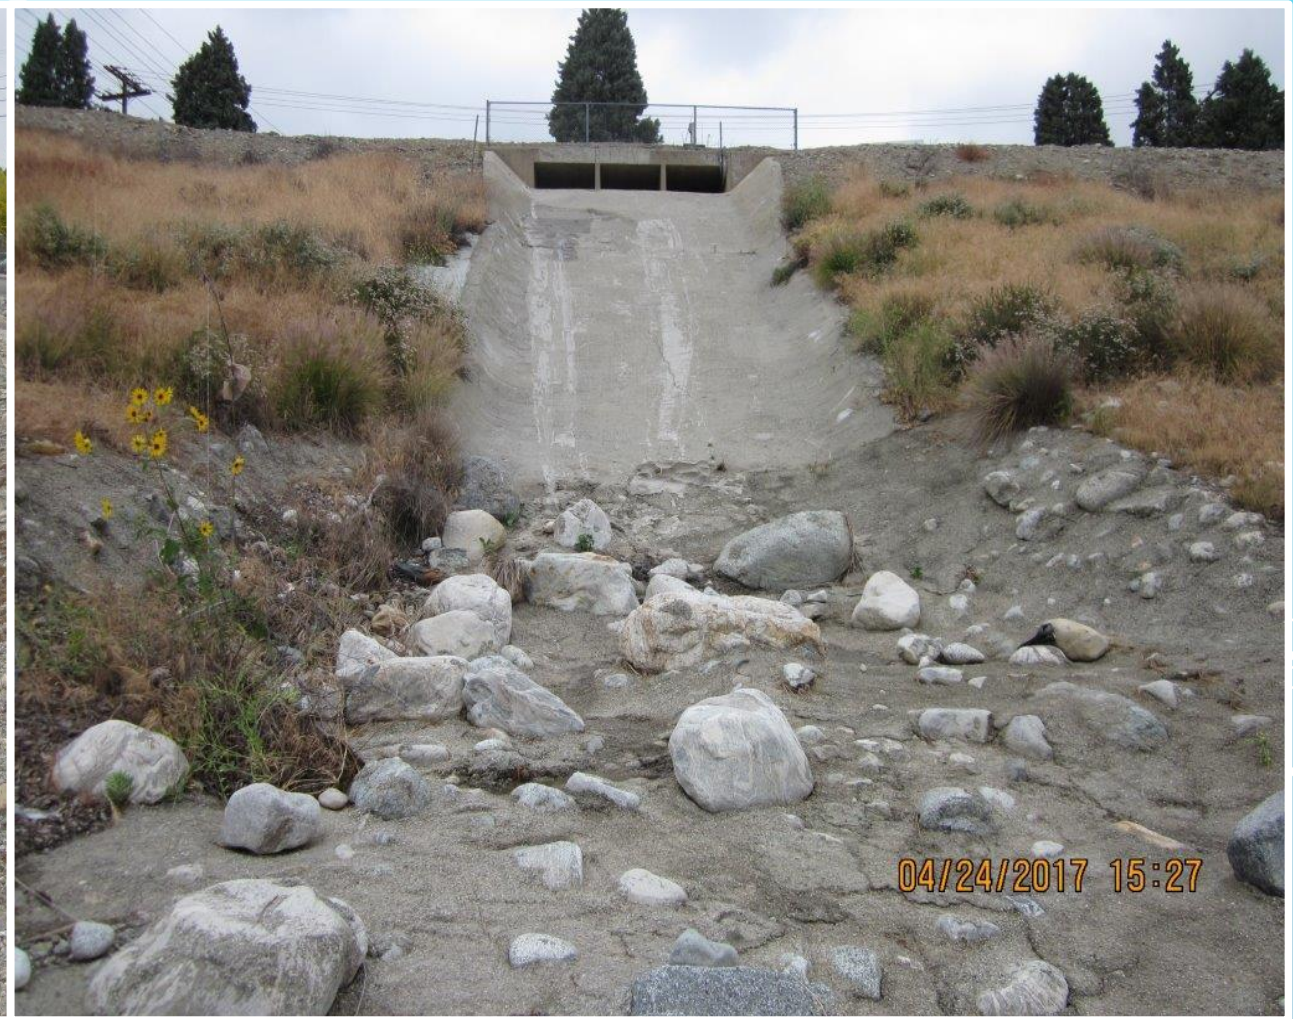
No Seepage Evident from Montclair 2 Spillway with High Water at Montclair 1

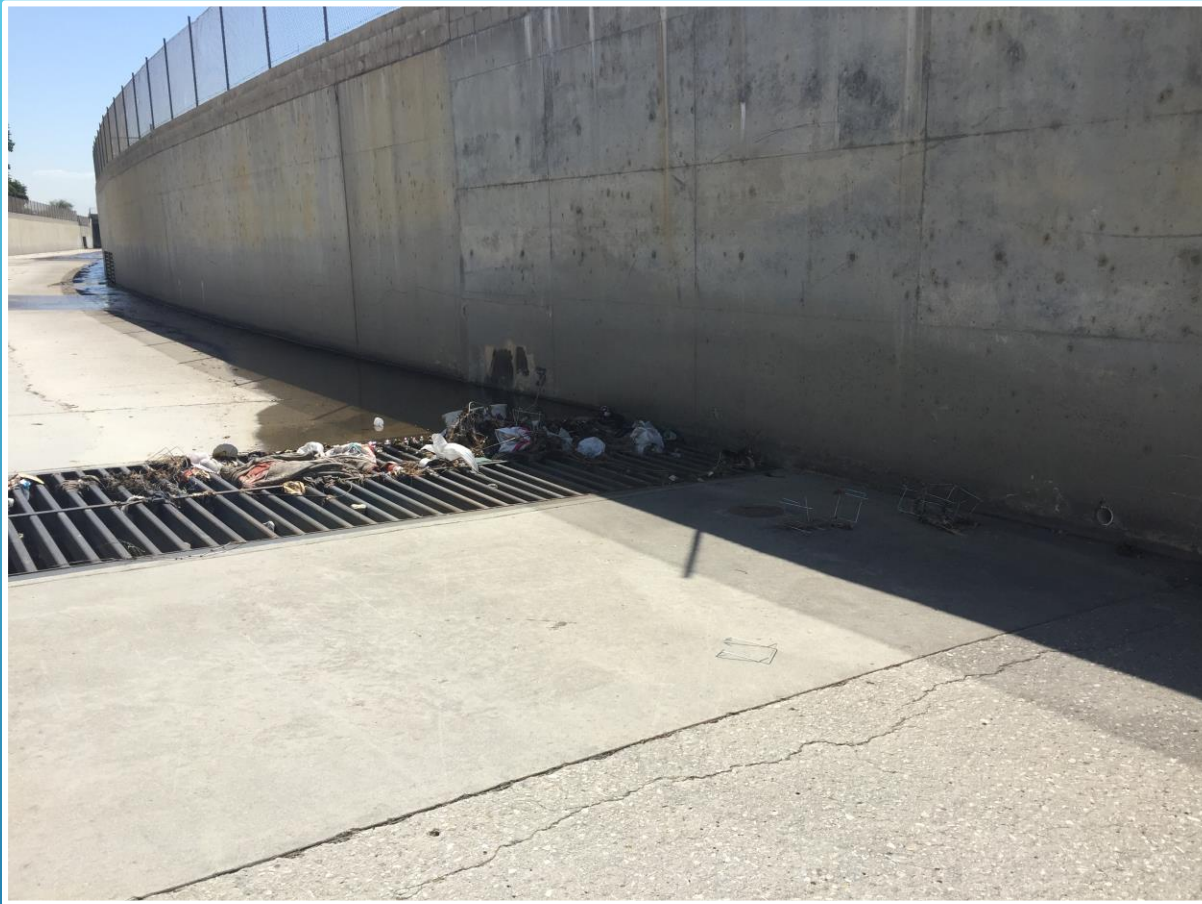
Trash Buildup on Grate Leading to Turner 4A

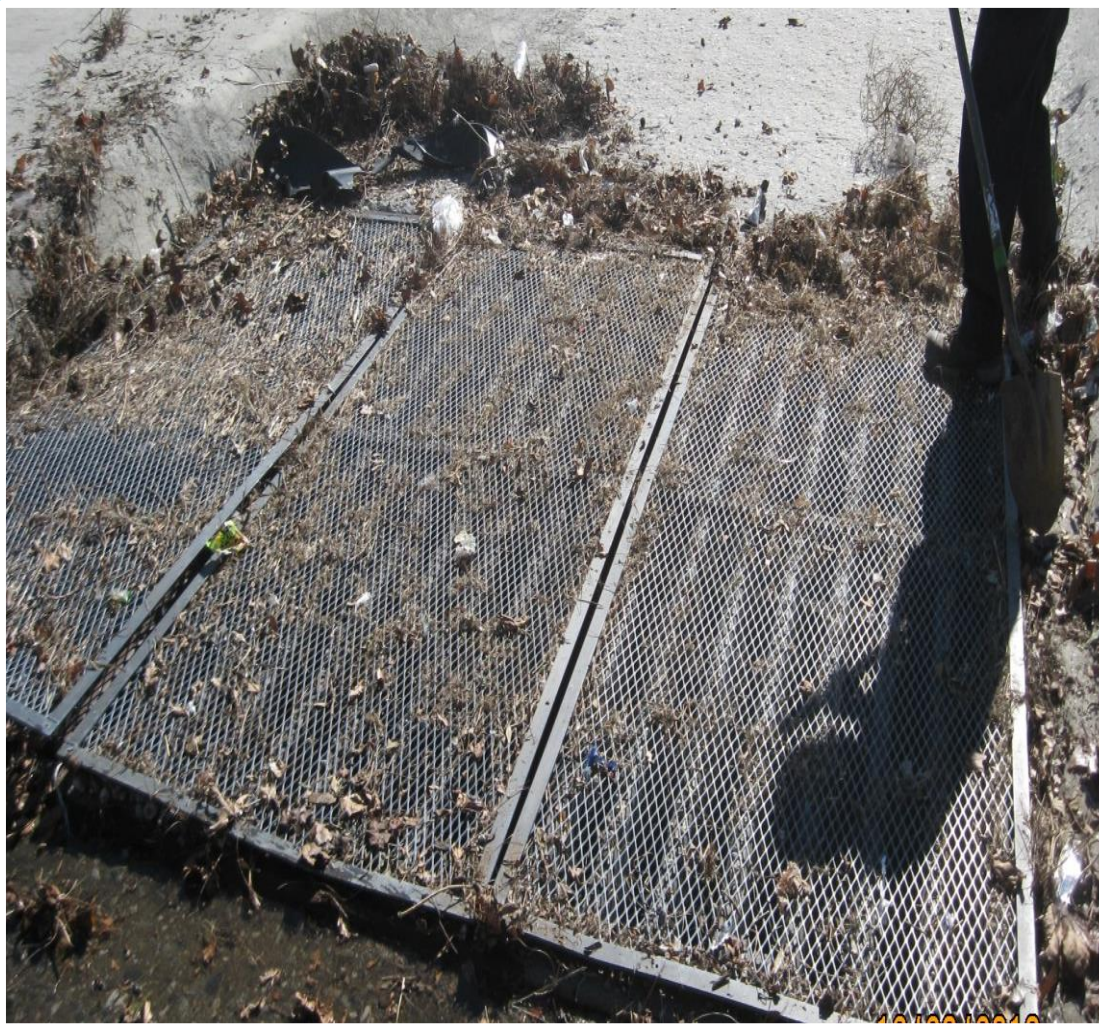
(Above) Victoria Inlet Being Cleaned
(Below) Victoria Inlet Missing Mesh Panel

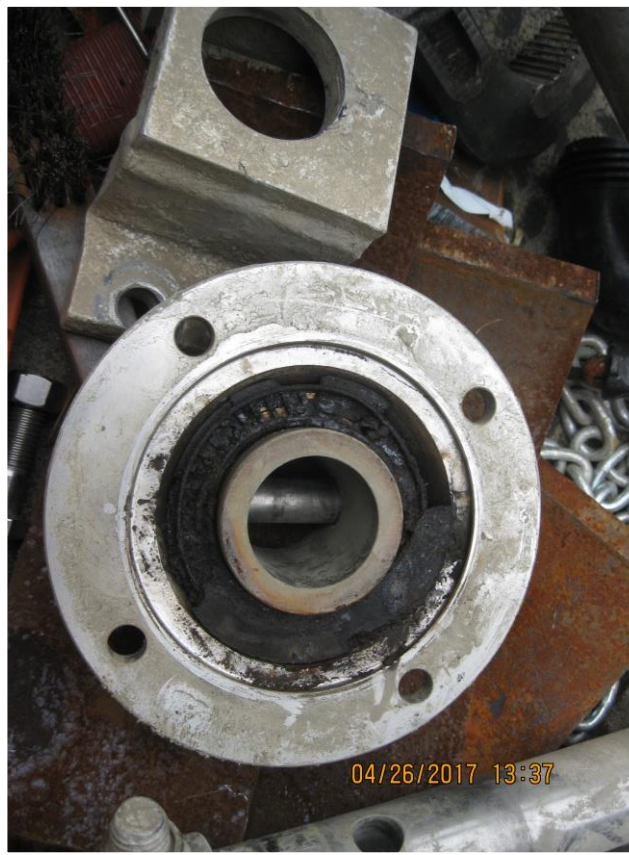
Failed Shaft Bearing from Declez Basin

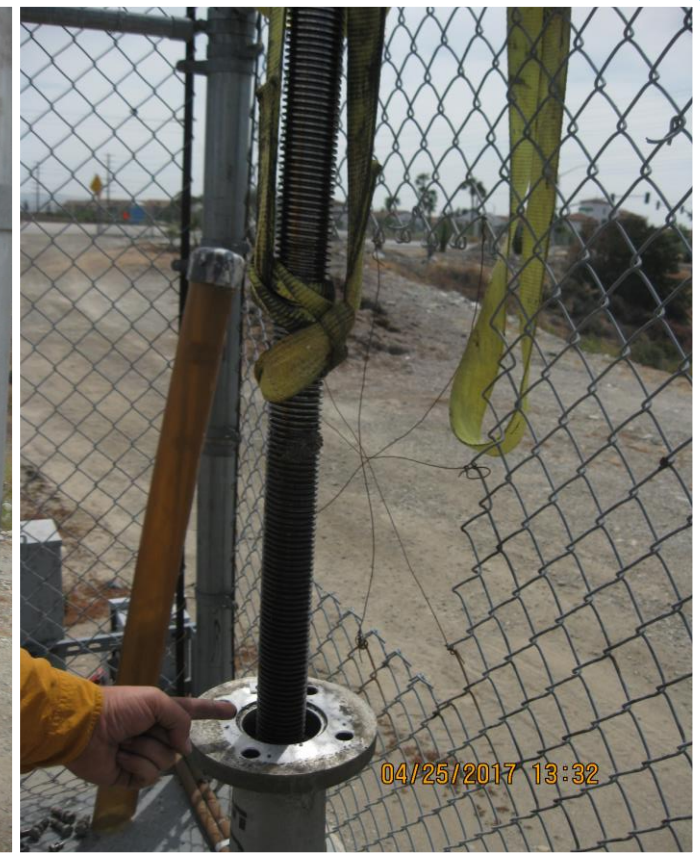
College Heights West Inlet Valve
Manual Open for Imported Water

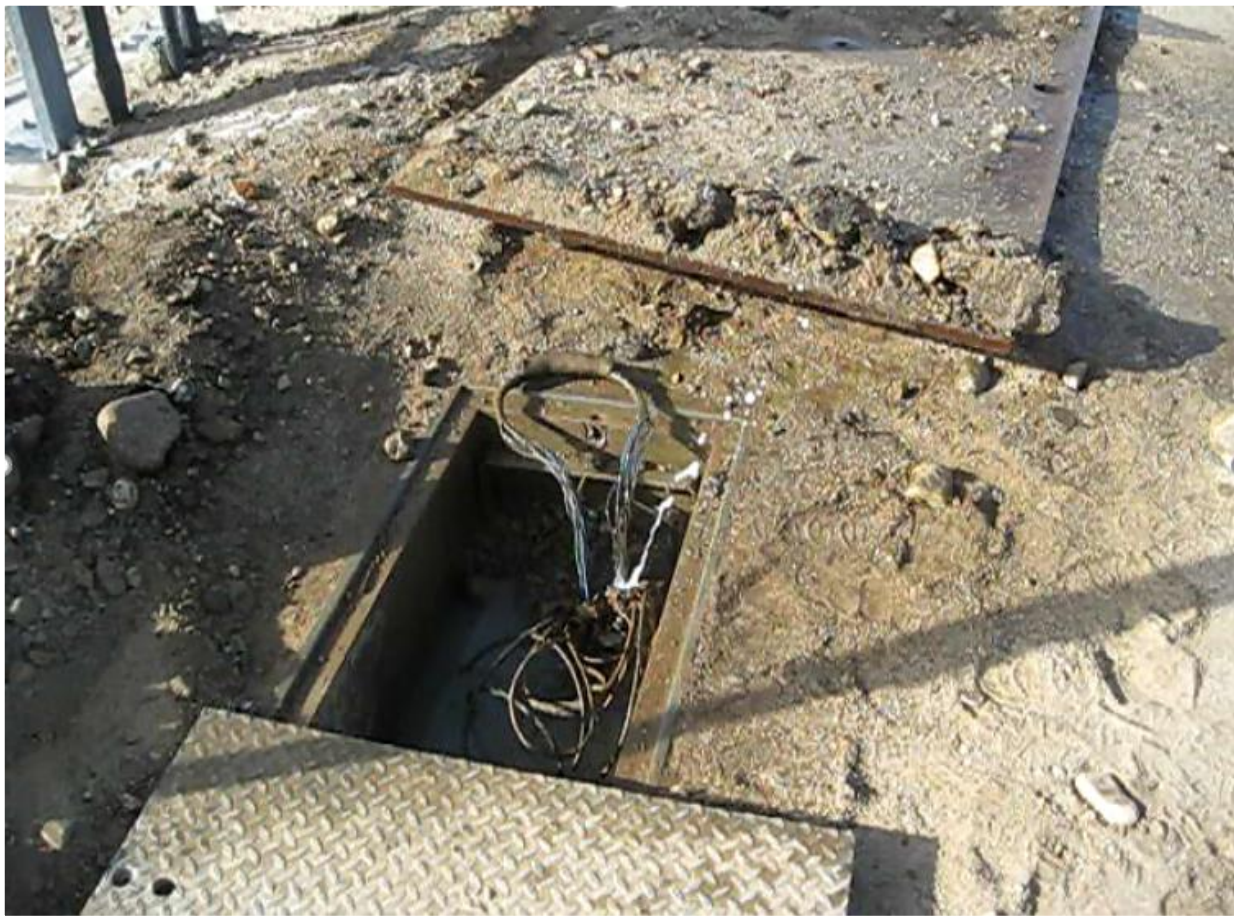
Pushing water Out of Communications Conduit at Turner 4A

FLOODING & EROSION CONTROL NEEDS TURNER 3&4

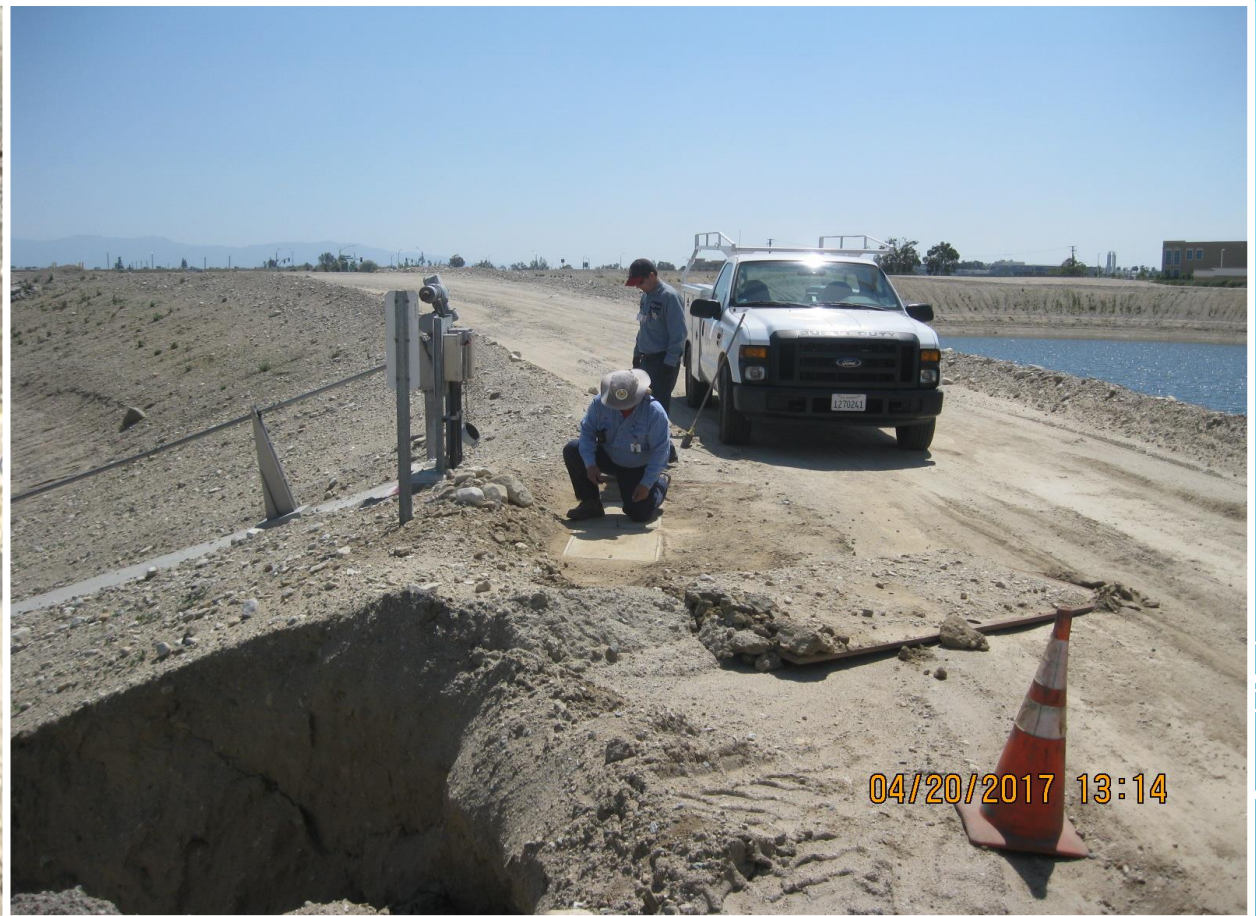
Inspecting Communication Wire Pull Box, note erosion in road
