2014 Annual Report of the Ground-Level Monitoring Committee

prepared for
Chino Basin Watermaster

July 2015

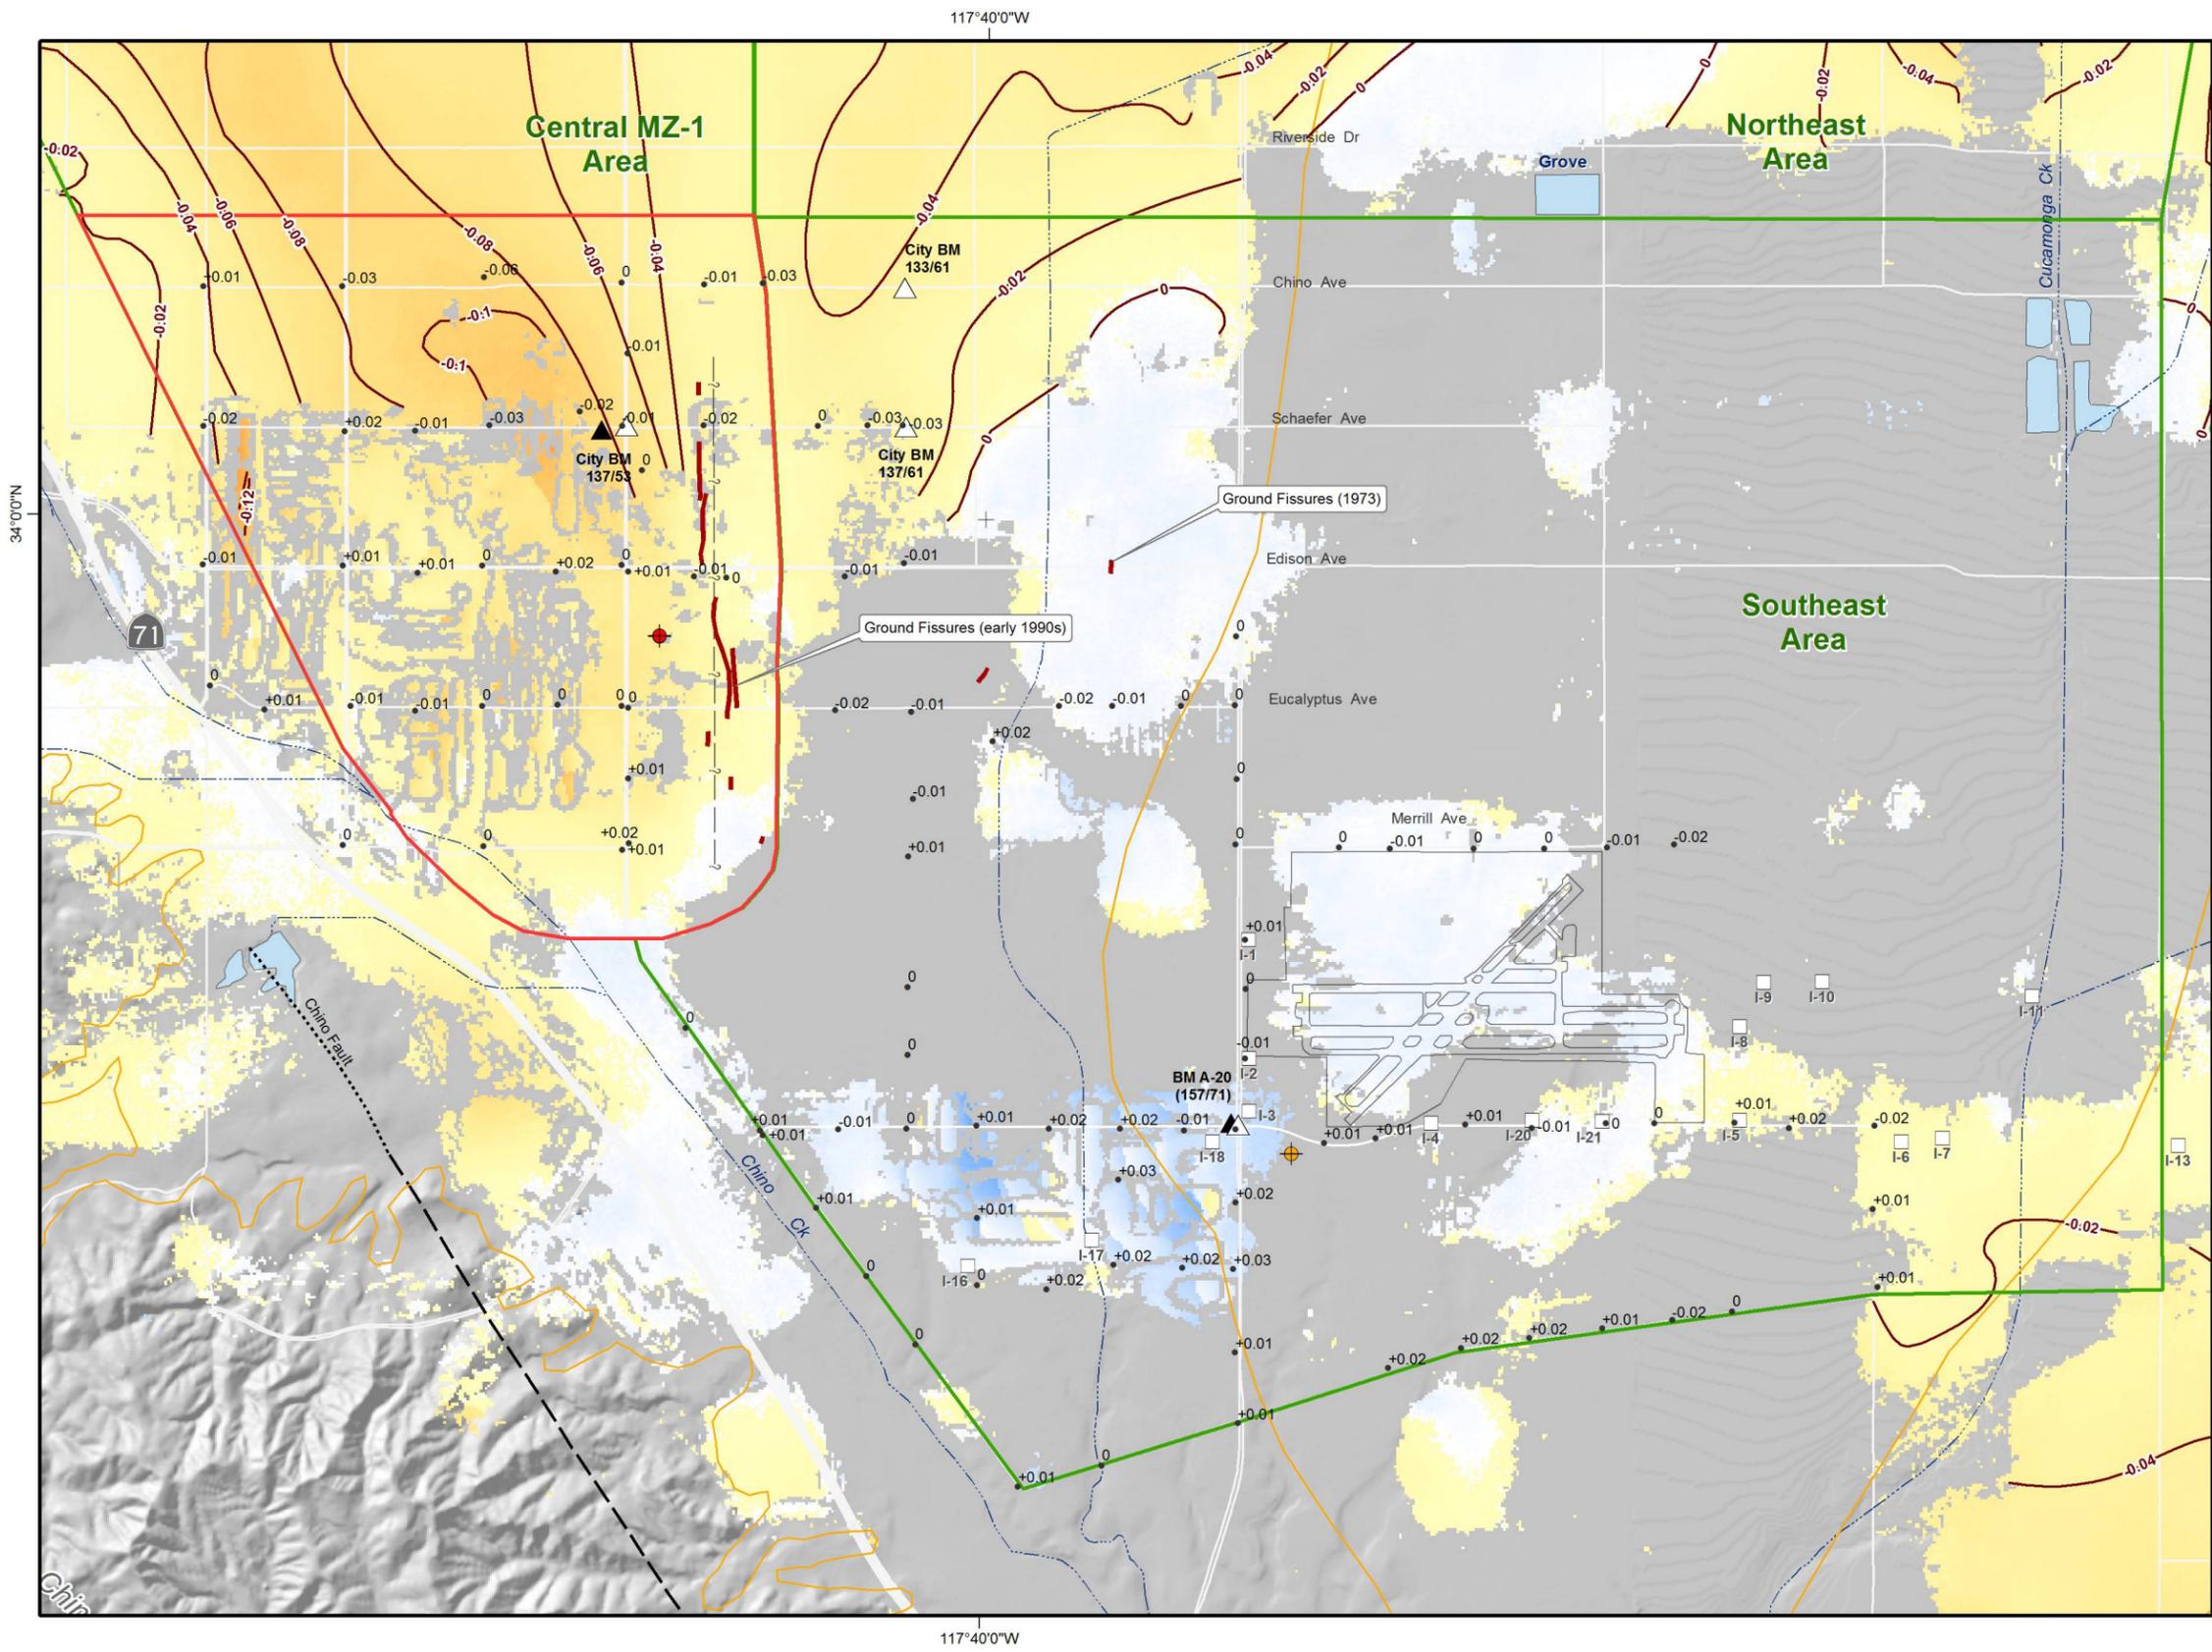
The InSAR data on Figure 3-5a indicate -0.02 to -0.12 ft of vertical ground motion across the Managed Area for the period March-2011 to December-2014. Figure 3-3 shows that groundwater levels at PA-7 were about 30 ft lower in December-2014 compared to March-2011, which suggests that the vertical ground motion shown by InSAR in the Managed Area is, in part, elastic, and may rebound when groundwater levels recover.

The InSAR data on Figure 3-5a are consistent with the Deep Extensometer record at Ayala Park during the period March-2011 to December-2014—the InSAR indicate about -0.05 ft of vertical ground motion; the Deep Extensometer measured -0.07 ft of vertical ground motion.

The leveling-survey data on Figure 3-5a indicate +0.02 to -0.06 ft of vertical ground motion across the Managed Area for the period November-2011 to March-2015. Figure 3-3 shows that groundwater levels at PA-7 were about the same in March-2015 compared to November-2011, which suggests very little, if any, subsidence occurred across the Managed Area over this period.

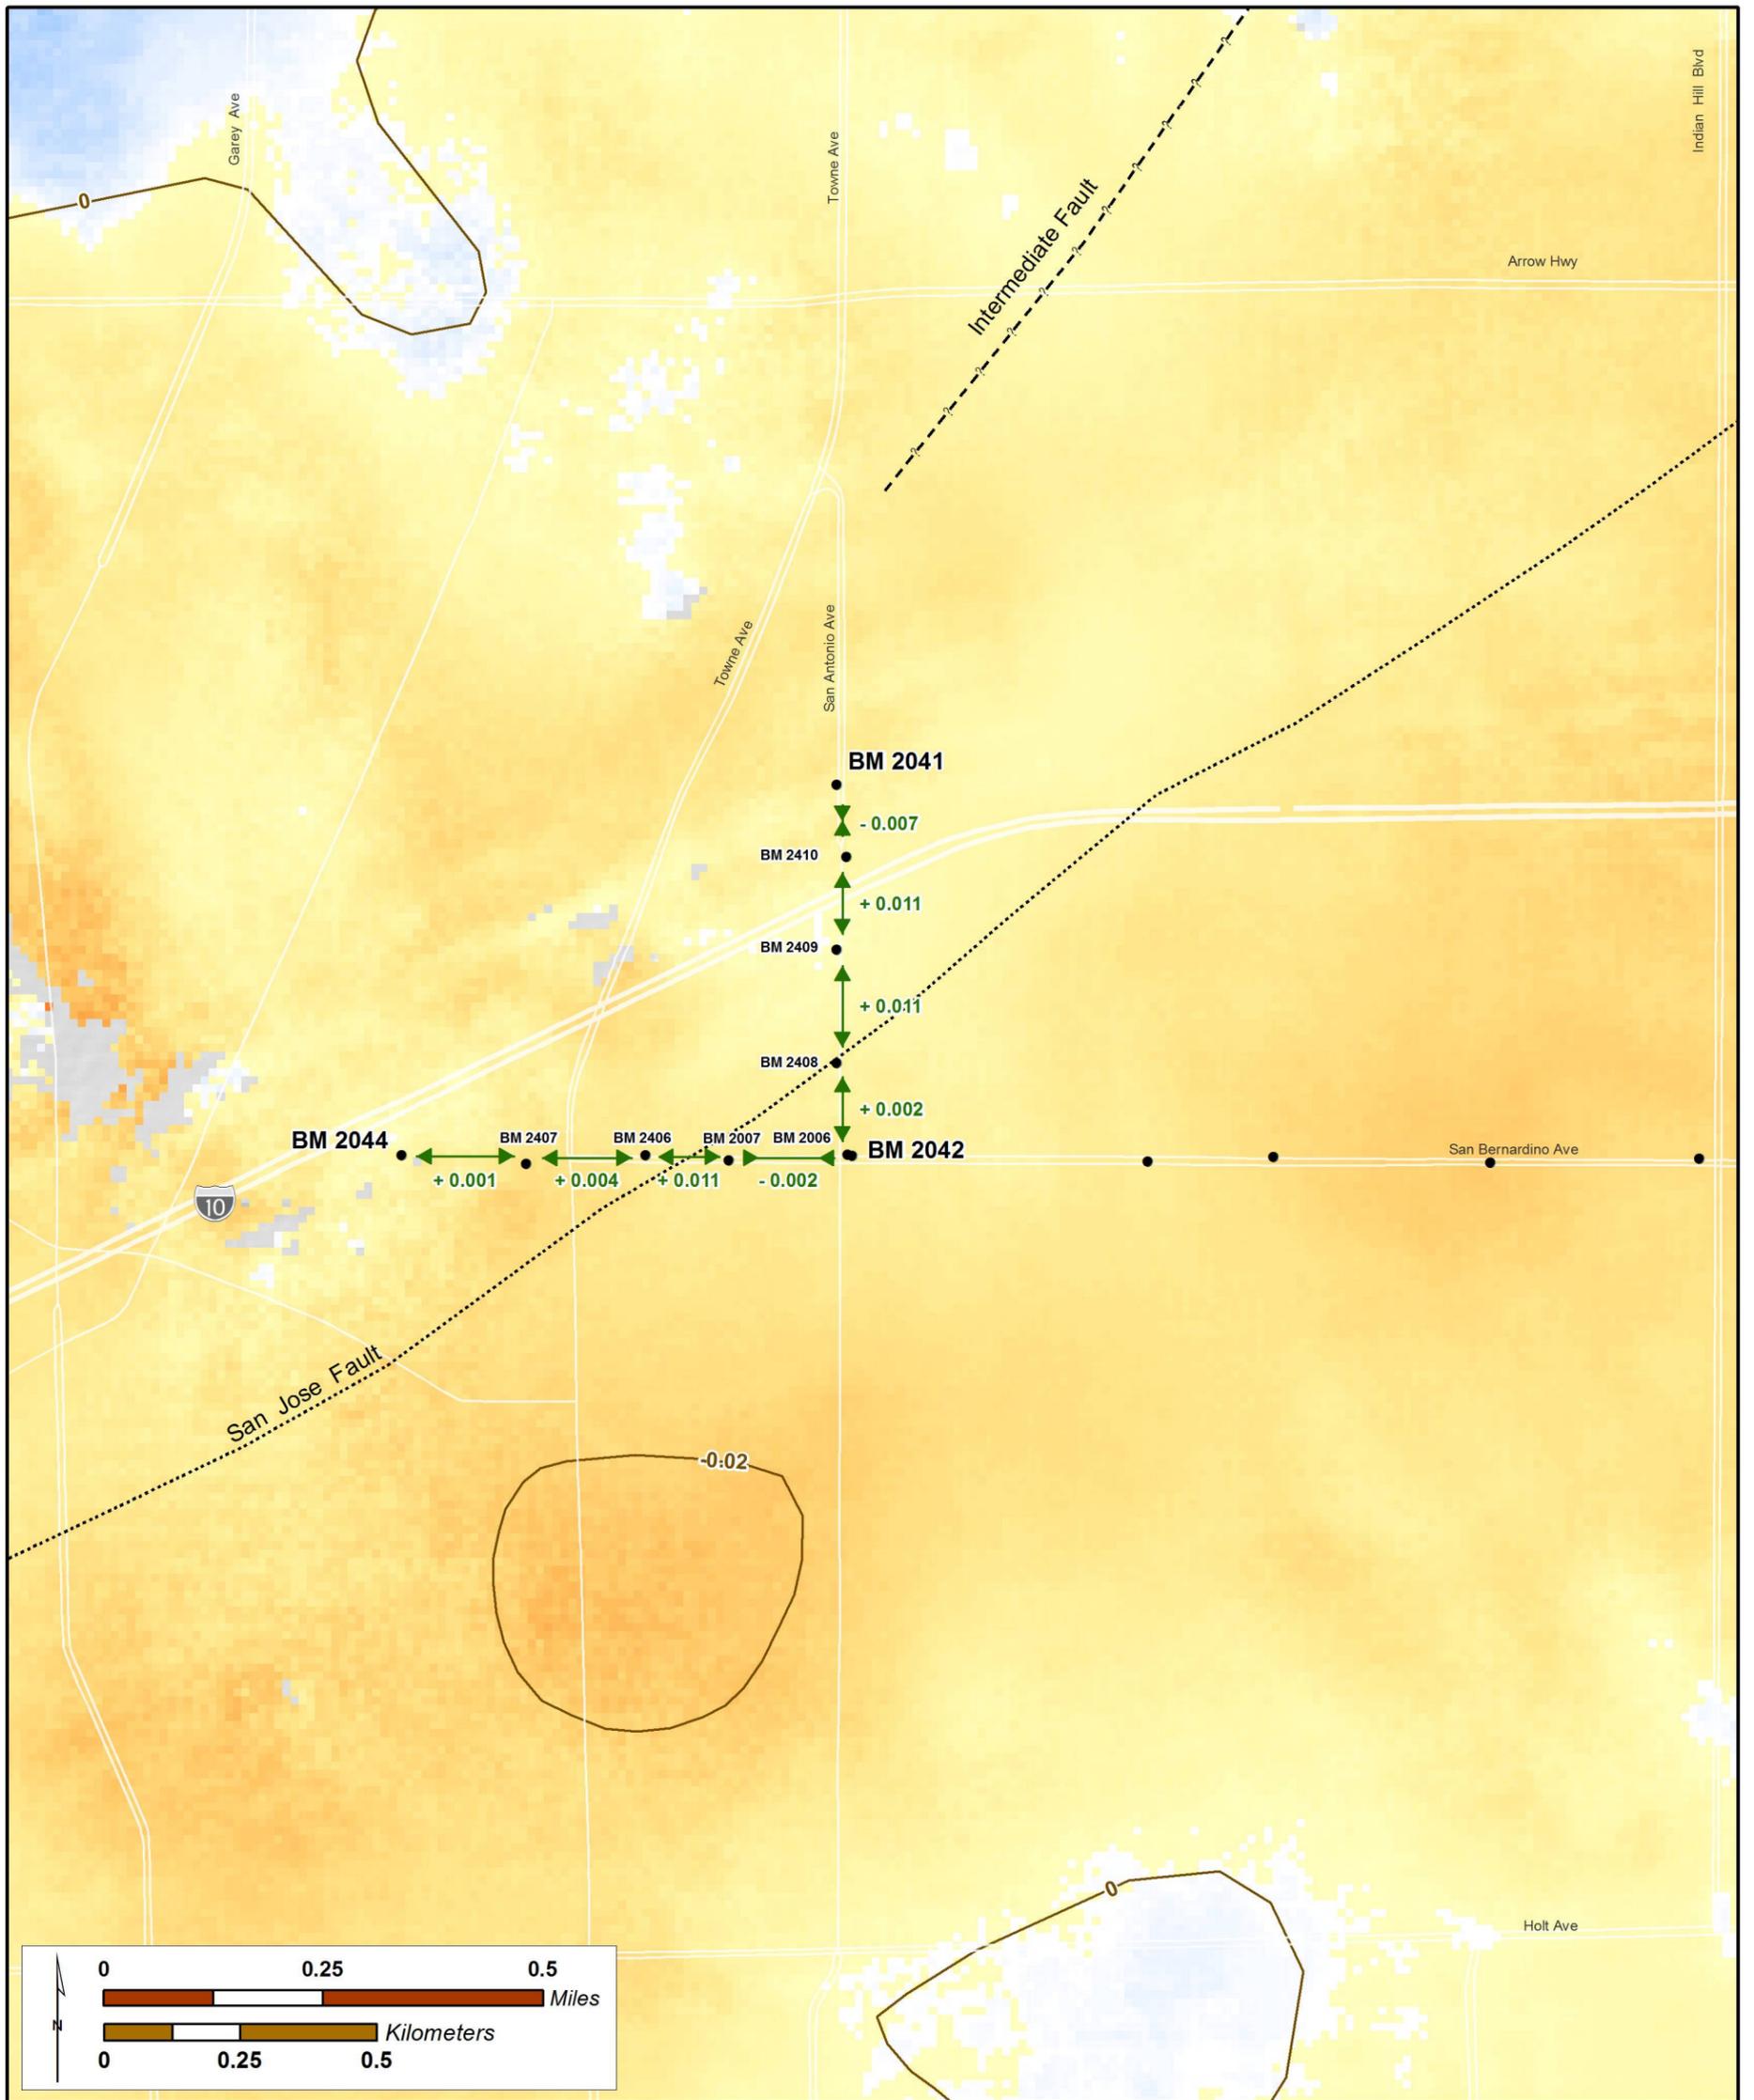
Figure 3-7

The pattern of vertical ground motion on Figures 3-1a and 3-1b is a continuation of the historical time-series of subsidence in this area shown on Figure 3-7, which indicates a total of about 1.4 feet of subsidence since 1992 (about 0.06 ft/yr). Of particular concern in Northwest MZ-1 Area is that the historical and ongoing subsidence has been differential across the San Jose Fault. Differential subsidence can result in ground fissuring, as it did in the Managed Area during the 1990s.
