TECHNICAL MEMORANDUM

DATE: September 27, 2021 Project No.: 941-80-12-59
SENT VIA: EMAIL

SUBJECT: Chino Basin Watermaster Other Recharge Improvement Projects Study

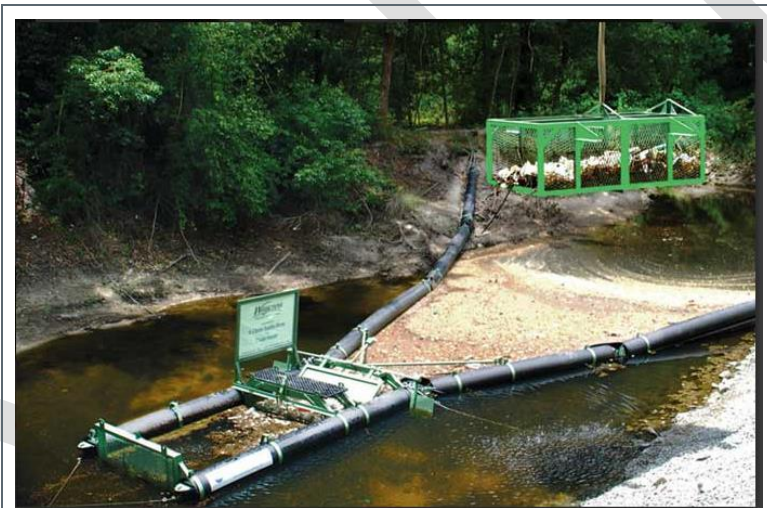
Photo 8
Bandalong Litter Trap

West Yost reviewed a number a trash booms that would direct floating trash to one side of the low flow channel. We also looked at the Bandalong Litter Trap, which has floating booms along with a lift out trash collection basket. Due to the cost of the Litter Trap, \$187,400, it was not considered as an alternative for trash collection. The Litter Trap is shown is Photo 8.
