# 2016 ANNUAL REPORT OF THE GROUND-LEVEL MONITORING COMMITTEE

*FINAL REPORT  
SEPTEMBER 2017*

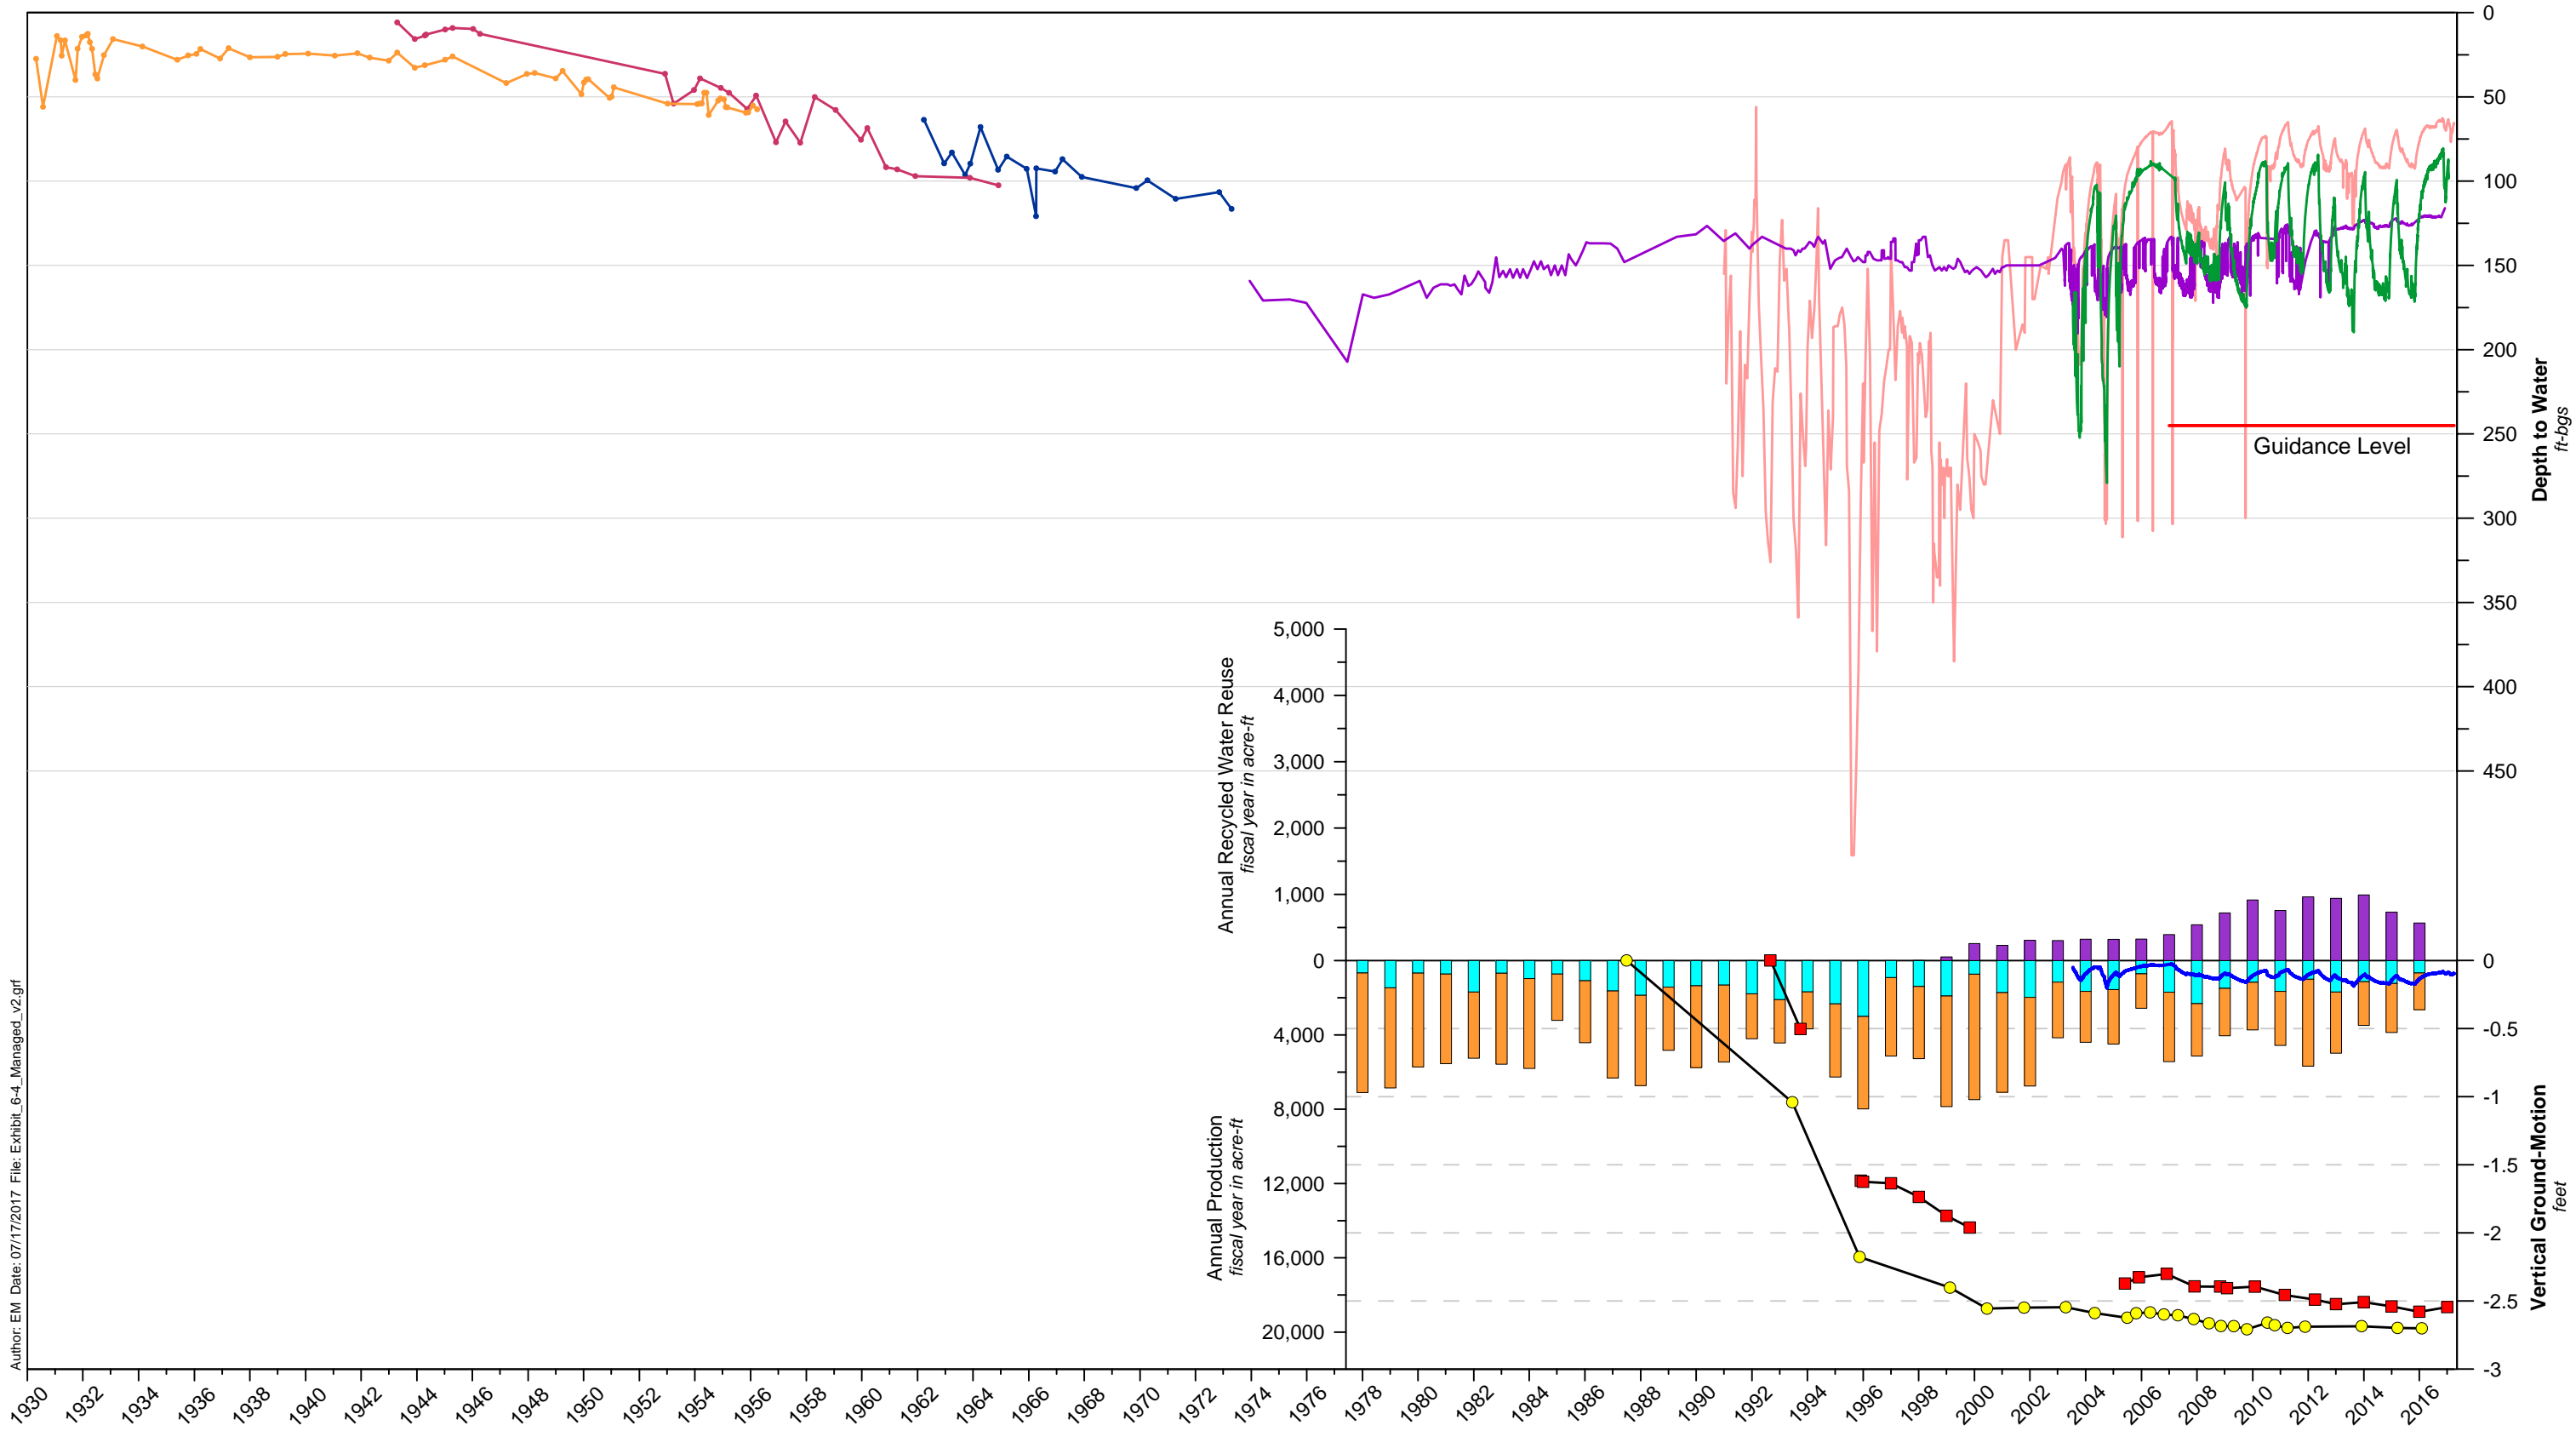
**Figure 3-2**

## The History of Land Subsidence in the Managed Area

Figure 3-2 is a chart that illustrates the long-term history of groundwater production, piezometric levels, and vertical ground motion in the Managed Area. Also shown is the volume of the direct use of recycled water in the Managed Area, which is a recently available alternative water supply that can result in decreased groundwater production from the area. The main observations from this chart are:

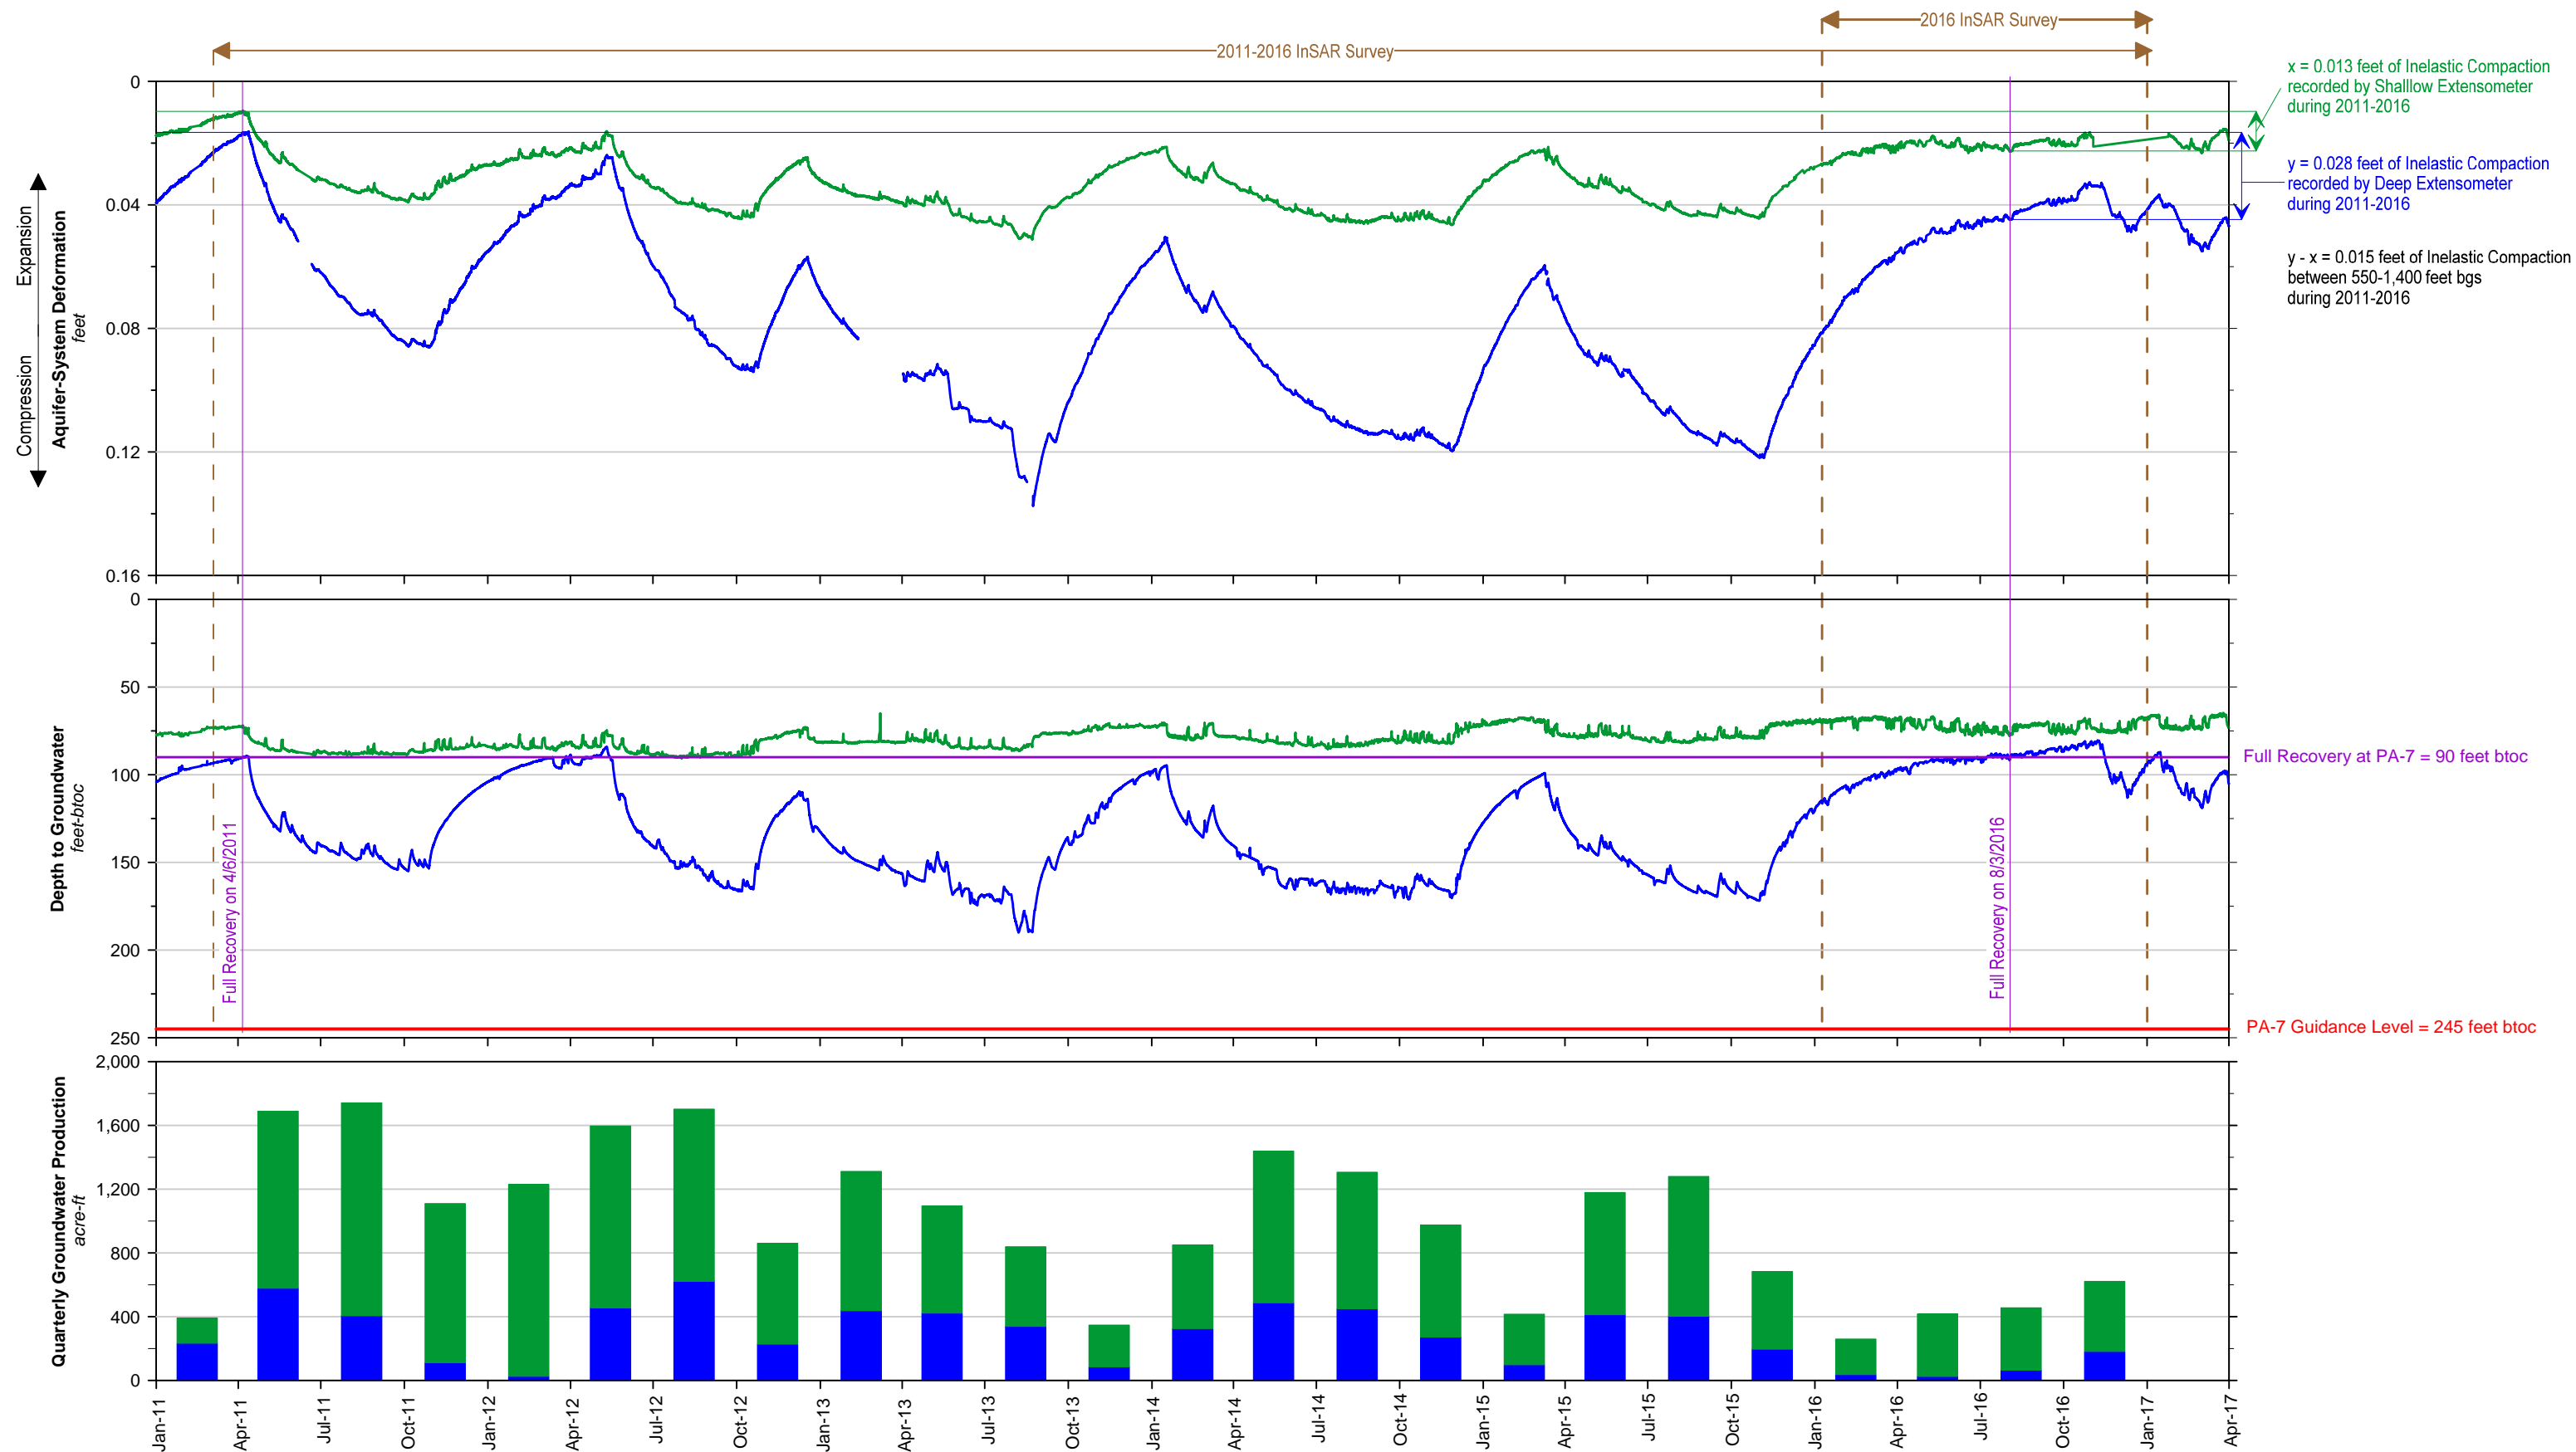
**Figure 3-3**

**Stress and Strain  
within the Managed Area**

Figure 3-3 is a time-series chart that displays groundwater production and the resultant piezometric change (stress) and aquifer-system deformation (strain) in the Managed Area for the period of 2011 and 2016. The chart illustrates the seasonal pattern of production in the Managed Area: increased production during the spring and summer months and decreased production during the fall and winter months.

Figure 3-3 also displays the time-series of piezometric levels at two piezometers at Ayala Park, PA-7 (deep aquifer-system) and PA-10 (shallow aquifer-system), illustrating the deep and shallow piezometric responses to seasonal groundwater production stresses. These data are consistent with the conclusions of the IMP and show that pumping from the deep, confined aquifer-system causes a piezometric decline that is much greater in magnitude than the piezometric decline caused by pumping of the shallow aquifer-system—even though more groundwater production occurs from the shallow aquifer-system. The chart shows that piezometric levels at PA-7 have fluctuated from a low of approximately 190 ft-btoc in August 2013 to a high of about 80 ft-btoc in November 2016 and have not declined below the Guidance Level of 245 ft-btoc. The recovery of piezometric levels at PA-7 to above 90 ft-btoc in 2016 represented a “full recovery” of piezometric levels at PA-7 as defined in the SMP. This is the first instance of full recovery since 2012, which complies with the recommendation in the SMP for full piezometric recovery within the deep aquifer system at least once every five years.<sup>8</sup>

Figure 3-3 includes a time-series chart of vertical deformation of the aquifer-system as measured at the Ayala Park Extensometer during 2011-2016. These data show that the seasonal vertical compression and expansion of the aquifer system is responding to the seasonal decline and recovery of piezometric levels and indicate that the vertical deformation of the aquifer-system was mainly elastic during this period. However, between April 6, 2011 to August 3, 2016 (dates of full recovery of piezometric levels at PA-7 to 90 ft-btoc), the Deep Extensometer recorded about 0.028 ft of compression within the aquifer-system, which indicates that this compression is permanent compaction that occurred within the depth interval of 30-1,400 ft-bgs. Over this

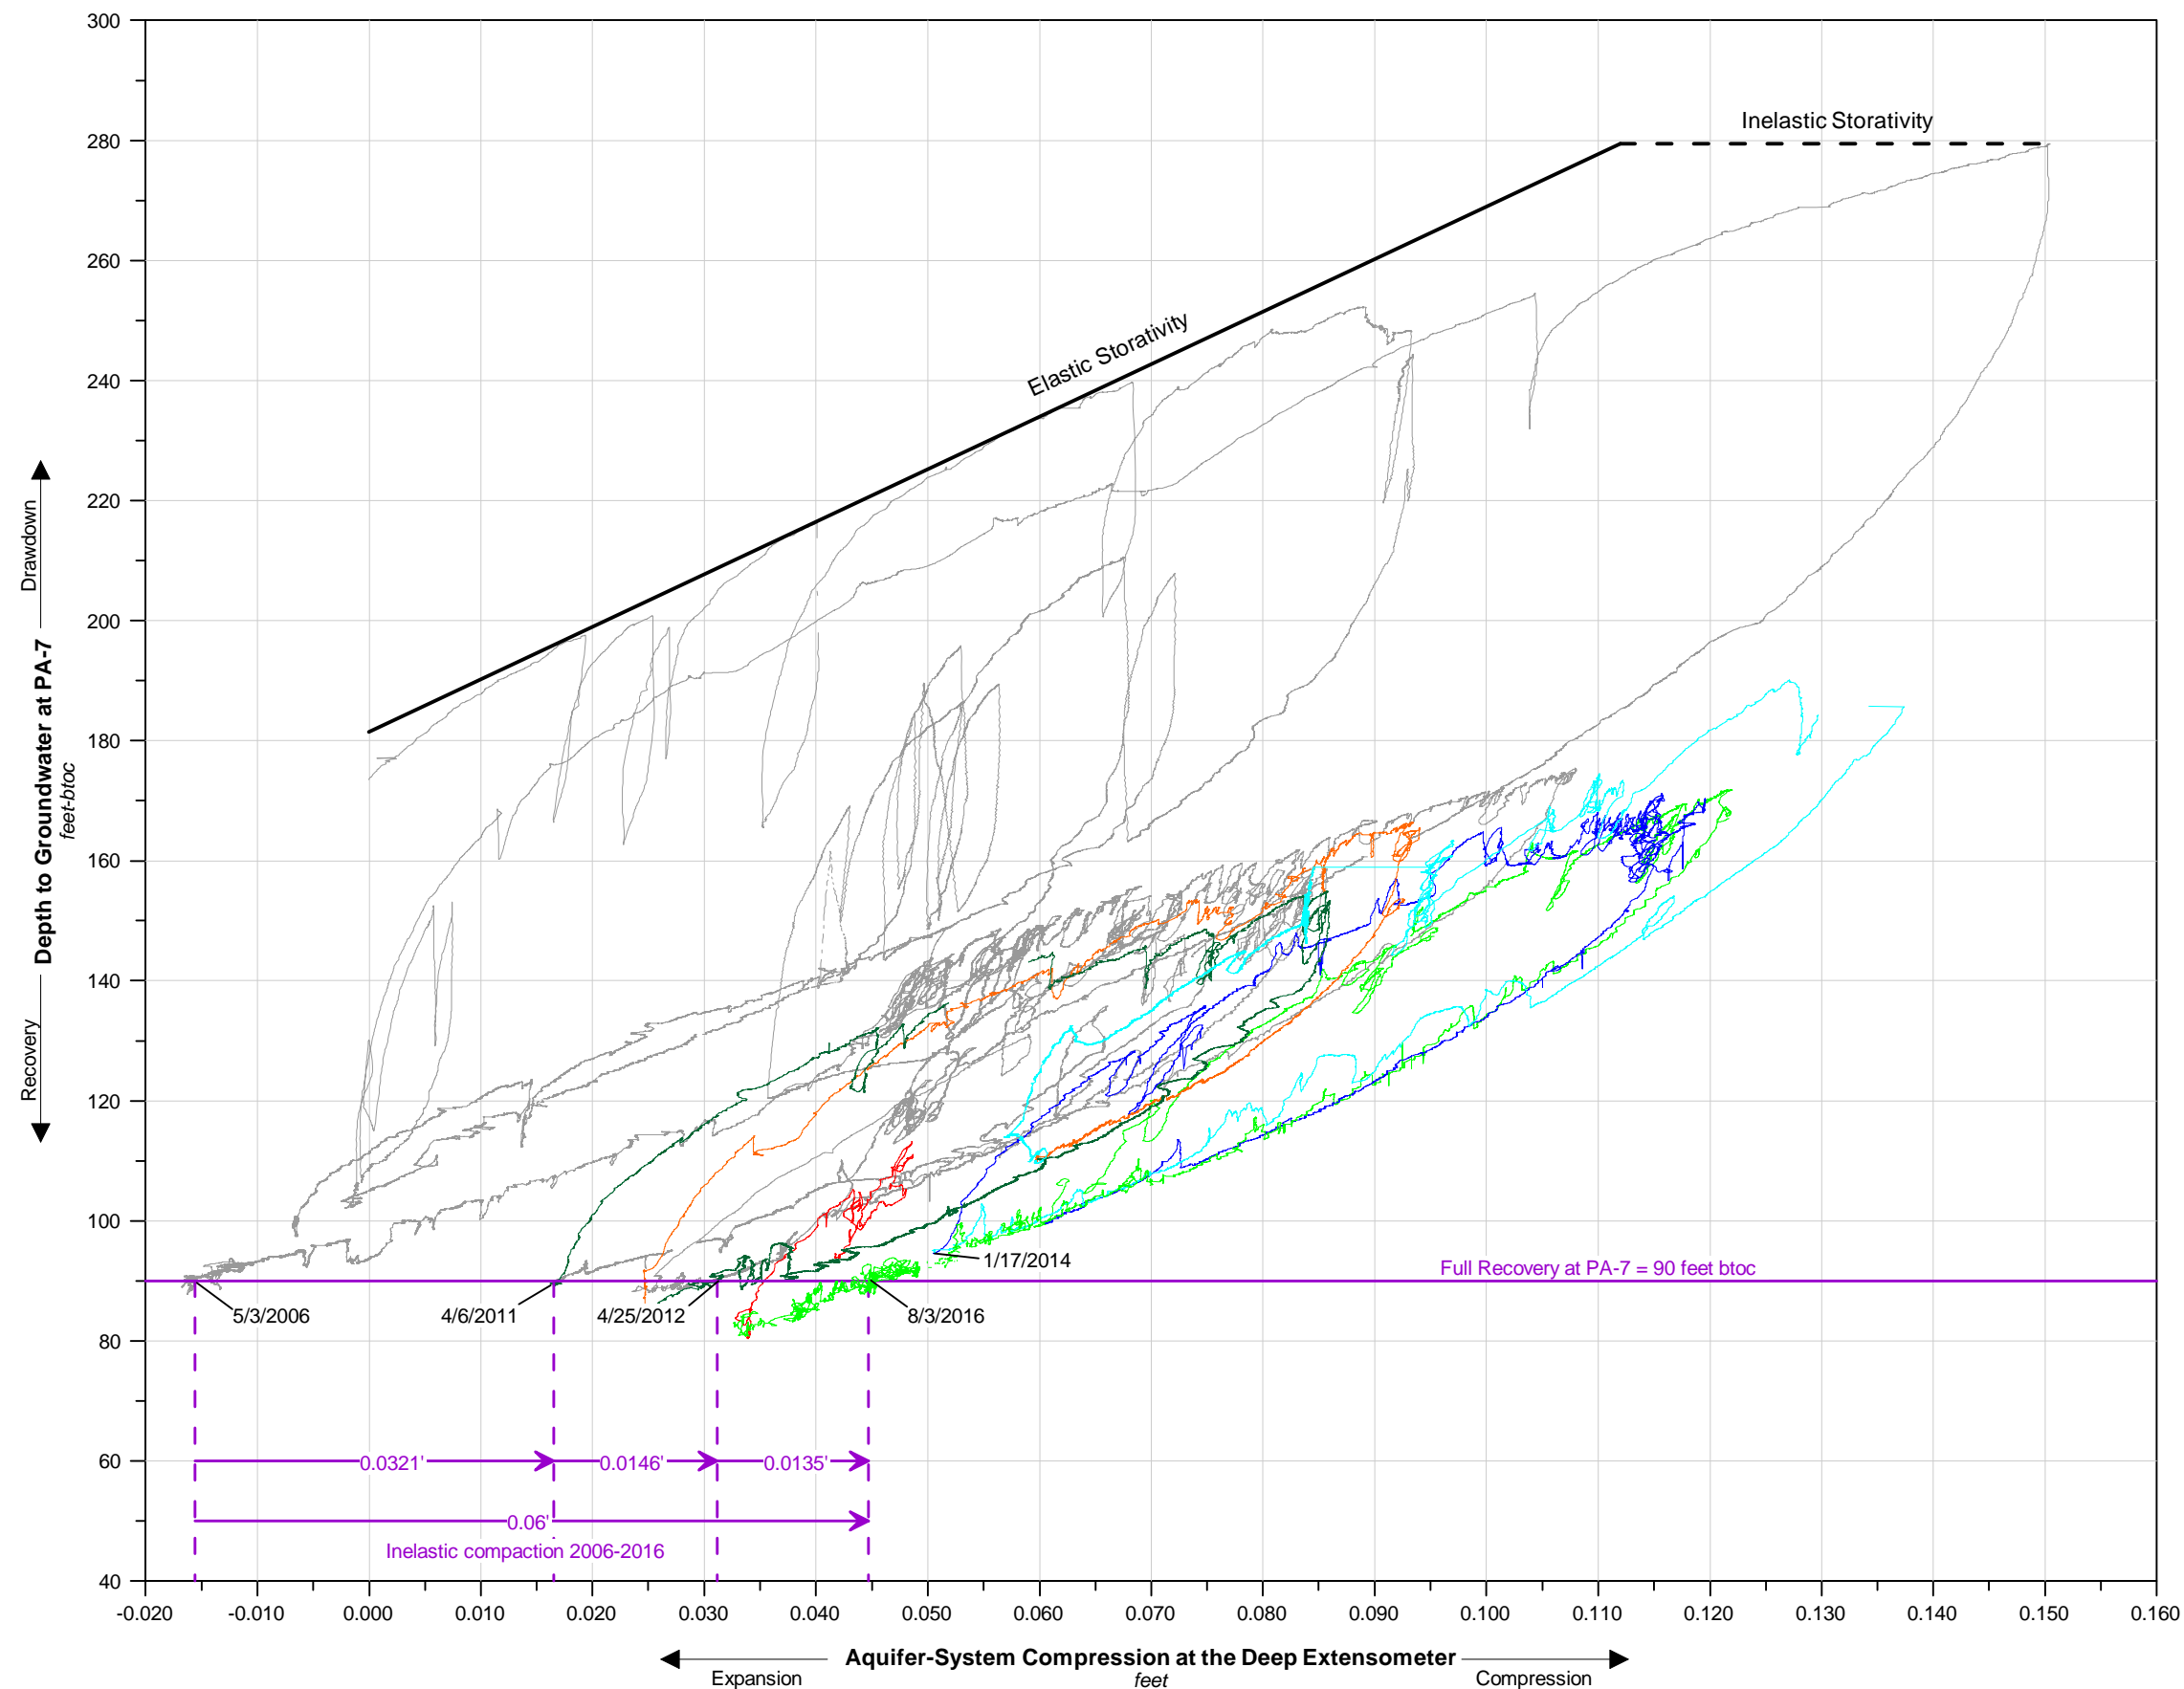
**Figure 3-4**

\*PA-7 Well-Screen Interval: 438-448 ft-bgs  
Depth Interval of the Deep Extensometer: 30-1,400 feet-bgs

Figure 3-4 is a stress-strain diagram of piezometric levels measured at PA-7 (stress) versus vertical deformation of the aquifer-system sediments as measured at the Deep Extensometer (strain). The hysteresis loops on this figure represent piezometric decline-recovery cycles and the resultant compression-expansion of the aquifer-system sediments. The diagram can be interpreted to understand the timing and magnitude of the occurrence of compaction within the depth interval of aquifer-system that is penetrated by the Deep Extensometer. Piezometric decline is shown as increasing from bottom to top on the Y-axis, and aquifer-system compression is shown as increasing from left to right on the X-axis. From April 2011 to January 2014, the hysteresis loops progressively shift to the right on this chart, indicating that about 0.028 ft of inelastic compaction occurred during this period within the depth interval of 30-1,400 ft-bgs. The overlapping hysteresis loops from 2014 to 2016 indicate that inelastic compaction at Ayala Park had ceased by about 2014 and that the seasonal vertical deformation of the aquifer-system sediments since 2014 has been virtually entirely elastic.

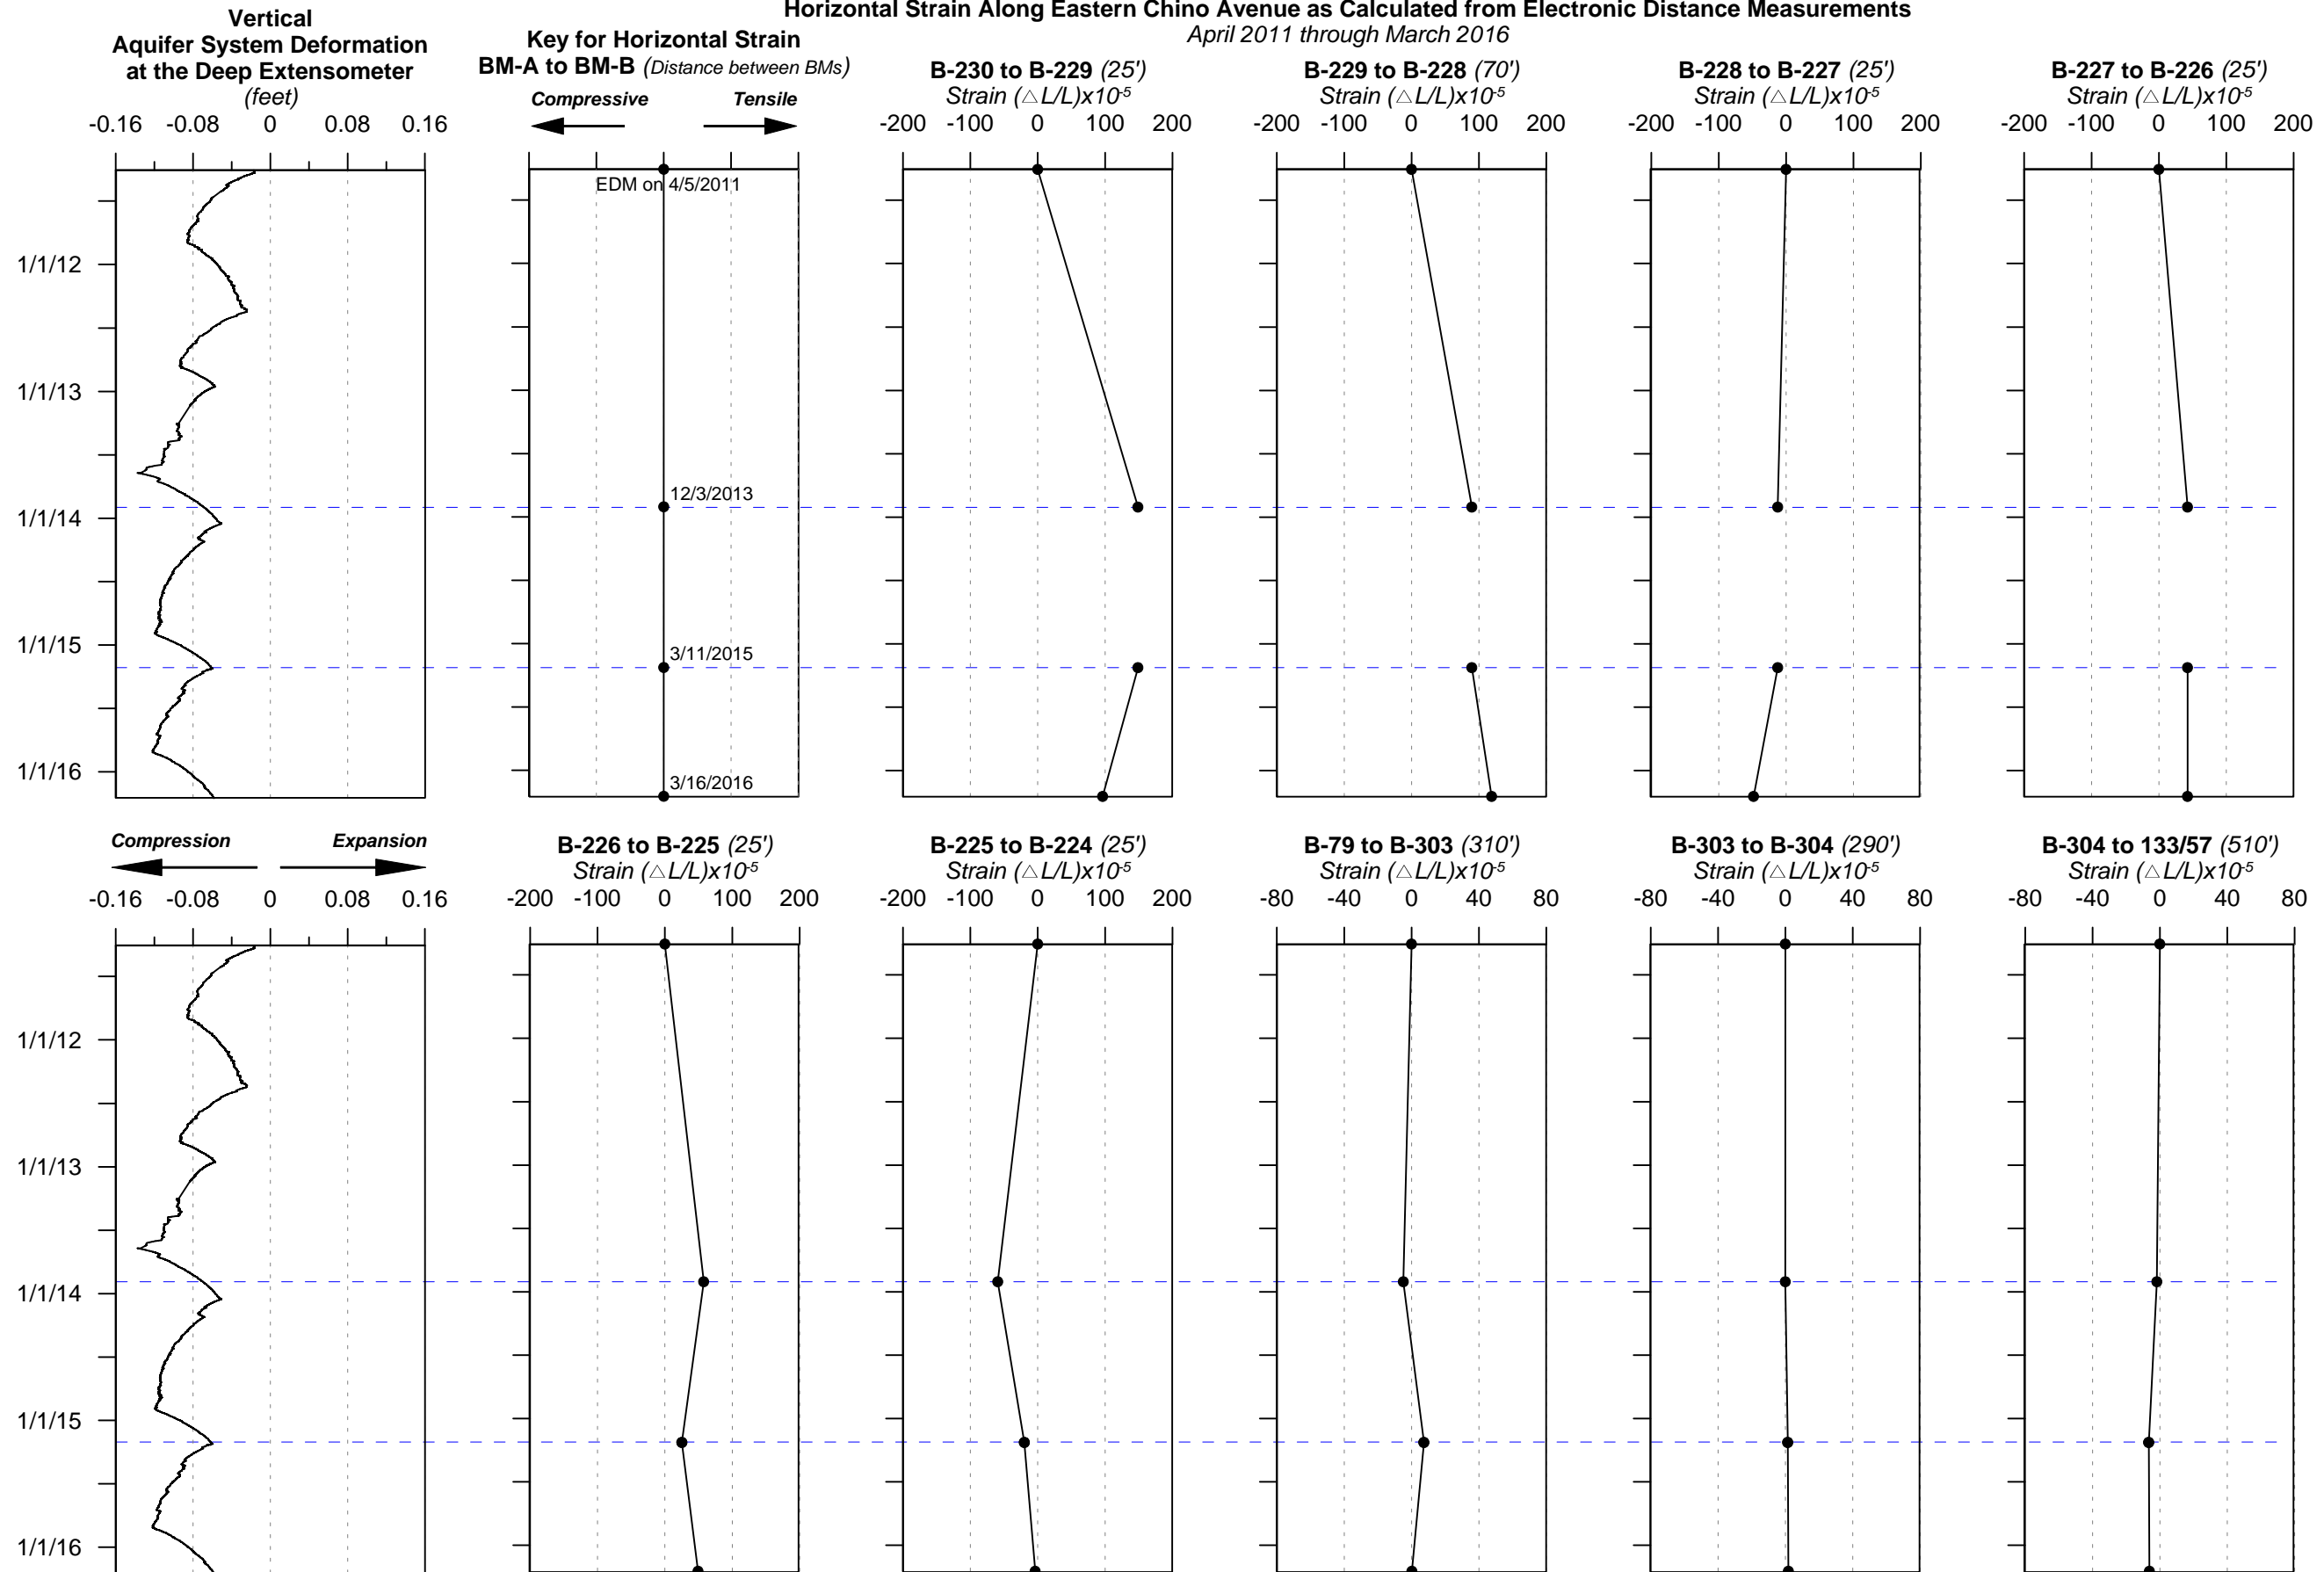
Figure 3-8c  
April 2011 through March 2016

Horizontal Strain Along Eastern Chino Avenue as Calculated from Electronic Distance Measurements

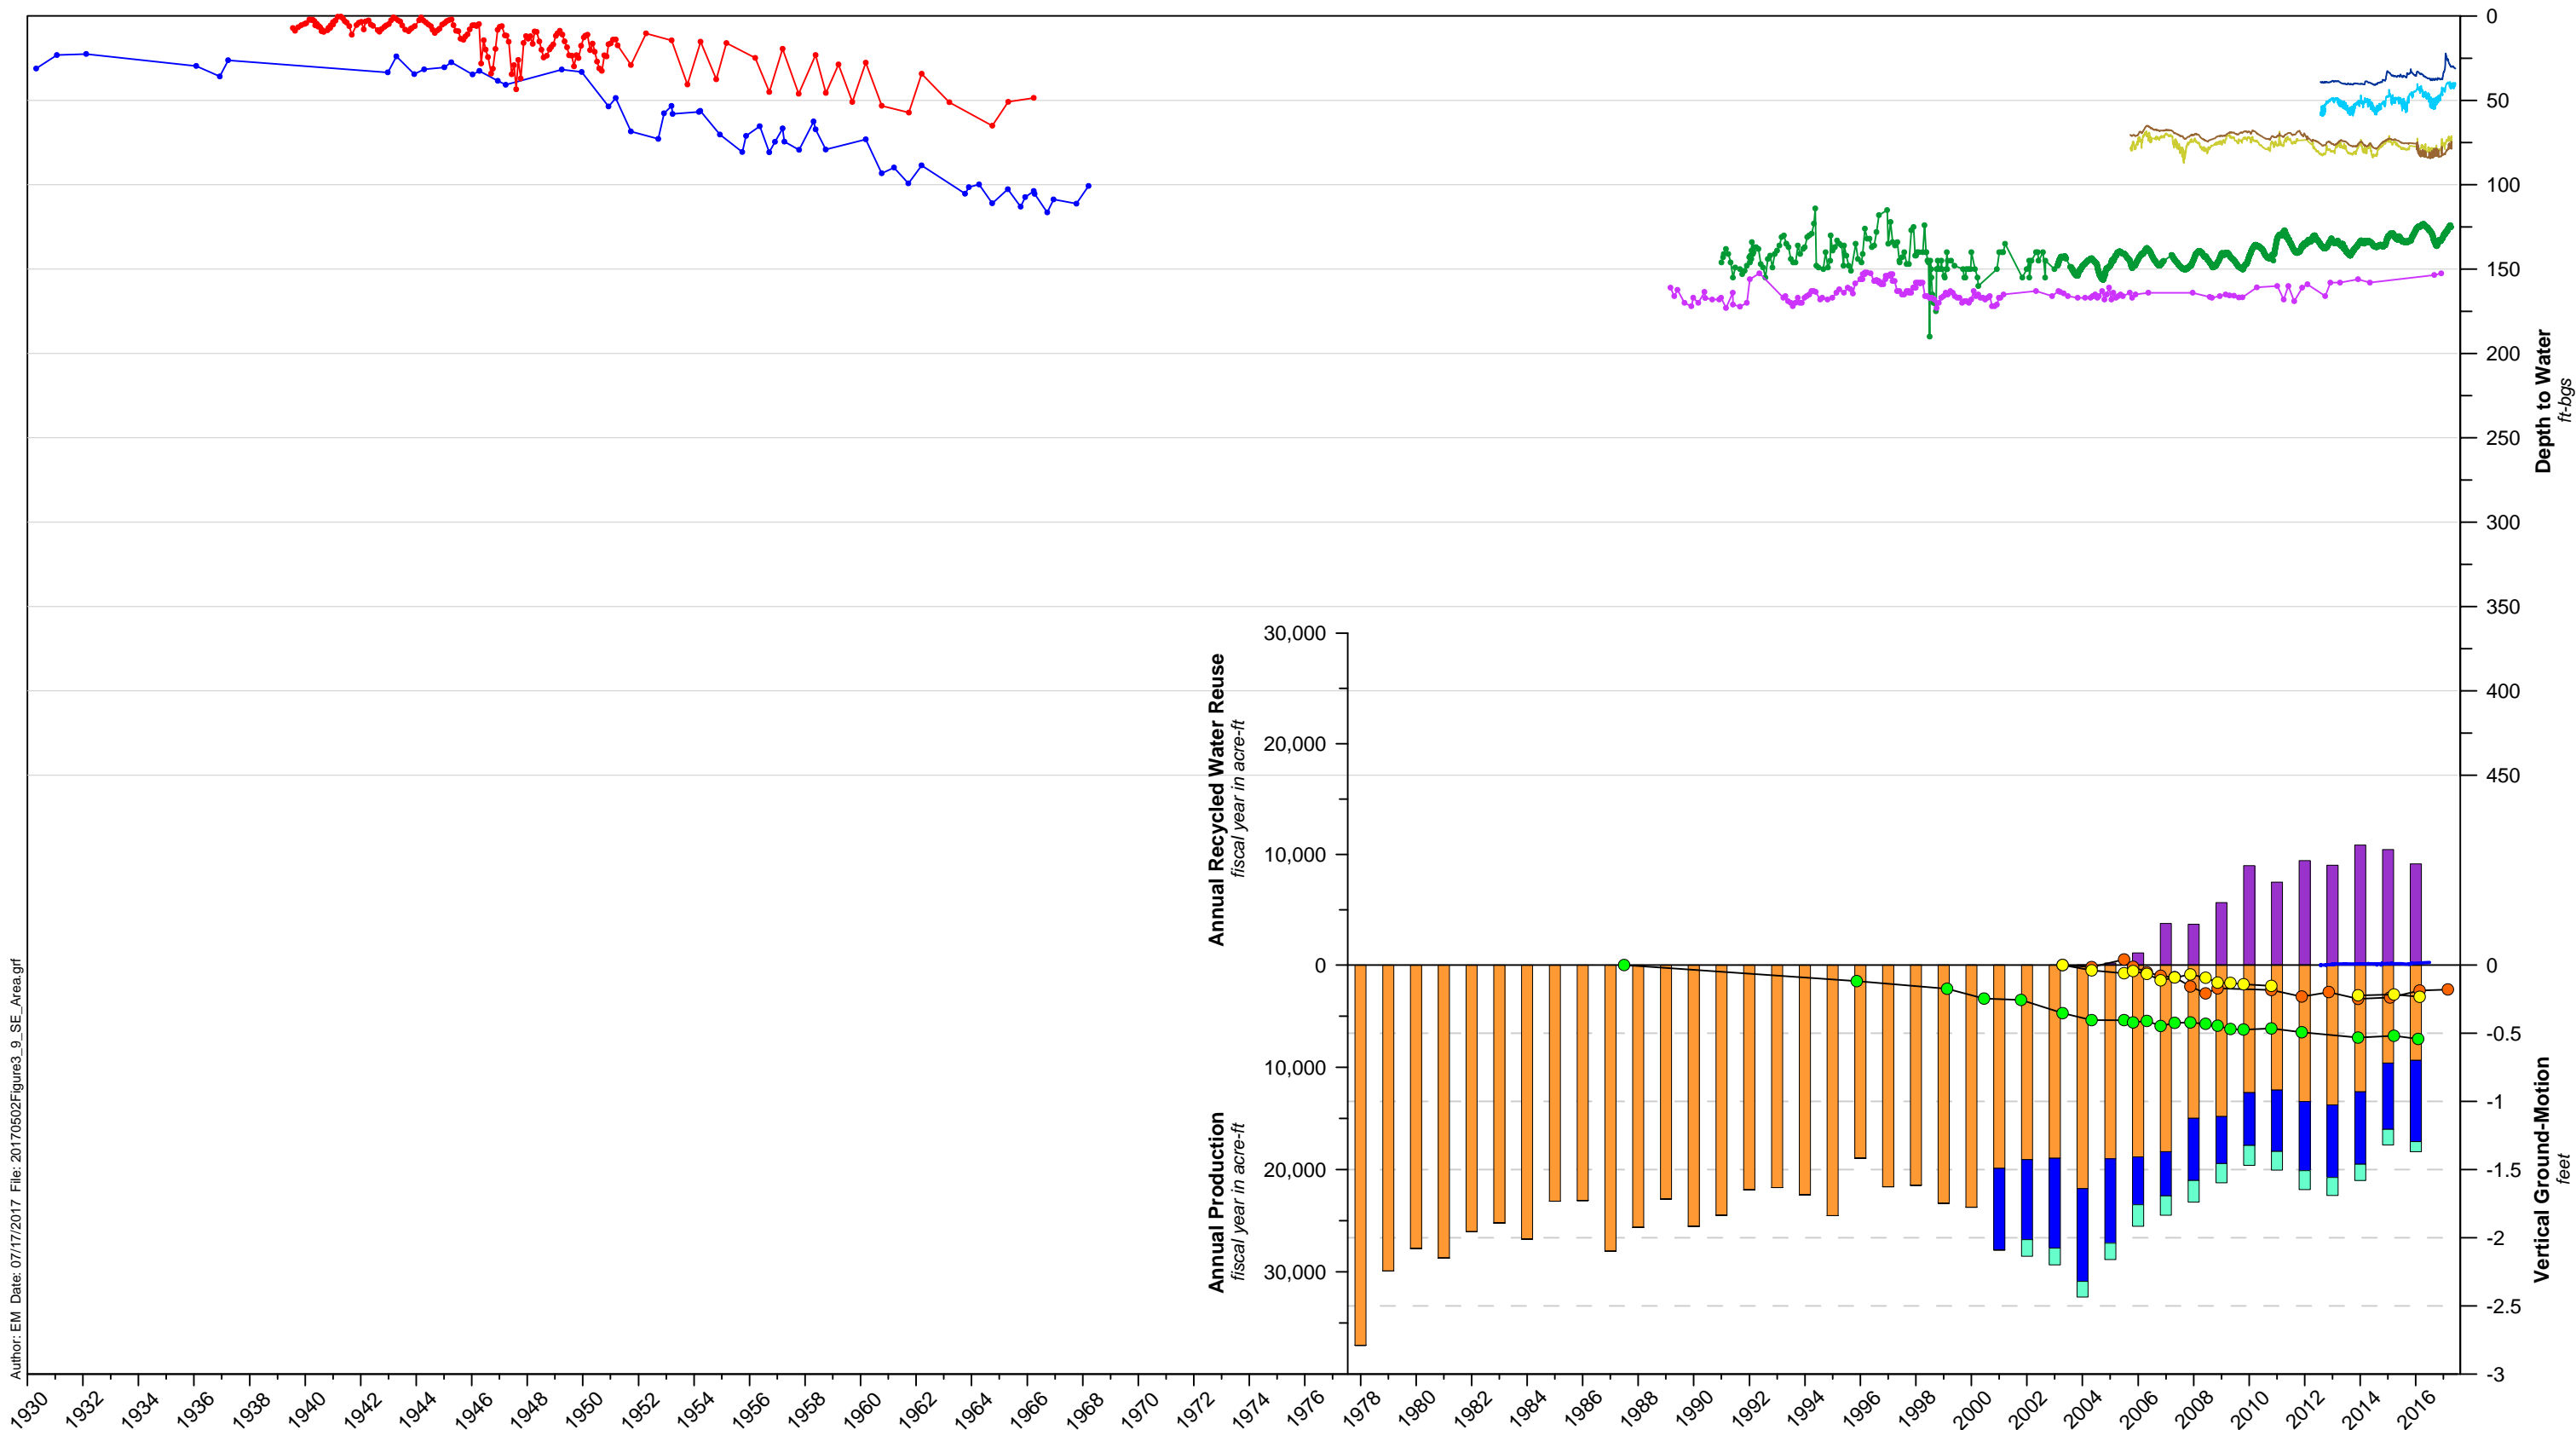
Piezometric Levels at Wells (Top-Bottom of Screen Interval)

The History of Land Subsidence  
in the Southeast Area

Vertical ground motion is measured across the Southeast Area via InSAR, traditional ground-level surveys, and the CCX. Figure 3-9 is a time-series chart that displays and describes the long-term history of land subsidence in the Southeast Area. InSAR data are generally incoherent
