# 2016 ANNUAL REPORT OF THE GROUND-LEVEL MONITORING COMMITTEE

*FINAL REPORT  
SEPTEMBER 2017*

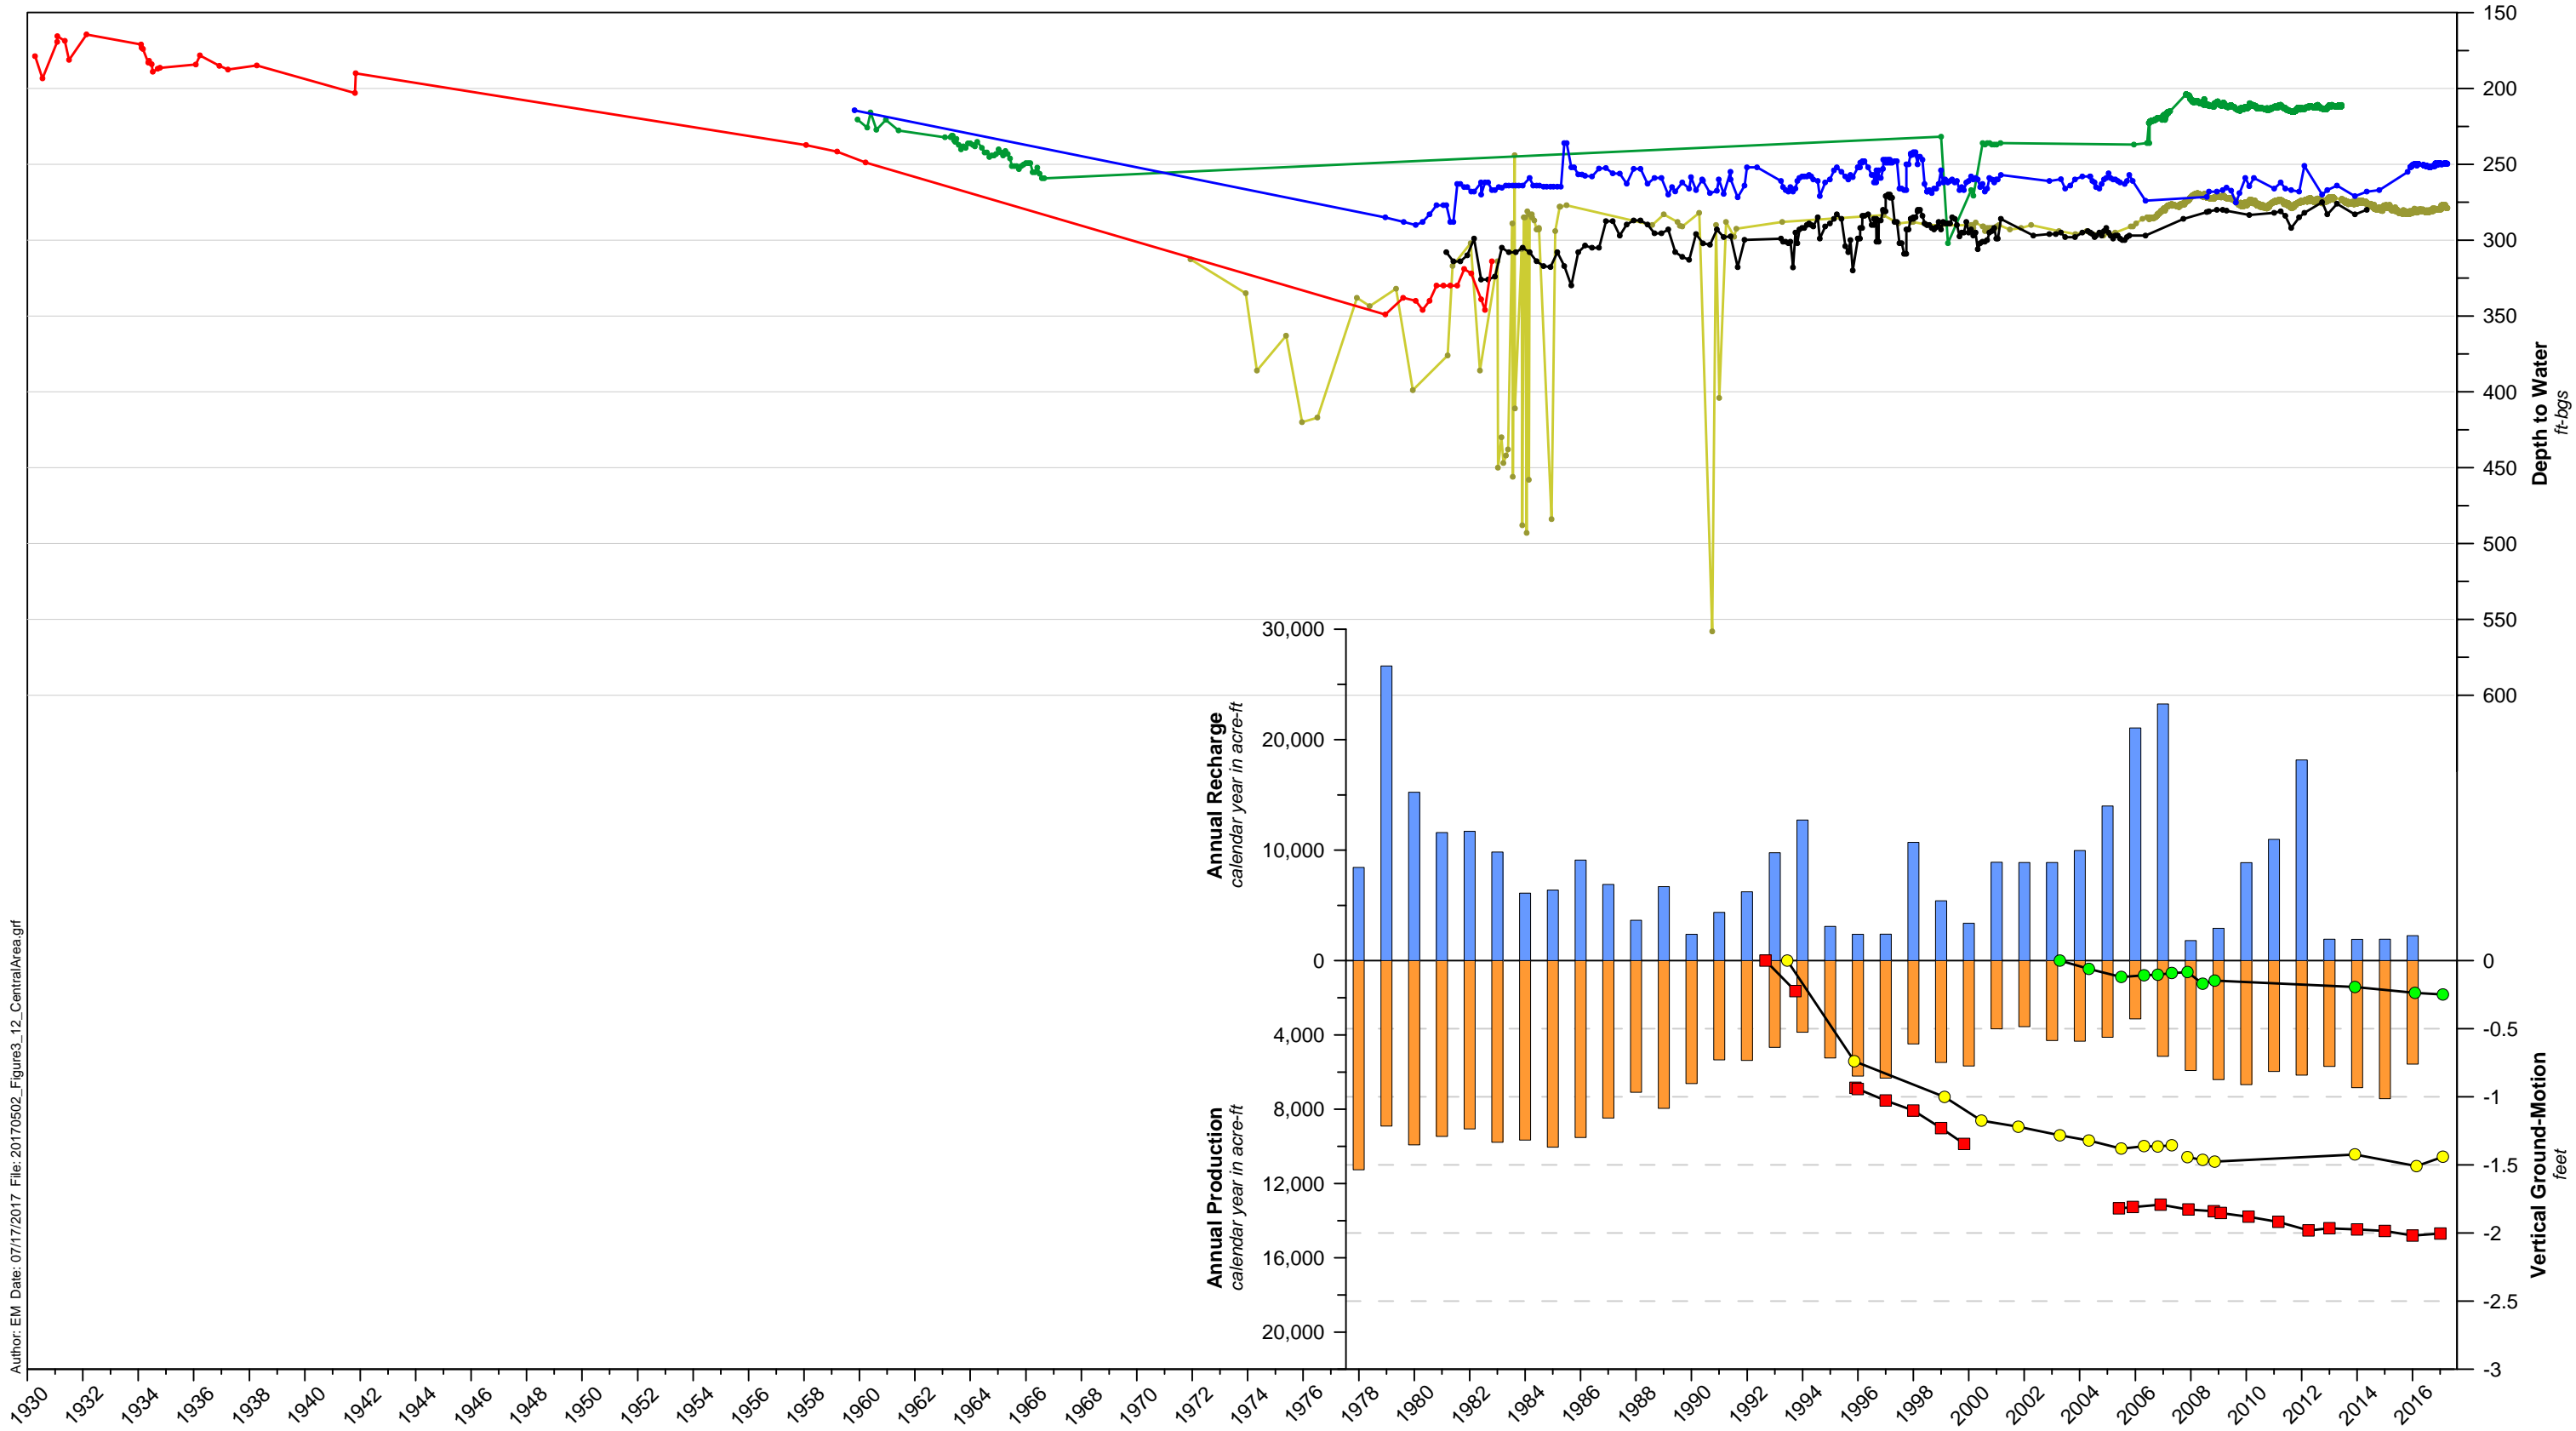
## The History of Land Subsidence in the Central MZ-1 Area

Vertical ground-motion is measured across the Central MZ-1 Area via InSAR and traditional ground-level surveys. Figures 3-1a and 3-1b illustrate vertical ground motion as measured by InSAR across Central MZ-1 during 2011-2016 and 2016, respectively. Figure 3-12 is a time-series chart that displays and describes the long-term history of land subsidence in Central MZ-1. These maps and charts show that the time history and magnitude of vertical ground motion in Central MZ-1 is similar to the time history and magnitude of vertical ground motion in the Managed Area, which suggests a relationship to the causes of land subsidence in the Managed Area; however, there is not enough historical piezometric level data in this area to confirm this relationship.

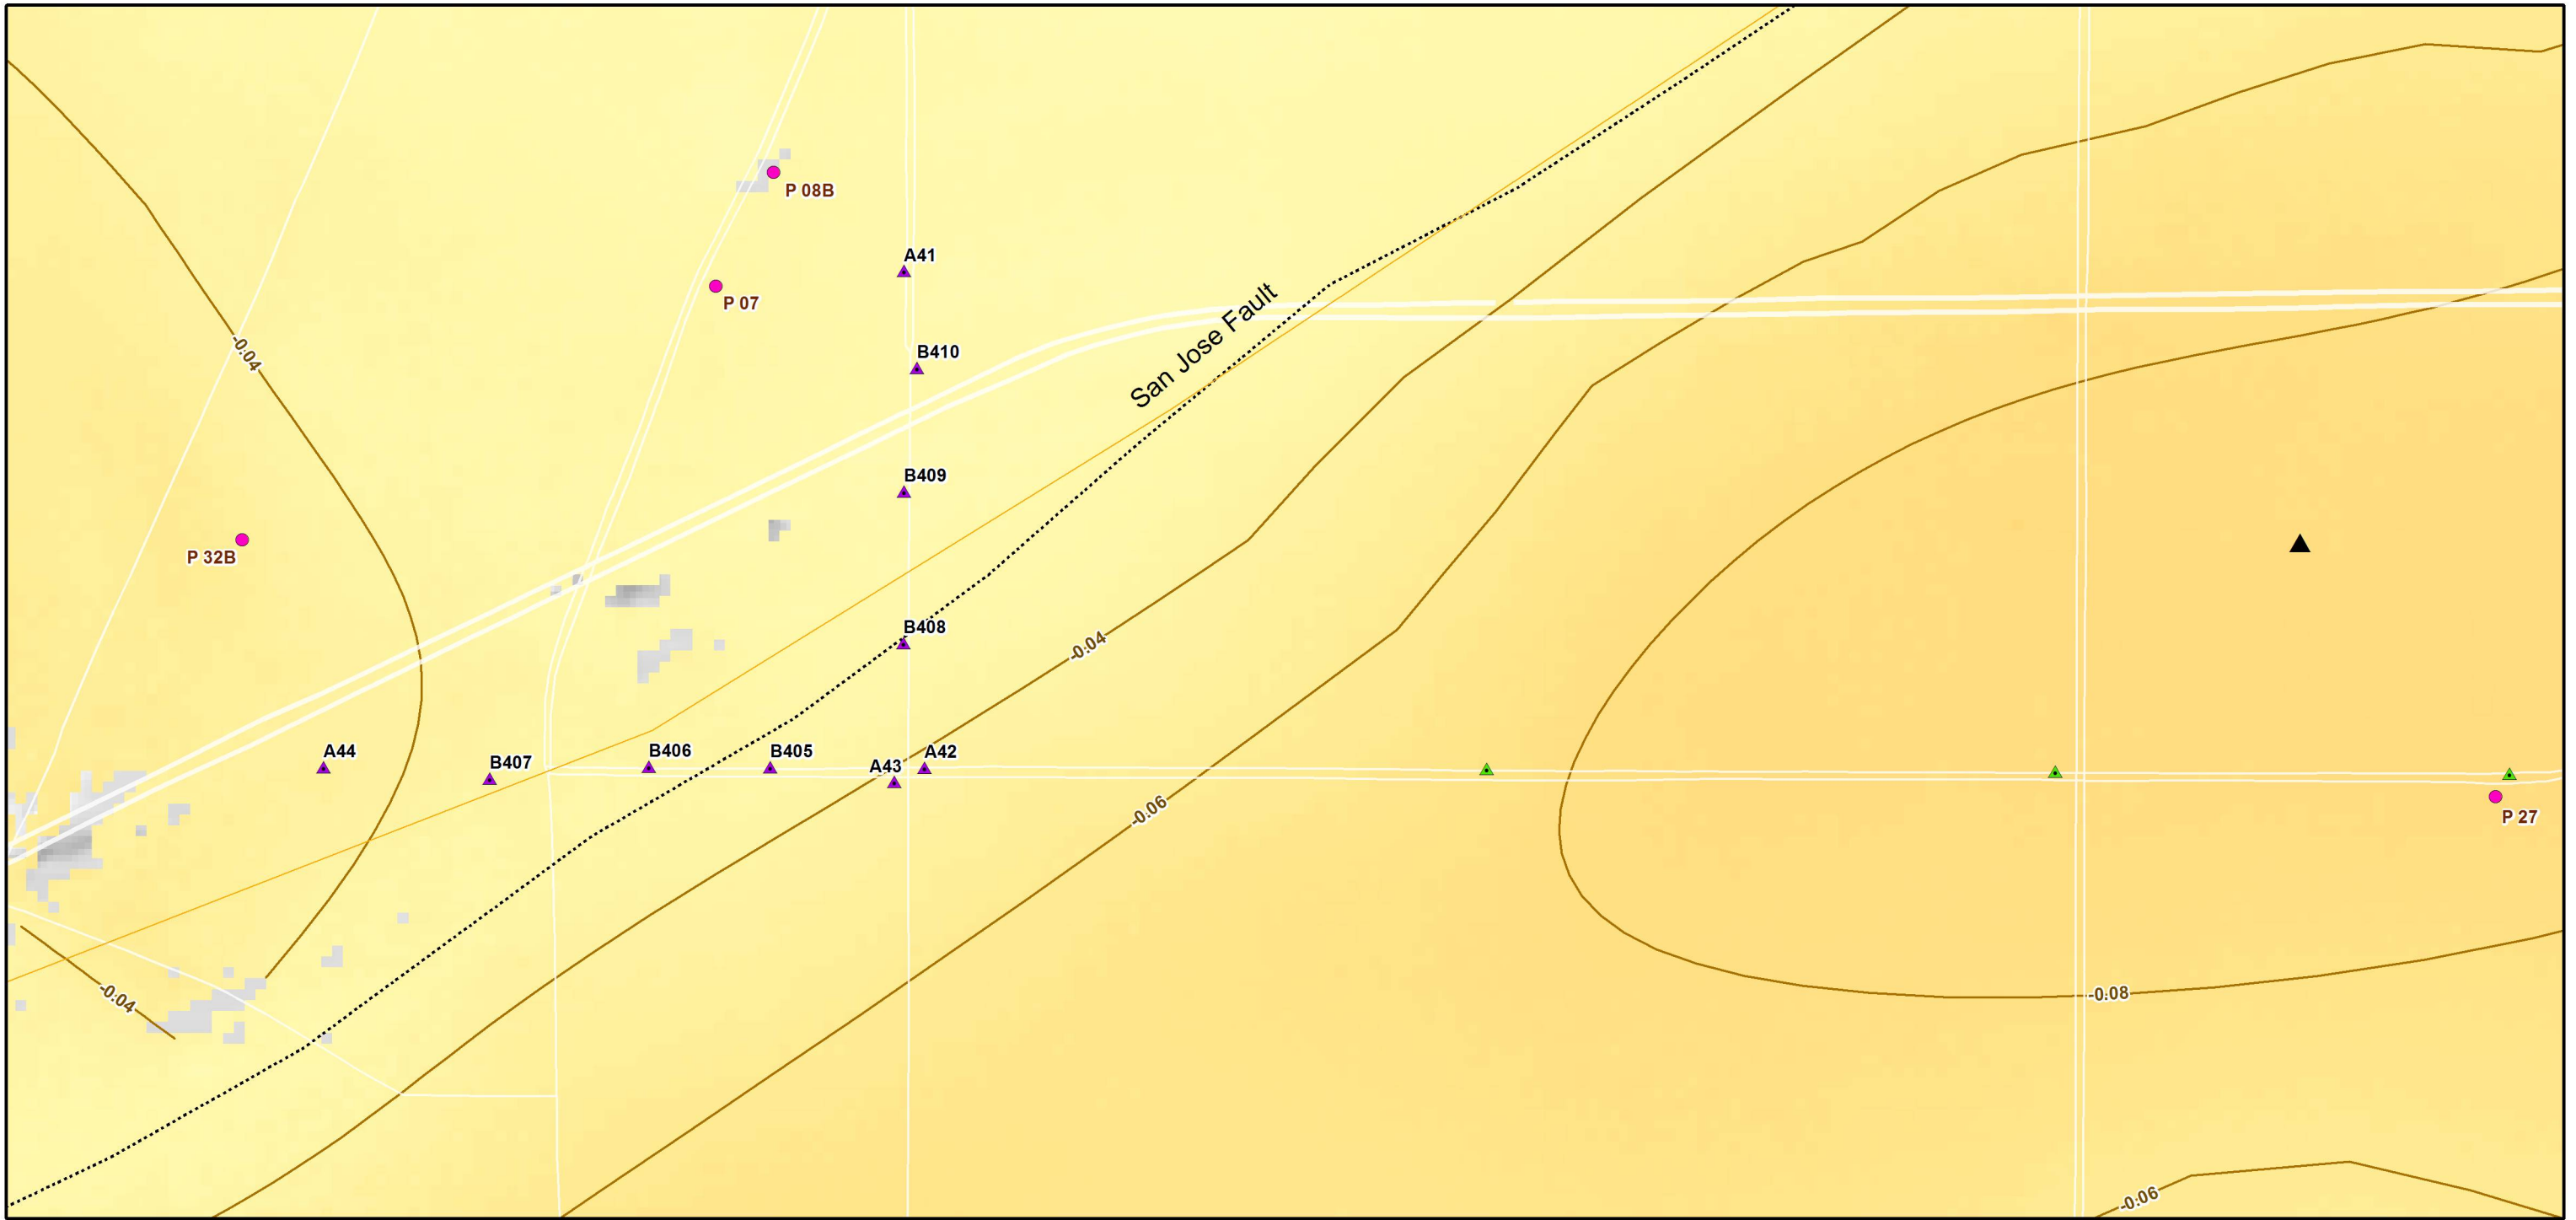
**Figure 3-16**

**Benchmark Monuments  
Across the San Jose Fault**

To identify the potential areas of accumulation of tensile horizontal strain in the shallow soils in this area, annual EDM surveys between benchmark monuments that cross the San Jose Fault have been performed since 2014. Figure 3-16 displays: (i) the vertical ground motion that occurred in Northwest MZ-1 from 2014-2016 as measured by InSAR and (ii) the closely-spaced benchmark monuments where EDM surveys were performed across the San Jose Fault during 2014-2016. Figure 3-17 displays the time series of east/west-oriented and north/south-oriented strain between the pairs of closely-spaced monuments, shown on Figure 3-16, during 2014-2016. Although tensile strain has been calculated from the EDMs between some monuments (e.g. B-409 to B-408), it is pre-mature to draw conclusions at this point. The GLMC should recommend the continuance of annual elevation and EDM surveys across the San Jose Fault Zone during the development of the *Subsidence Management Plan for the Northwest MZ-1 Area*.
